PARTIAL DISCHARGE REPORT

CUSTOMER: AJINOMOTO CO., (THAILAND) LTD.

FACTORY: BIRDY

DATE: AUGUST 8th, 2019

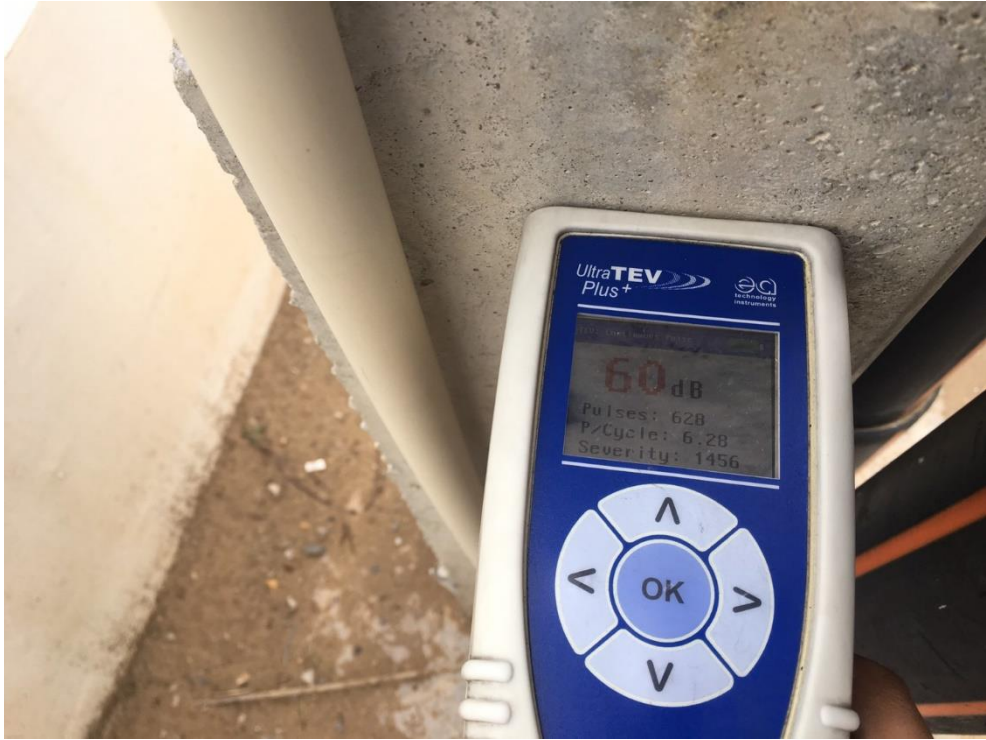
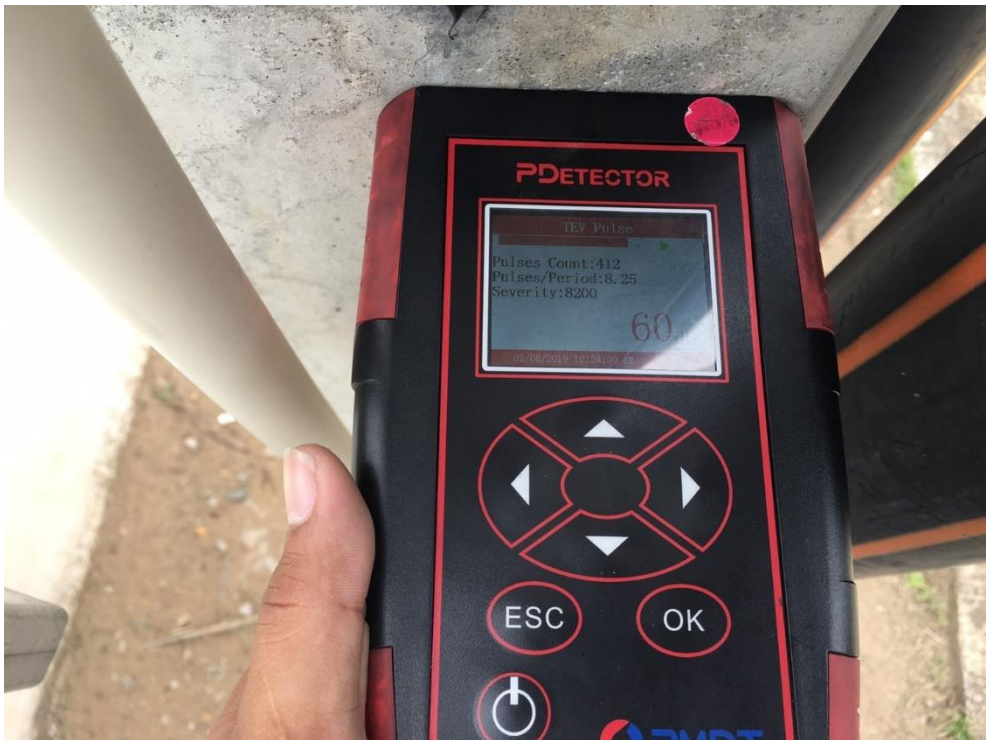
จากการตรวจสอบหา PARTIAL DISCHARGE ภายในบริษัท AJINOMOTO CO., (THAILAND) LTD. FACTORY BIRDY เมื่อวันที่ 8 สิงหาคม 2562 ผลการตรวจสอบพบการเกิด PARTIAL DISCHARGE ขึ้นที่ CT,PT ดังนั้นควรขึ้นไปตรวจสอบ DEFACT ที่เกิดขึ้น โดยการปลด HOTLINE CLAMP ก่อนเข้า DISCONNECTING SWITCH ออกเพื่อความปลอดภัยต่อผู้ปฏิบัติงาน หากตรวจสอบแล้วพบการ DEFACT ควรหาแนวทางแก้ไขโดยด่วน หากปล่อยไว้ จะทำให้เกิดการระเบิดและเป็นอันตราย และควรตรวจสอบทุกๆ ปี เพื่อดูแนวโน้มการเปลี่ยนแปลง

POSITION	YEAR	TEV (dB)	RESULT
POLE	2017	22	Normal
	2018	59	Warning
	2019	60	Critical

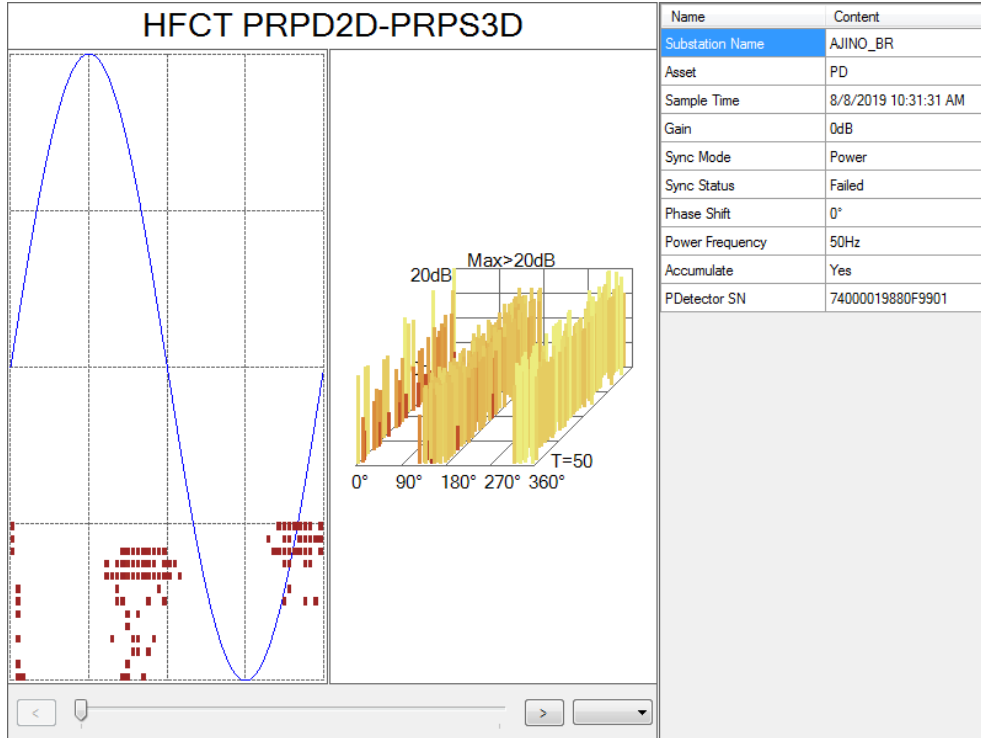
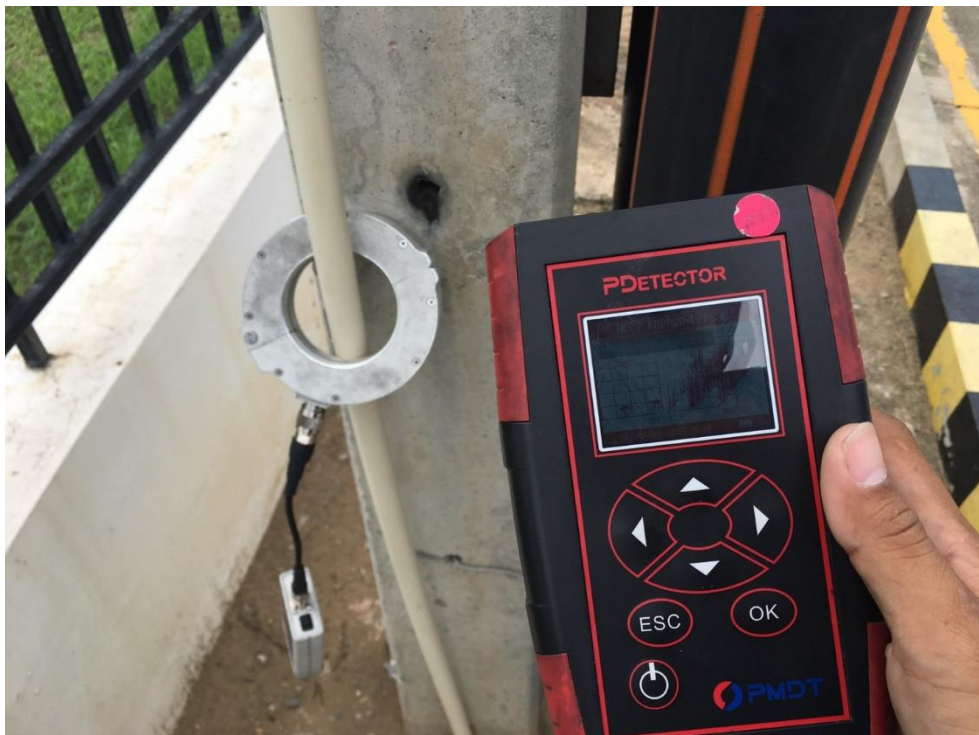
2. PARTIAL DISCHARGE DETECTED METHOD BY HFCT MODE

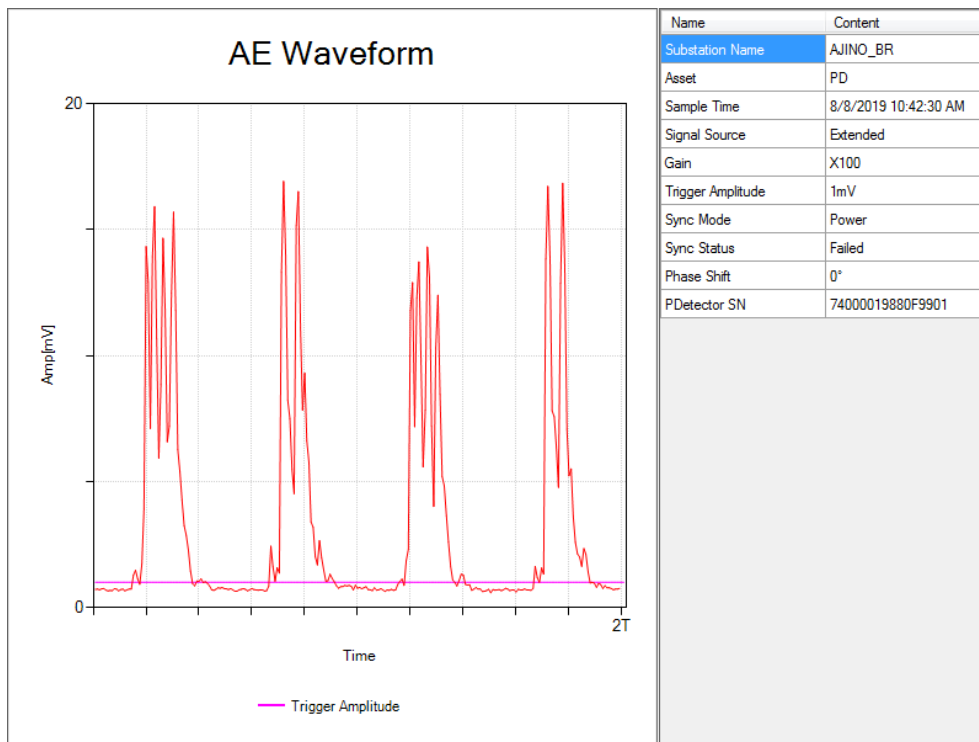
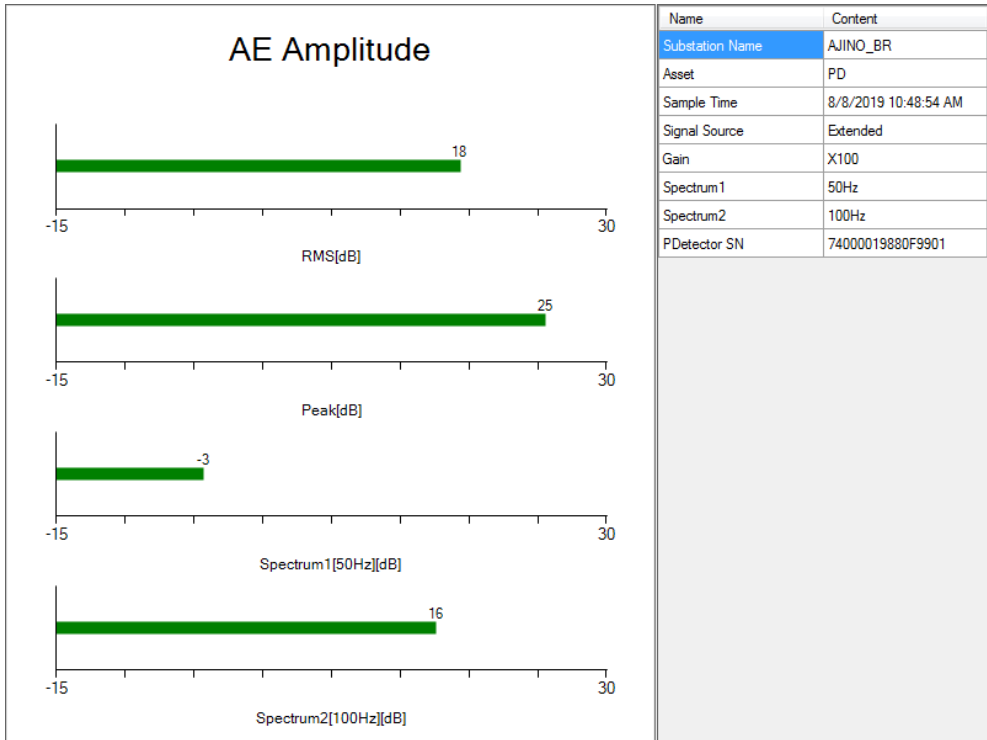
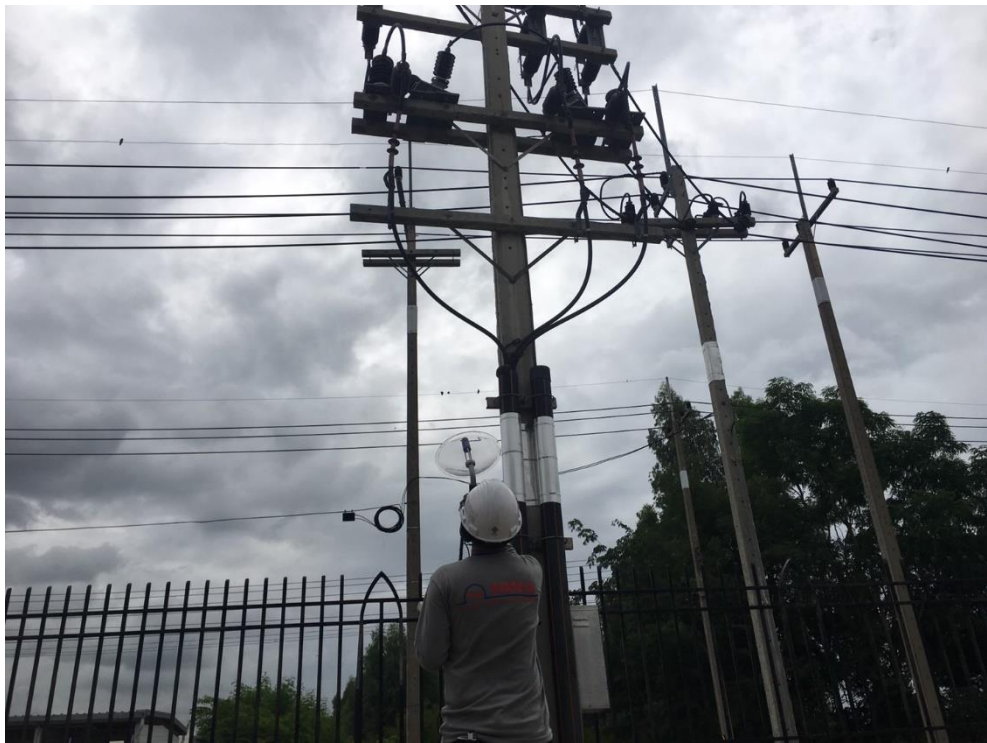
PARTIAL DISCHARGE DETECTED METHOD BY ULTRADISH MODE

POSITION	YEAR	ULTRADISH MODE (dB)	SHOULD BE
POLE	2018	23	6
	2019	25

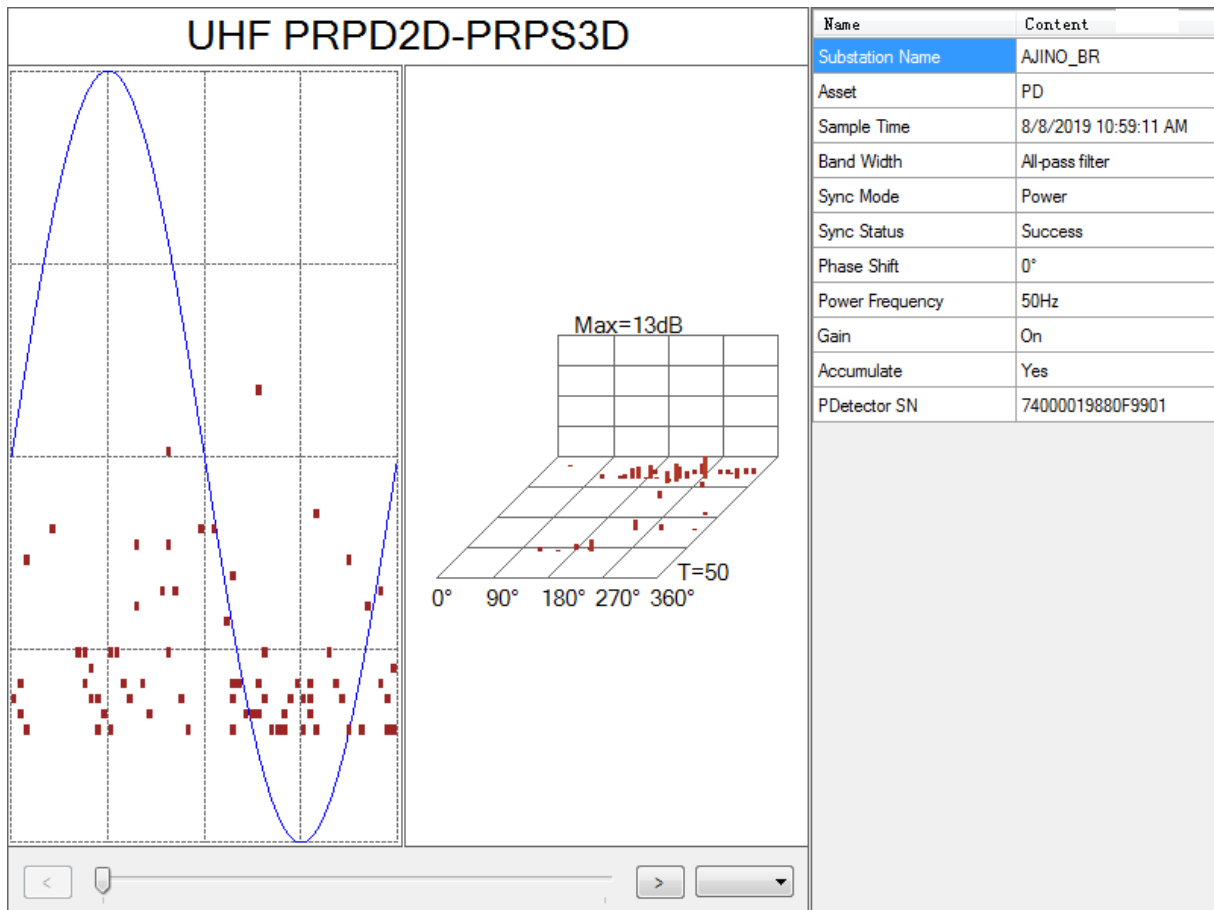
FACTORY	AJINOMOTO CO., (THAILAND) LTD.
SUBSTATION	DISTRIBUTION POLE METERING
VOLTAGE LEVEL	22 kV
POSITION	POLE
PANEL NAME	DROP OUT FUSE
POWER FREQUENCY	50 Hz

COMMENT	No partial discharge (PD) was found.
EVALUATION	Nomal
SUGGESTION	No action
TESTED AND REPORTED BY	Mr.Tukdanai Pothanak
APPROVED BY	Mr.Chanvit Crukaew

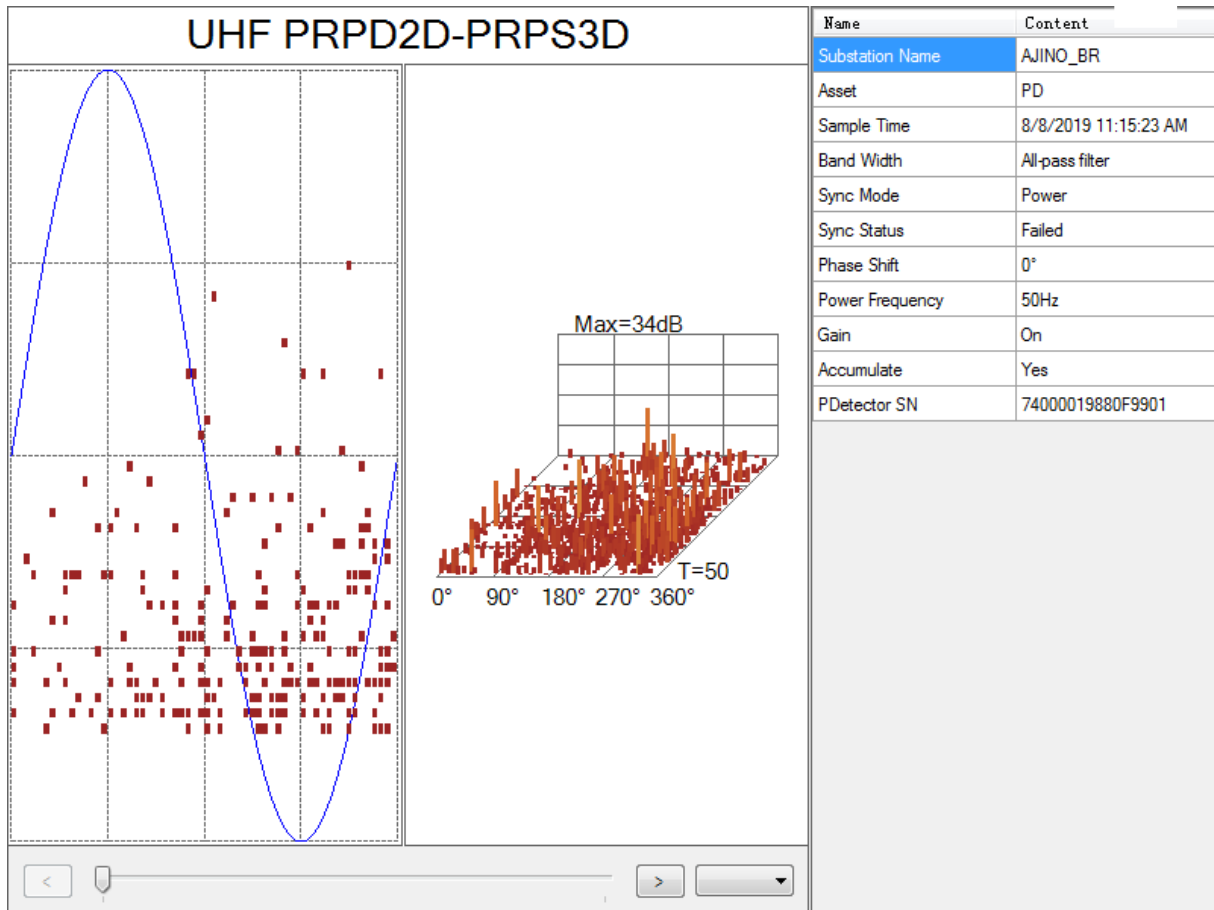
FACTORY	AJINOMOTO CO., (THAILAND) LTD.
SUBSTATION	SUBSTATION NO.1
VOLTAGE LEVEL	22 kV
POSITION	RING MAIN UNIT
PANEL NAME	RMU SUBSTATION NO.1
POWER FREQUENCY	50 Hz

COMMENT	No partial discharge (PD) was found.
EVALUATION	Nomal
SUGGESTION	No action
TESTED AND REPORTED BY	Mr.Tukdanai Pothanak
APPROVED BY	Mr.Chanvit Crukaew

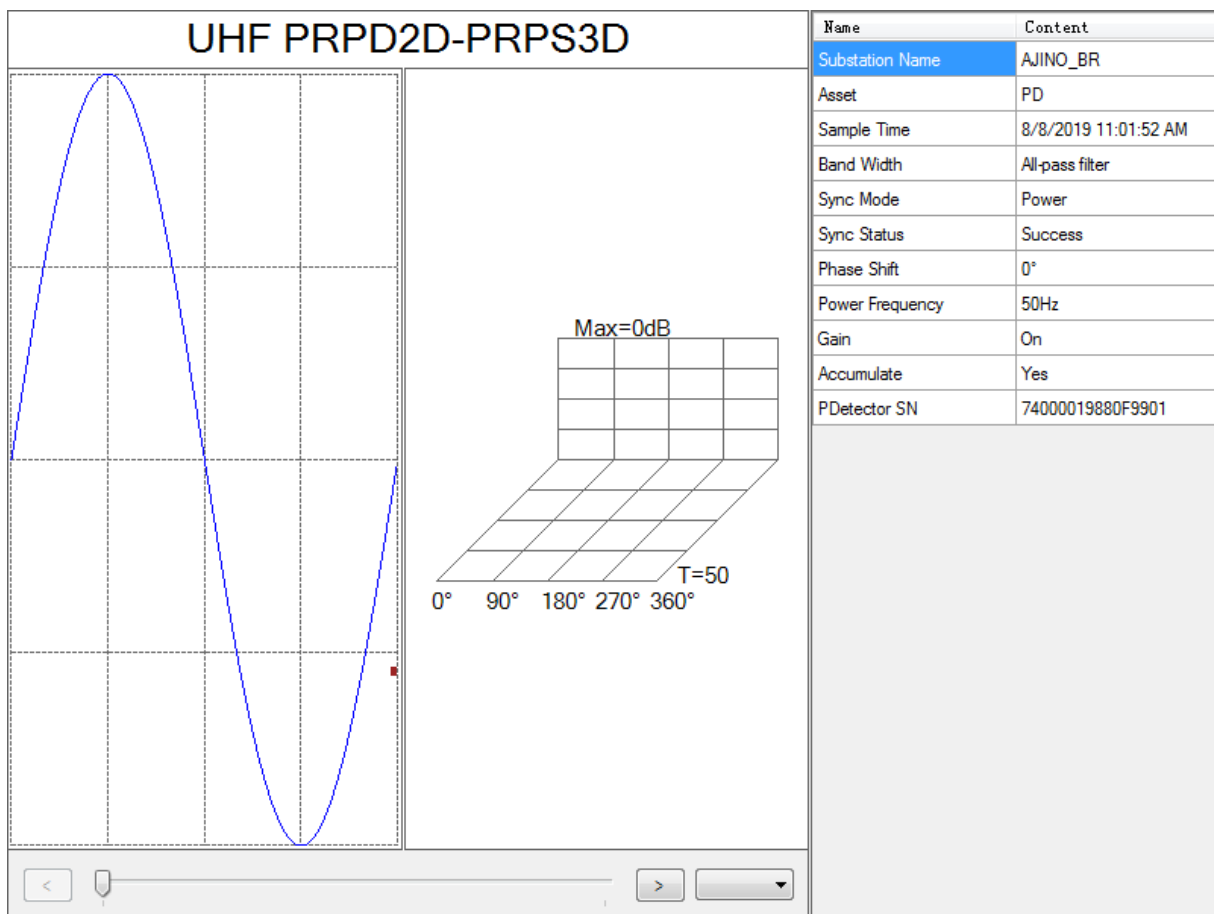
FACTORY	AJINOMOTO CO., (THAILAND) LTD.
SUBSTATION	SUBSTATION NO.1
VOLTAGE LEVEL	22 kV
POSITION	DISTRIBUTION TRANSFORMER
PANEL NAME	TR NO.1 2000 kVA
POWER FREQUENCY	50 Hz

COMMENT	No partial discharge (PD) was found.
EVALUATION	Nomal
SUGGESTION	No action
TESTED AND REPORTED BY	Mr.Tukdanai Pothanak
APPROVED BY	Mr.Chanvit Crukaew

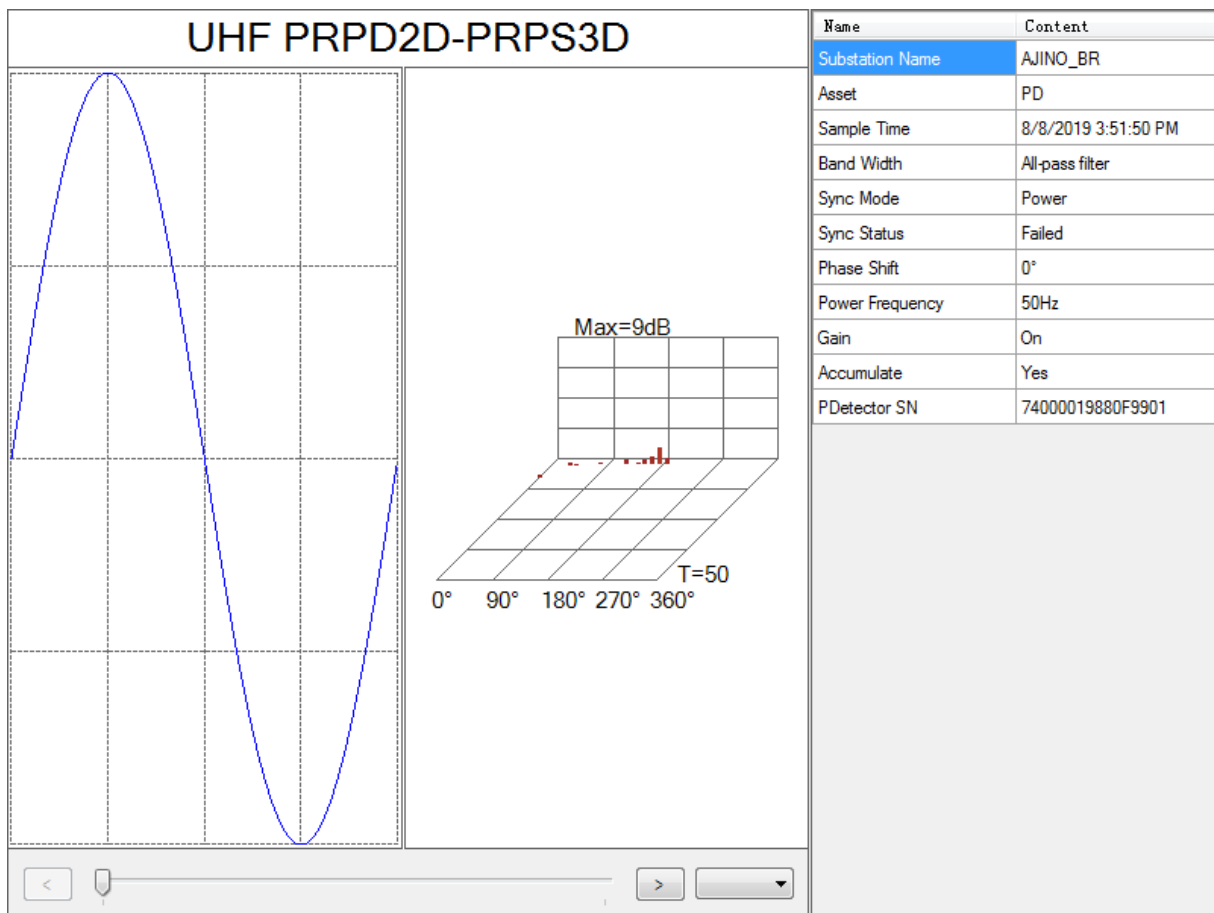
FACTORY	AJINOMOTO CO., (THAILAND) LTD.
SUBSTATION	SUBSTATION NO.2
VOLTAGE LEVEL	22 kV
POSITION	RING MAIN UNIT
PANEL NAME	RMU SUBSTATION NO.2
POWER FREQUENCY	50 Hz

COMMENT	No partial discharge (PD) was found.
EVALUATION	Nomal
SUGGESTION	No action
TESTED AND REPORTED BY	Mr.Tukdanai Pothanak
APPROVED BY	Mr.Chanvit Crukaew

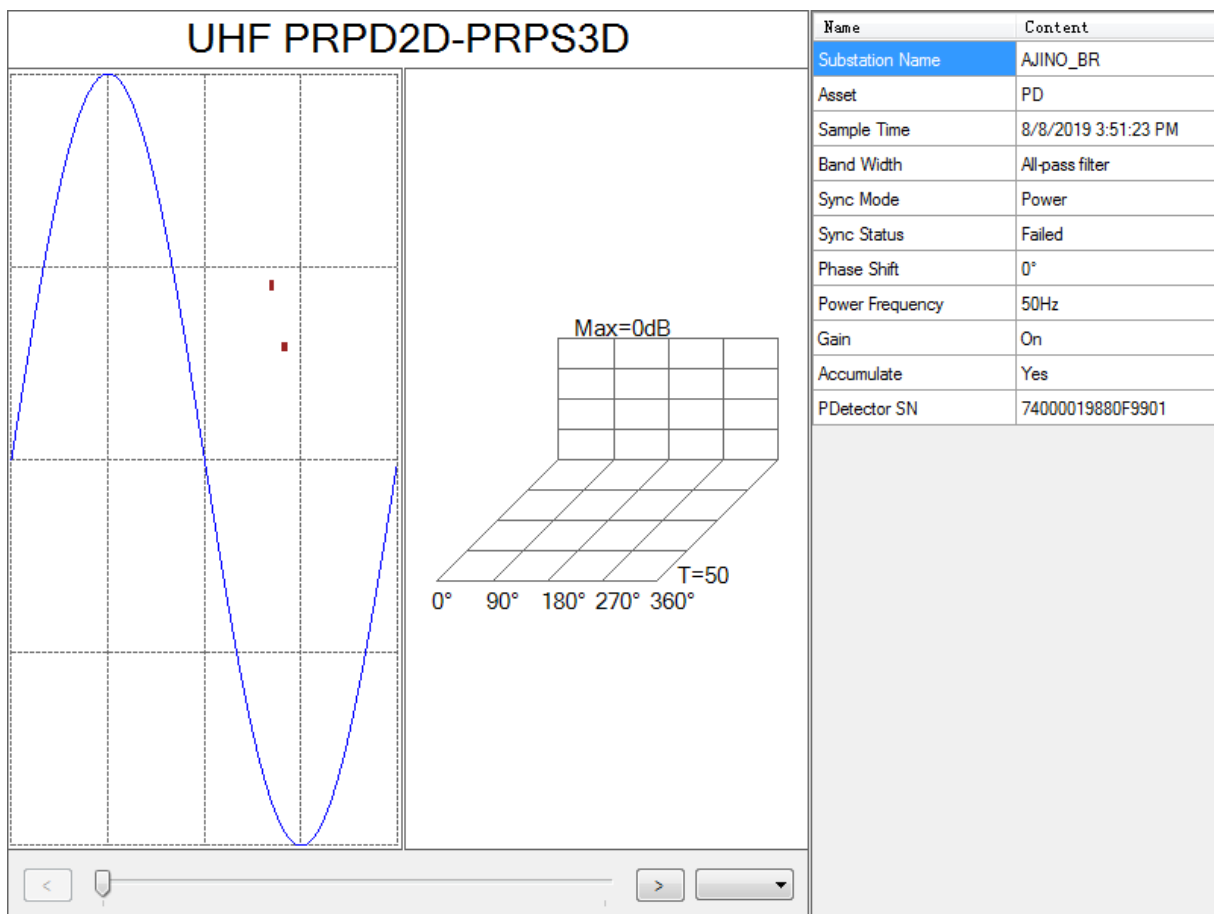
FACTORY	AJINOMOTO CO., (THAILAND) LTD.
SUBSTATION	SUBSTATION NO.2
VOLTAGE LEVEL	22 kV
POSITION	DISTRIBUTION TRANSFORMER
PANEL NAME	TR NO.2 2000 kVA
POWER FREQUENCY	50 Hz

COMMENT	No partial discharge (PD) was found.
EVALUATION	Nomal
SUGGESTION	No action
TESTED AND REPORTED BY	Mr.Tukdanai Pothanak
APPROVED BY	Mr.Chanvit Crukaew

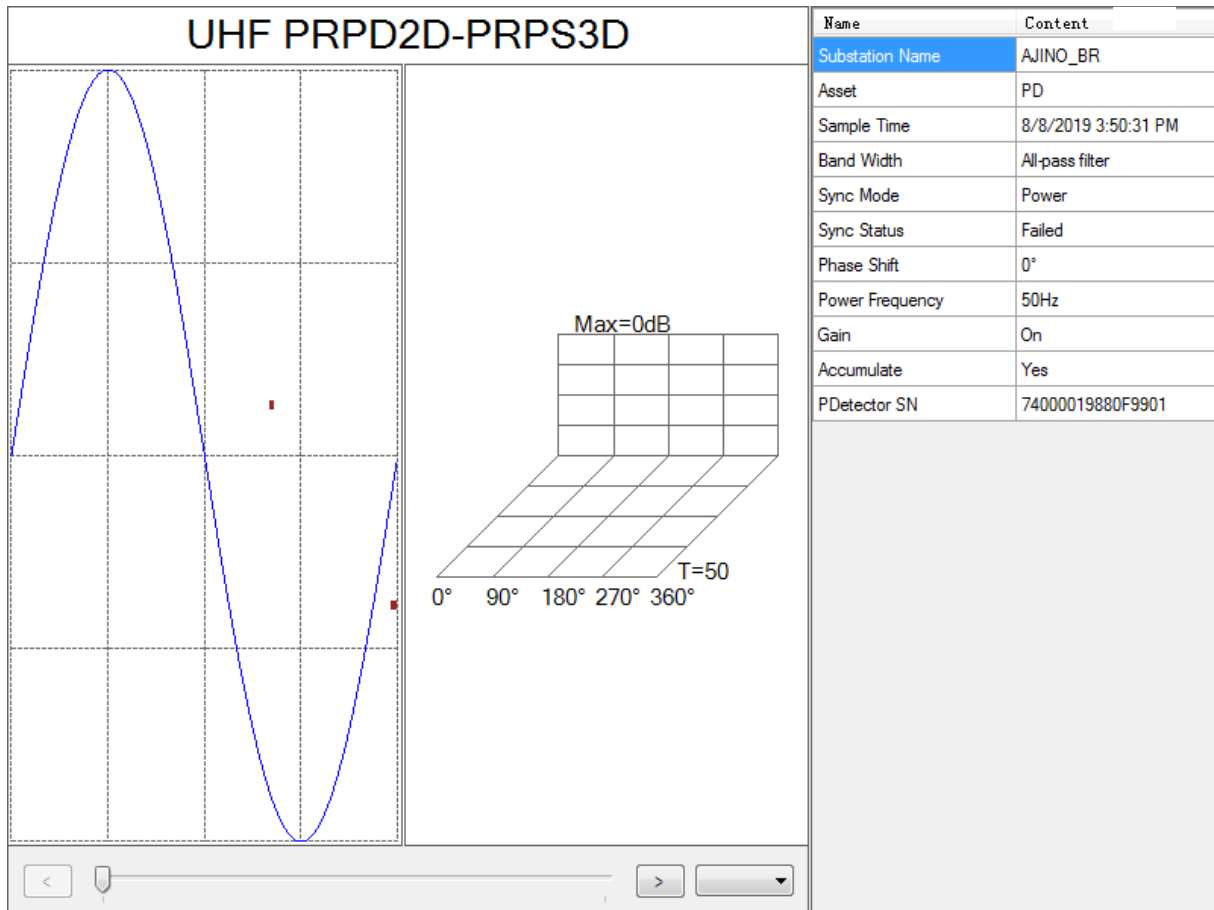
FACTORY	AJINOMOTO CO., (THAILAND) LTD.
SUBSTATION	SUBSTATION NO.3
VOLTAGE LEVEL	22 kV
POSITION	DISTRIBUTION TRANSFORMER
PANEL NAME	TR NO.3 2000 kVA
POWER FREQUENCY	50 Hz

COMMENT	No partial discharge (PD) was found.
EVALUATION	Nomal
SUGGESTION	No action
TESTED AND REPORTED BY	Mr.Tukdanai Pothanak
APPROVED BY	Mr.Chanvit Crukaew

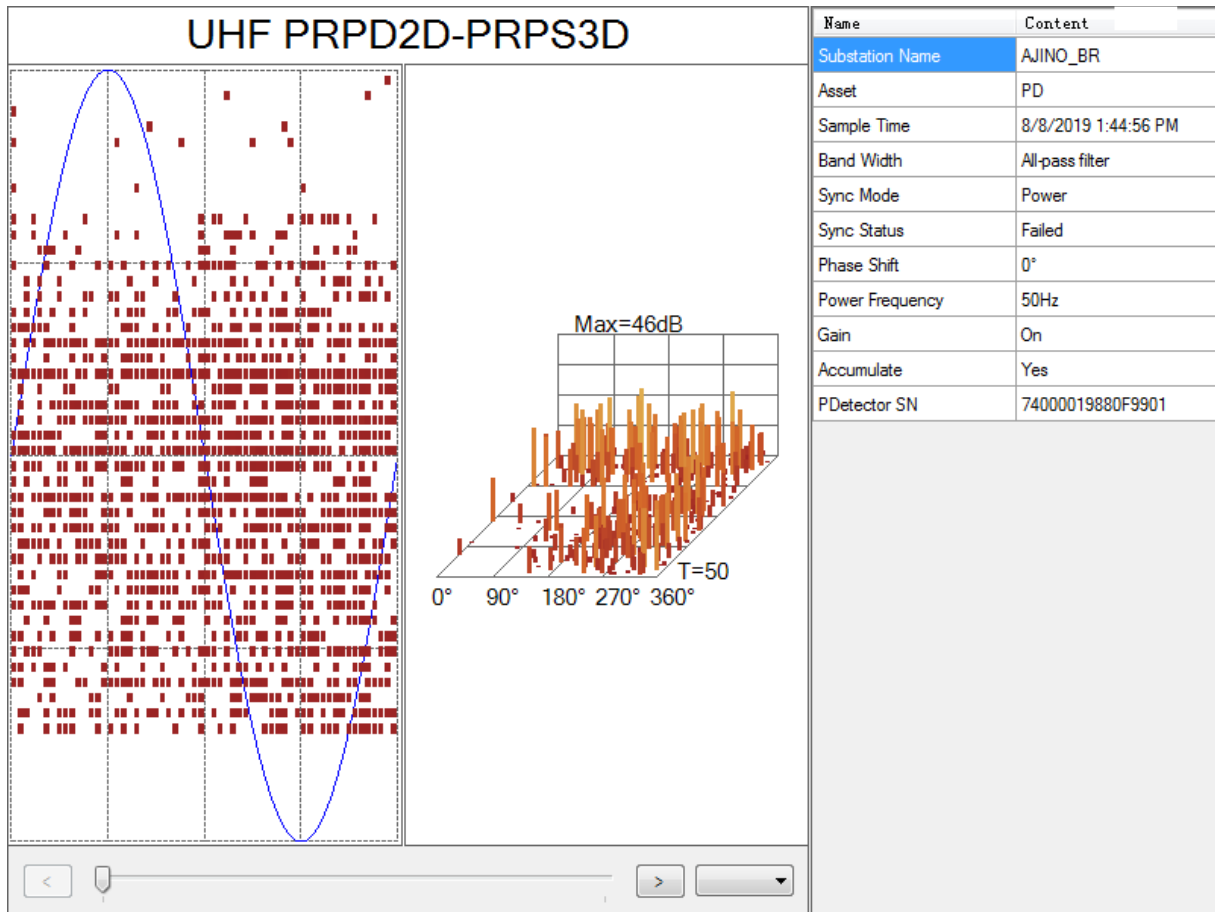
FACTORY	AJINOMOTO CO., (THAILAND) LTD.
SUBSTATION	SUBSTATION NO.4
VOLTAGE LEVEL	22 kV
POSITION	RING MAIN UNIT
PANEL NAME	RMU SUBSTATION NO.4
POWER FREQUENCY	50 Hz

COMMENT	No partial discharge (PD) was found.
EVALUATION	Nomal
SUGGESTION	No action
TESTED AND REPORTED BY	Mr.Tukdanai Pothanak
APPROVED BY	Mr.Chanvit Crukaew

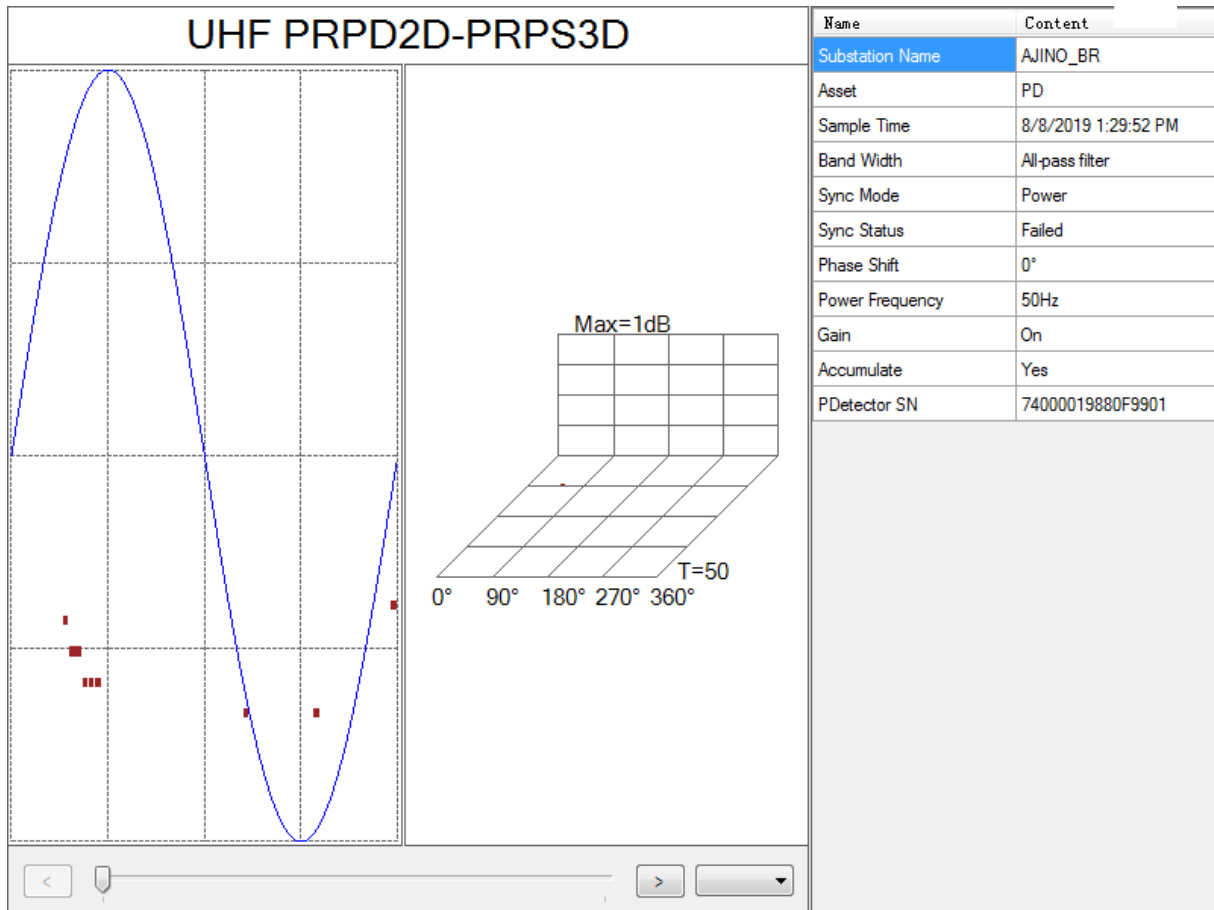
FACTORY	AJINOMOTO CO., (THAILAND) LTD.
SUBSTATION	SUBSTATION NO.4
VOLTAGE LEVEL	22 kV
POSITION	DISTRIBUTION TRANSFORMER
PANEL NAME	TR NO.4
POWER FREQUENCY	50 Hz

COMMENT	No partial discharge (PD) was found.
EVALUATION	Nomal
SUGGESTION	No action
TESTED AND REPORTED BY	Mr.Tukdanai Pothanak
APPROVED BY	Mr.Chanvit Crukaew

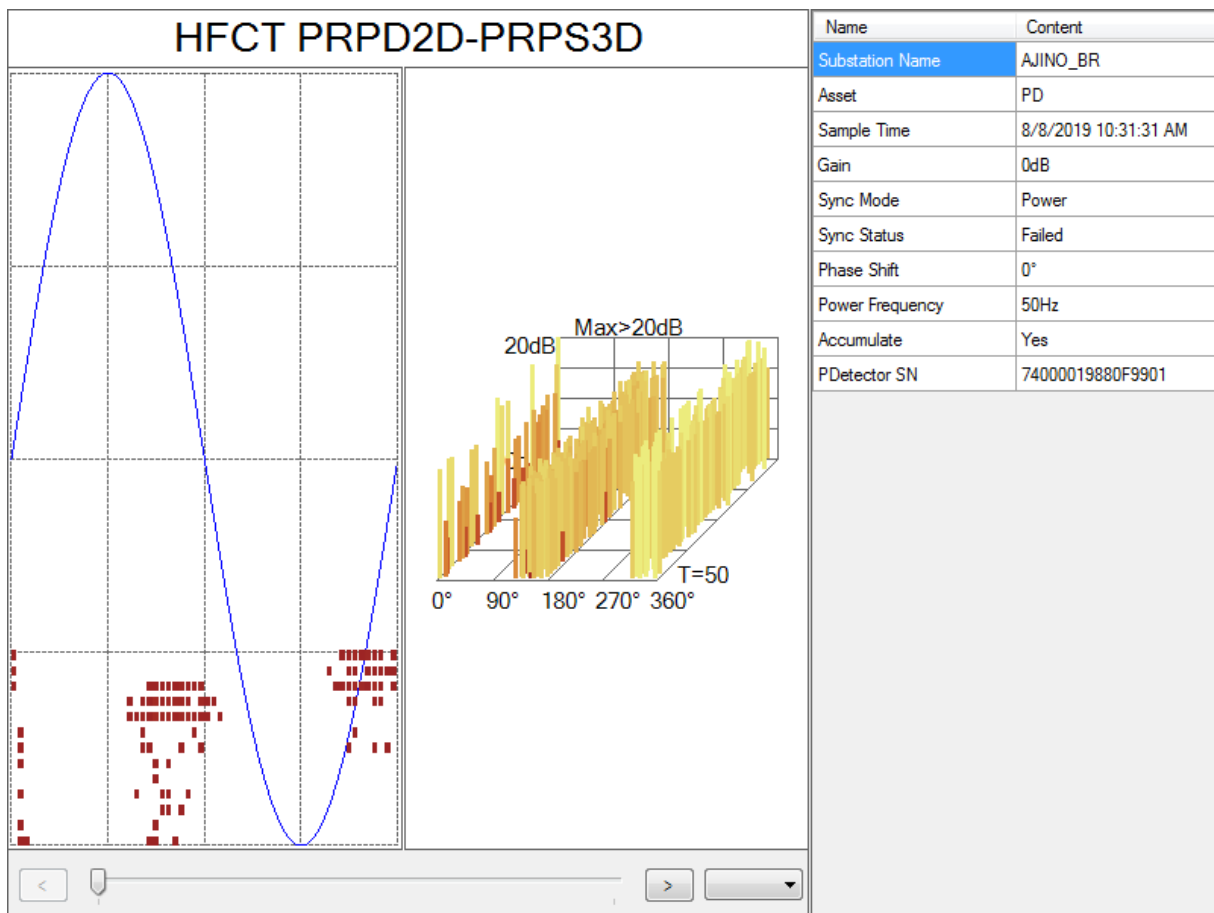
FACTORY	AJINOMOTO CO., (THAILAND) LTD.
SUBSTATION	DISTRIBUTION POLE METERING
VOLTAGE LEVEL	22 kV
POSITION	POLE
PANEL NAME	DROP OUT FUSE
POWER FREQUENCY	50 Hz

COMMENT	partial discharge (PD) was found.
EVALUATION	Warning
SUGGESTION	See in the summery
TESTED AND REPORTED BY	Mr.Tukdanai Pothanak
APPROVED BY	Mr.Chanvit Crukaew

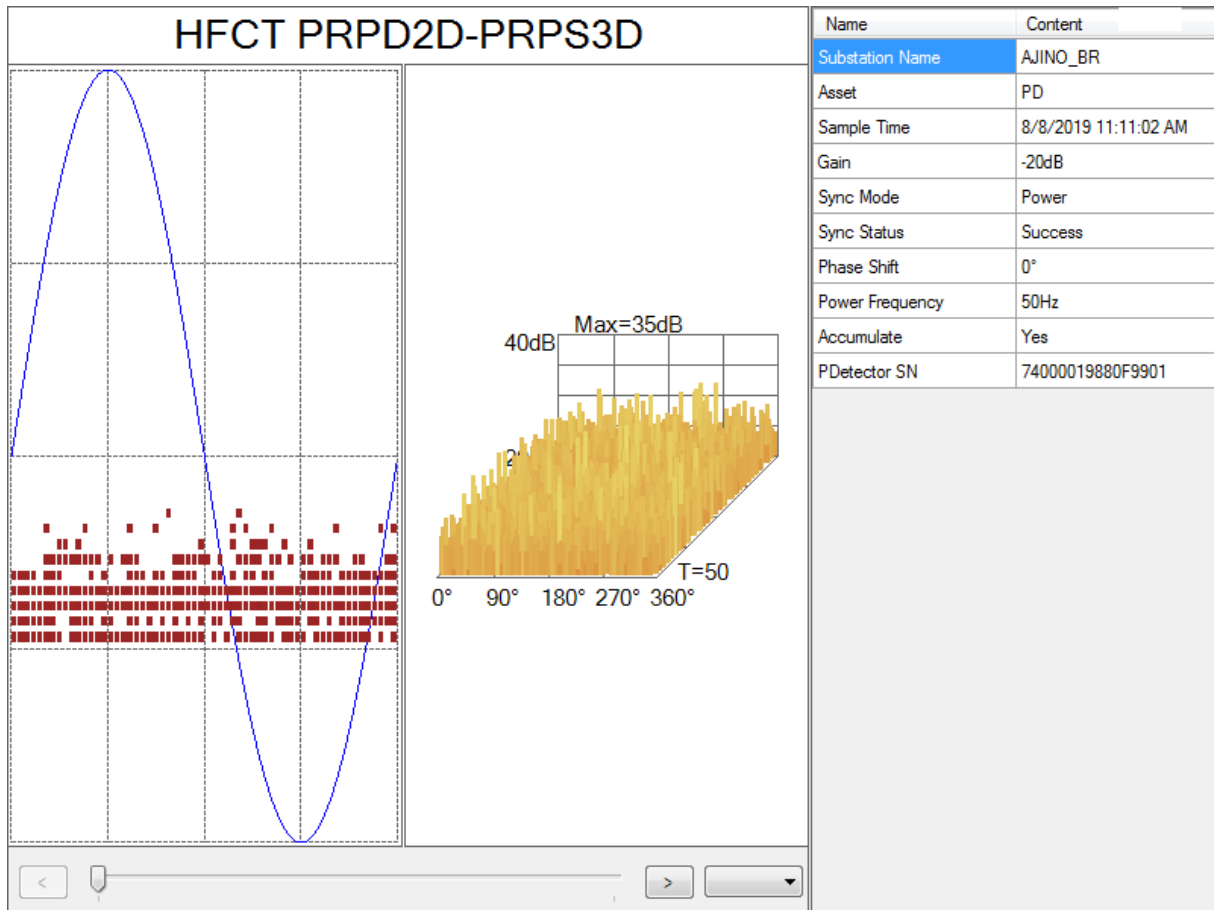
FACTORY	AJINOMOTO CO., (THAILAND) LTD.
SUBSTATION	SUBSTATION NO.1
VOLTAGE LEVEL	22 kV
POSITION	DISTRIBUTION TRANSFORMER
PANEL NAME	TR NO.1 2000 kVA
POWER FREQUENCY	50 Hz

COMMENT	No partial discharge (PD) was found.
EVALUATION	Nomal
SUGGESTION	No action
TESTED AND REPORTED BY	Mr.Tukdanai Pothanak
APPROVED BY	Mr.Chanvit Crukaew

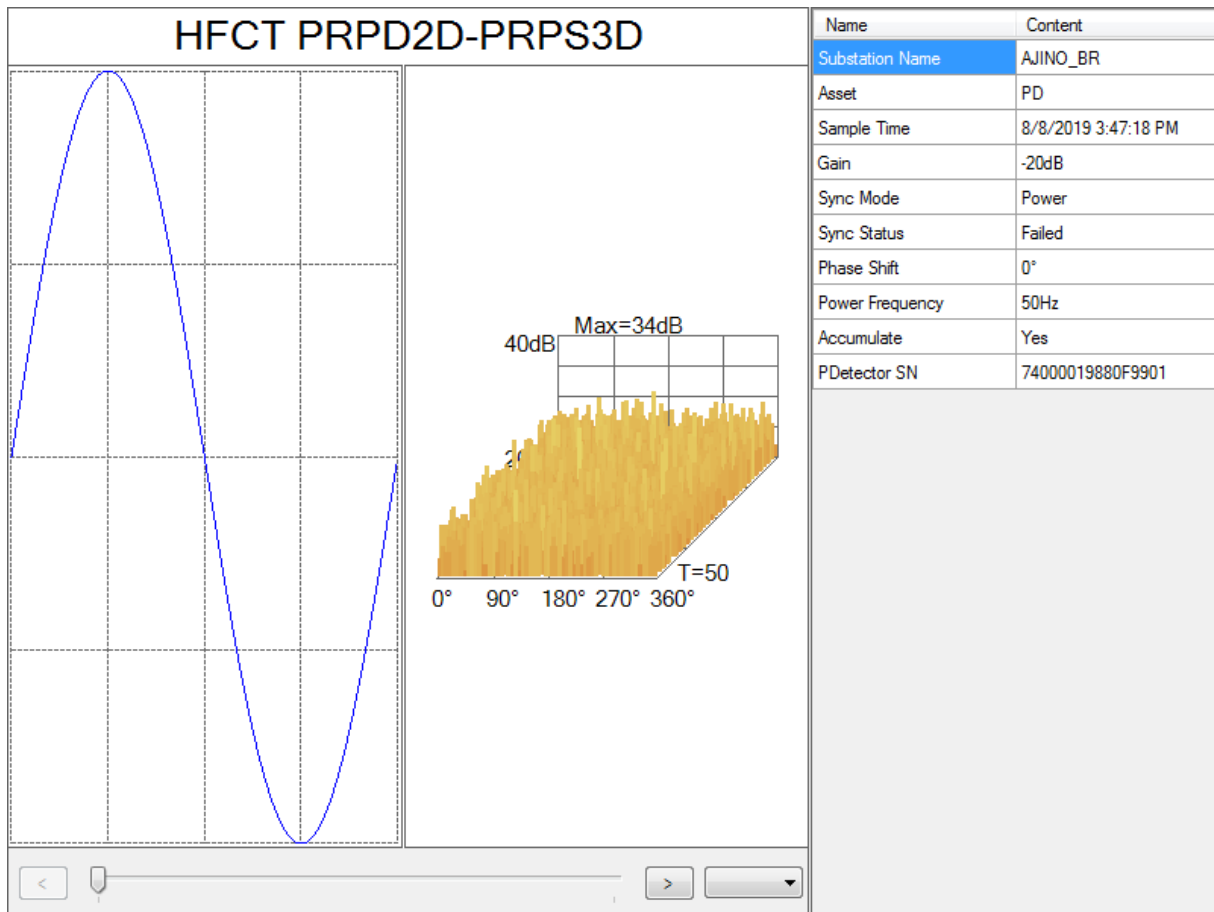
FACTORY	AJINOMOTO CO., (THAILAND) LTD.
SUBSTATION	SUBSTATION NO.2
VOLTAGE LEVEL	22 kV
POSITION	DISTRIBUTION TRANSFORMER
PANEL NAME	TR NO.2 2000 kVA
POWER FREQUENCY	50 Hz

COMMENT	No partial discharge (PD) was found.
EVALUATION	Nomal
SUGGESTION	No action
TESTED AND REPORTED BY	Mr.Tukdanai Pothanak
APPROVED BY	Mr.Chanvit Crukaew

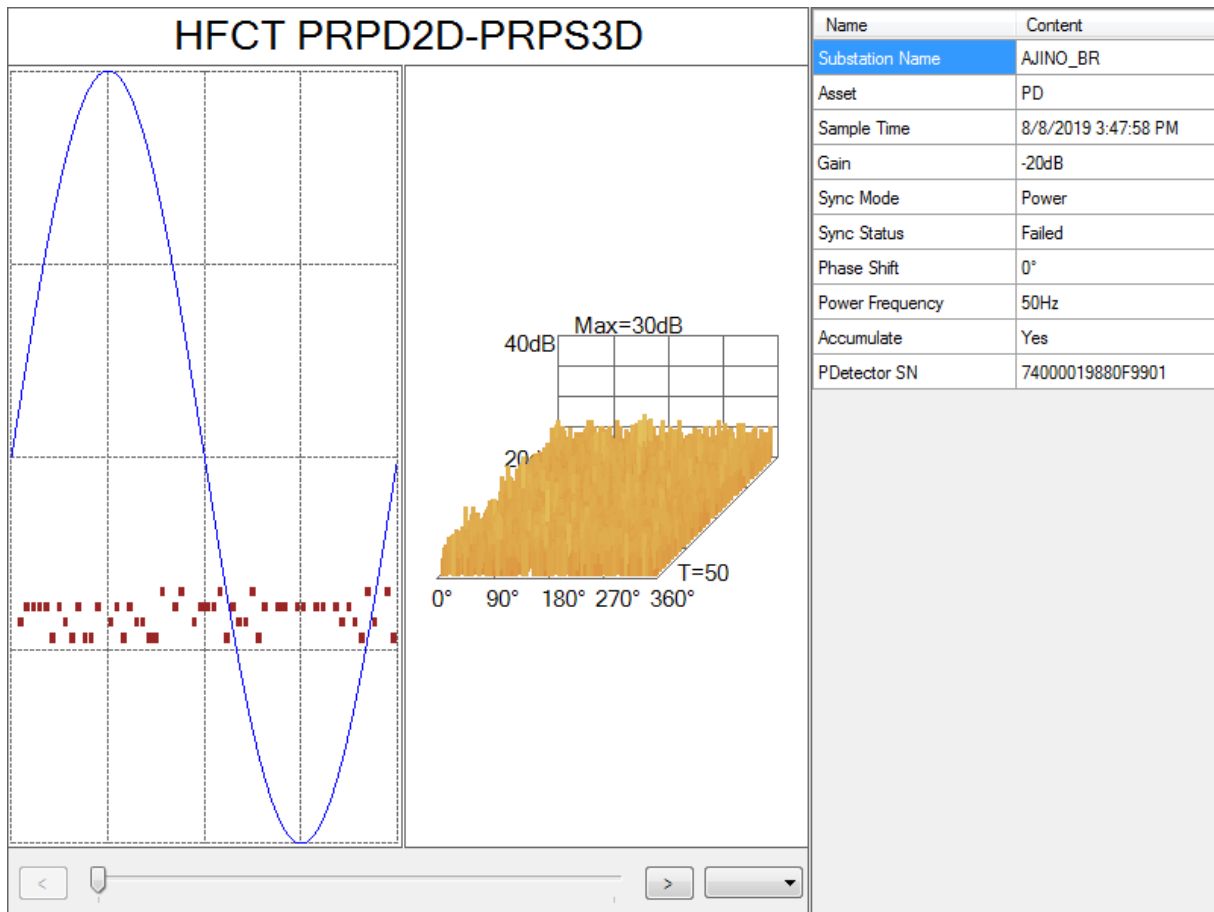
FACTORY	AJINOMOTO CO., (THAILAND) LTD.
SUBSTATION	SUBSTATION NO.3
VOLTAGE LEVEL	22 kV
POSITION	DISTRIBUTION TRANSFORMER
PANEL NAME	TR NO.3 2000 kVA
POWER FREQUENCY	50 Hz

COMMENT	No partial discharge (PD) was found.
EVALUATION	Nomal
SUGGESTION	No action
TESTED AND REPORTED BY	Mr.Tukdanai Pothanak
APPROVED BY	Mr.Chanvit Crukaew

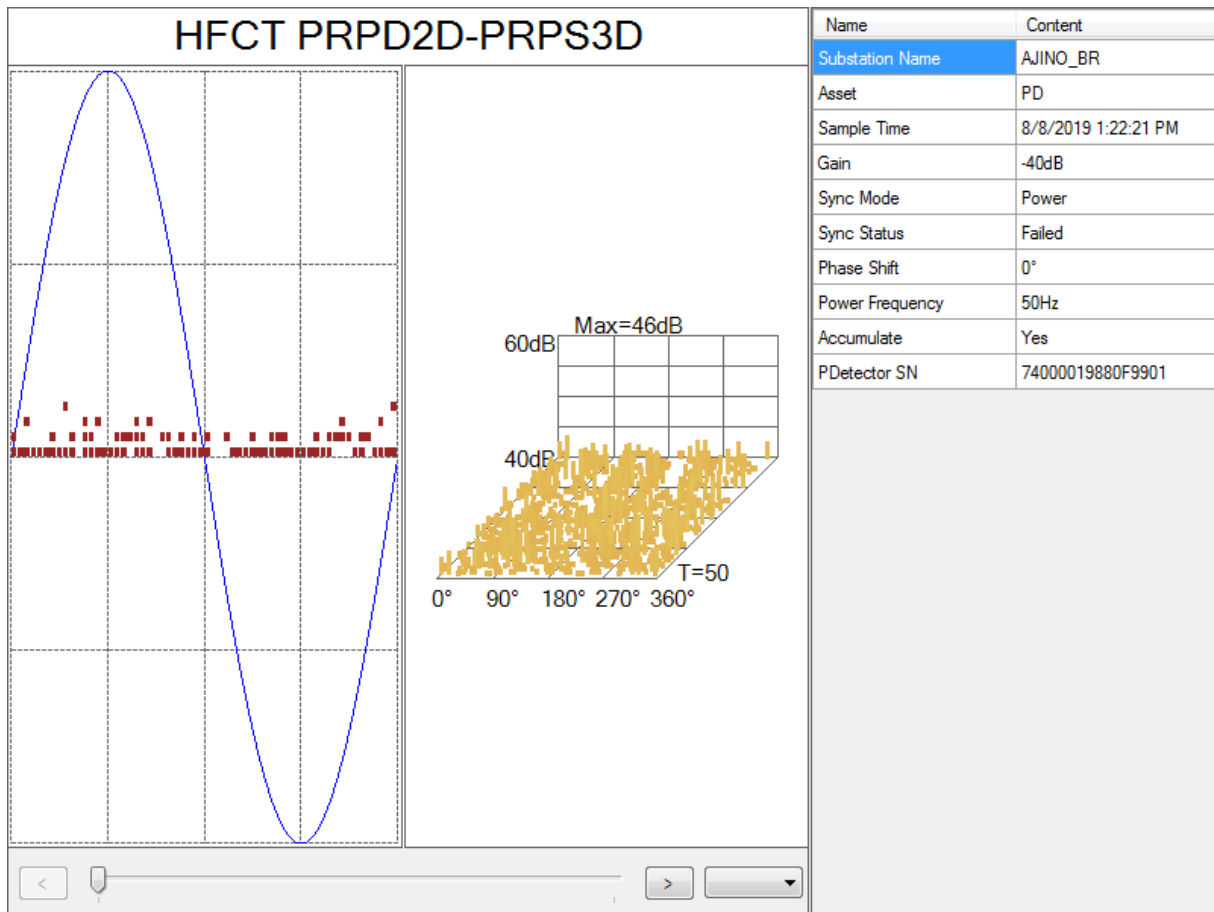
FACTORY	AJINOMOTO CO., (THAILAND) LTD.
SUBSTATION	SUBSTATION NO.4
VOLTAGE LEVEL	22 kV
POSITION	DISTRIBUTION TRANSFORMER
PANEL NAME	TR NO.4
POWER FREQUENCY	50 Hz

COMMENT	No partial discharge (PD) was found.
EVALUATION	Nomal
SUGGESTION	No action
TESTED AND REPORTED BY	Mr.Tukdanai Pothanak
APPROVED BY	Mr.Chanvit Crukaew

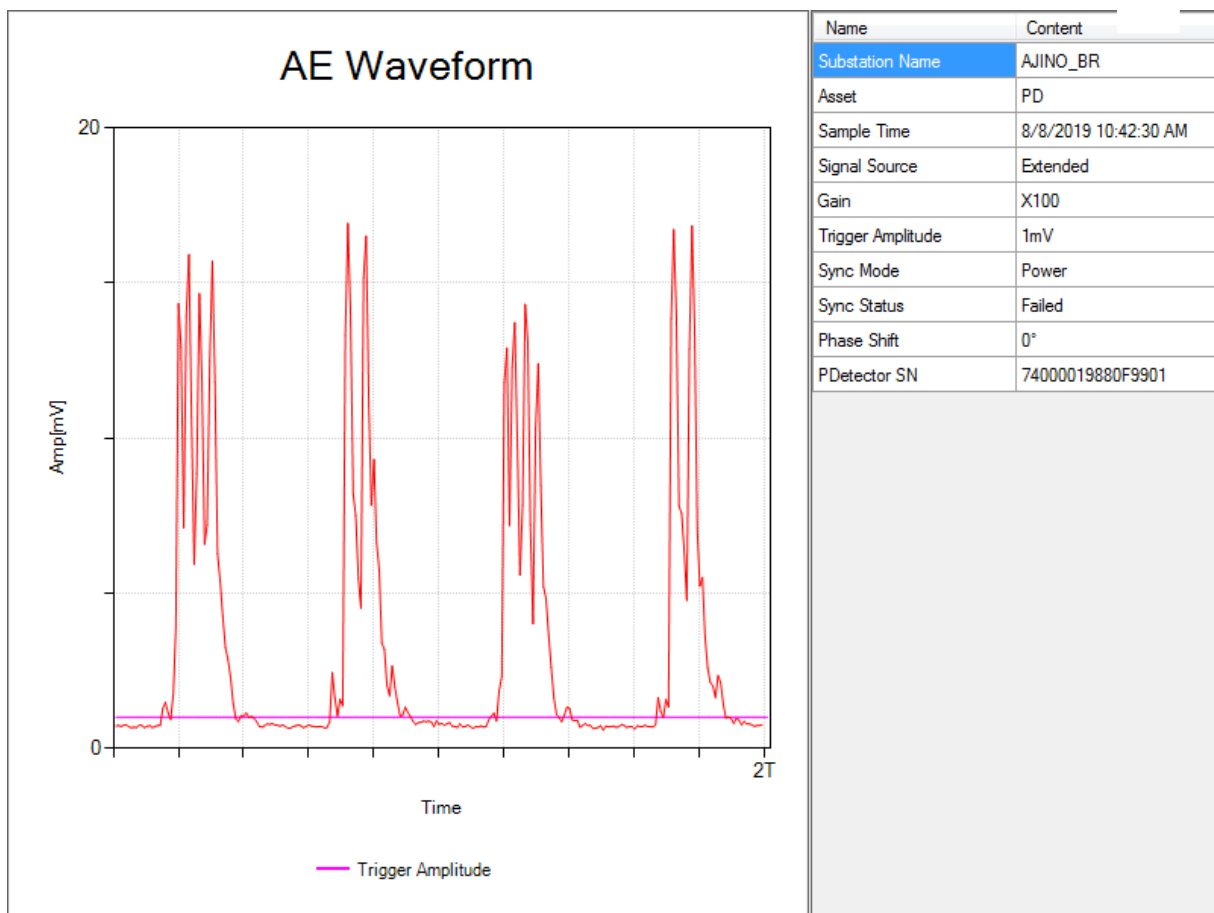
FACTORY	AJINOMOTO CO., (THAILAND) LTD.
SUBSTATION	DISTRIBUTION POLE METERING
VOLTAGE LEVEL	22 kV
POSITION	POLE
PANEL NAME	DROP OUT FUSE
POWER FREQUENCY	50 Hz

COMMENT	partial discharge (PD) was found.
EVALUATION	Warning
SUGGESTION	See in the summery
TESTED AND REPORTED BY	Mr.Tukdanai Pothanak
APPROVED BY	Mr.Chanvit Crukaew
