PARTIAL DISCHARGE REPORT

CUSTOMER: AJINOMOTO CO., (THAILAND) LTD.

FACTORY: BIRDY

DATE: AUGUST 8th, 2019

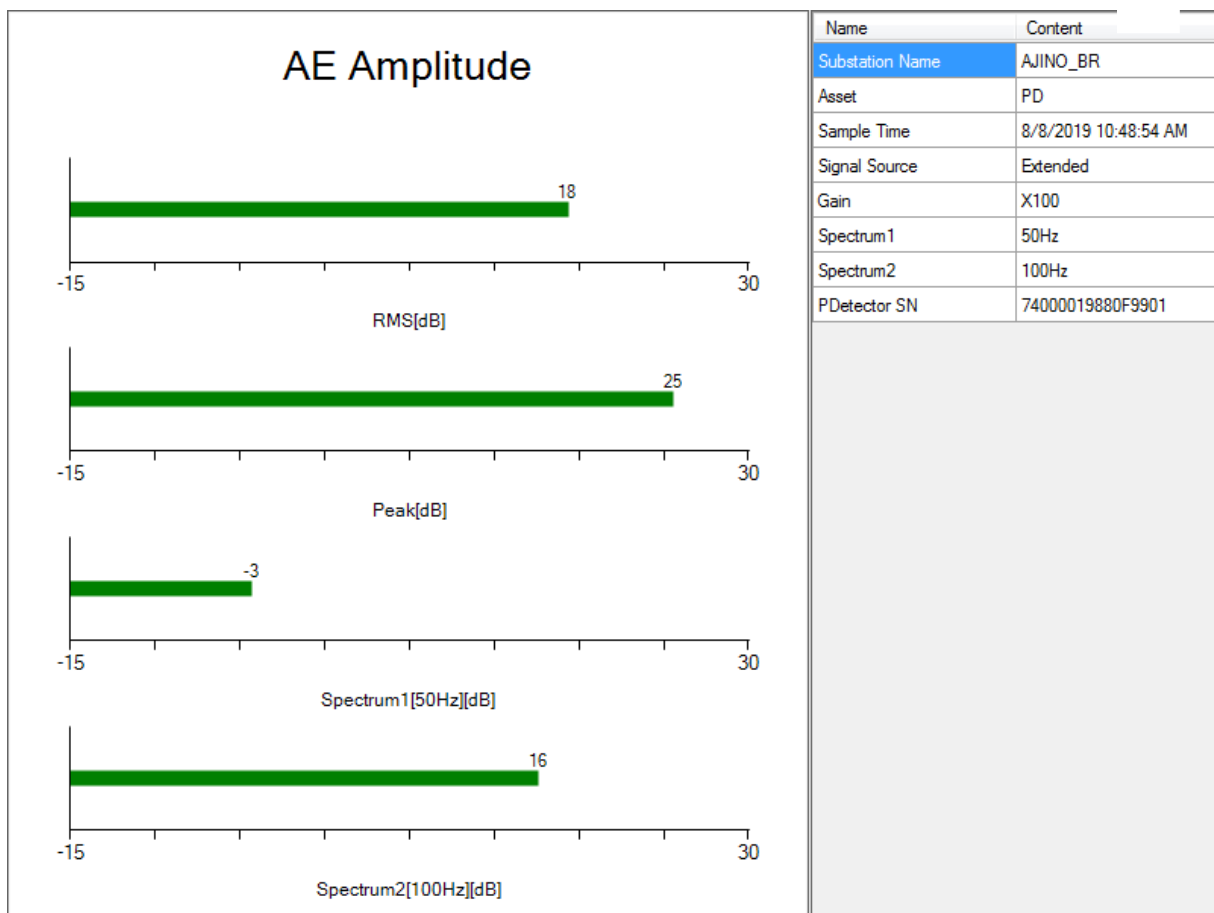
FACTORY	AJINOMOTO CO., (THAILAND) LTD.
SUBSTATION	DISTRIBUTION POLE METERING
VOLTAGE LEVEL	22 kV
POSITION	POLE
PANEL NAME	DROP OUT FUSE
POWER FREQUENCY	50 Hz

COMMENT	partial discharge (PD) was found.
EVALUATION	Warning
SUGGESTION	See in the summery
TESTED AND REPORTED BY	Mr.Tukdanai Pothanak
APPROVED BY	Mr.Chanvit Crukaew

จากการตรวจสอบหา PARTIAL DISCHARGE ภายในบริษัท AJINOMOTO CO., (THAILAND) LTD. FACTORY BIRDY เมื่อวันที่ 8 สิงหาคม 2562 ผลการตรวจสอบพบการเกิด PARTIAL DISCHARGE ขึ้นที่ CT,PT ดังนั้นควรขึ้นไปตรวจสอบ DEFACT ที่เกิดขึ้น โดยการปลด HOTLINE CLAMP ก่อนเข้า DISCONNECTING SWITCH ออกเพื่อความปลอดภัยต่อผู้ปฏิบัติงาน หากตรวจสอบแล้วพบการ DEFACT ควรหาแนวทางแก้ไขโดยด่วน หากปล่อยไว้ จะทำให้เกิดการระเบิดและเป็นอันตราย และควรตรวจสอบทุกๆ ปี เพื่อดูแนวโน้มการเปลี่ยนแปลง
