PARTIAL DISCHARGE REPORT

CUSTOMER :CO.,LTD.

DATE : July 8th, 2020

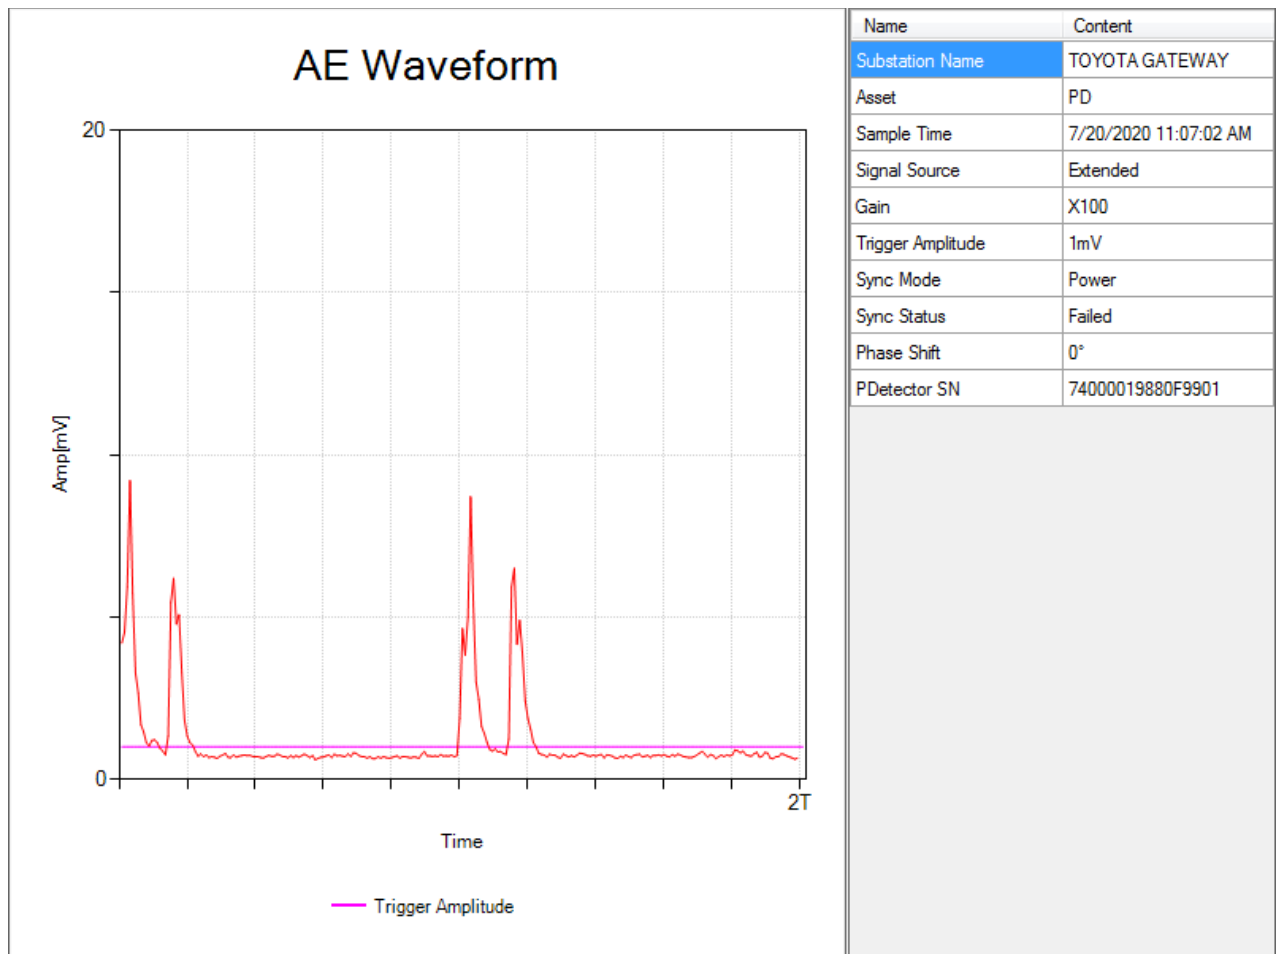
COMMENT	Partial discharge (PD) was found.
EVALUATION	Warning
SUGGESTION	The partial discharge should be inspected in the next year
TESTED AND REPORTED BY	Mr.Tukdanai Pothanak
APPROVED BY	Mr.Chanvit Crukaew

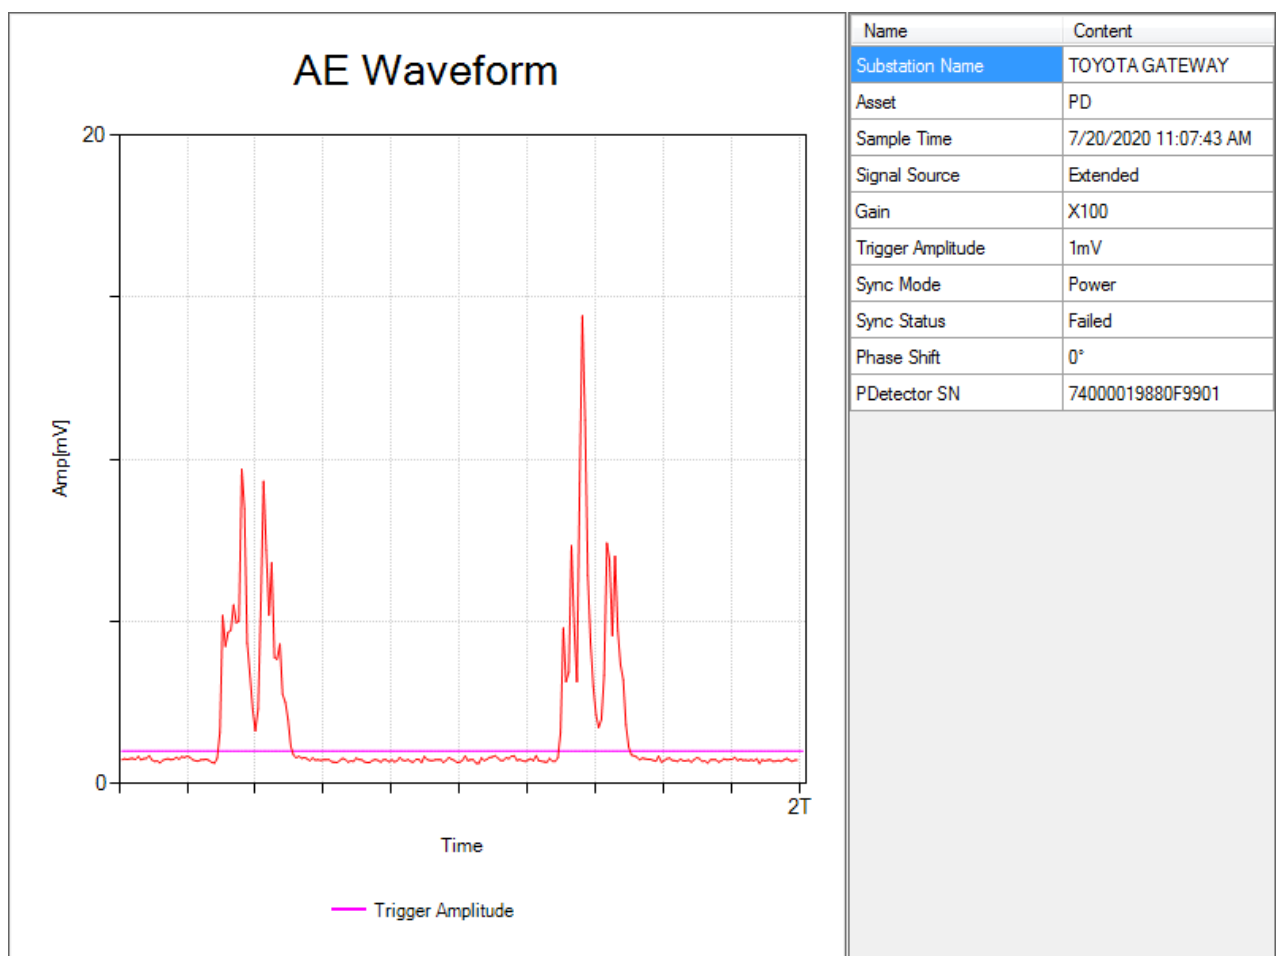
COMMENT	Partial discharge (PD) was found.
EVALUATION	Warning
SUGGESTION	The partial discharge should be inspected in the next year
TESTED AND REPORTED BY	Mr.Tukdanai Pothanak
APPROVED BY	Mr.Chanvit Crukaew

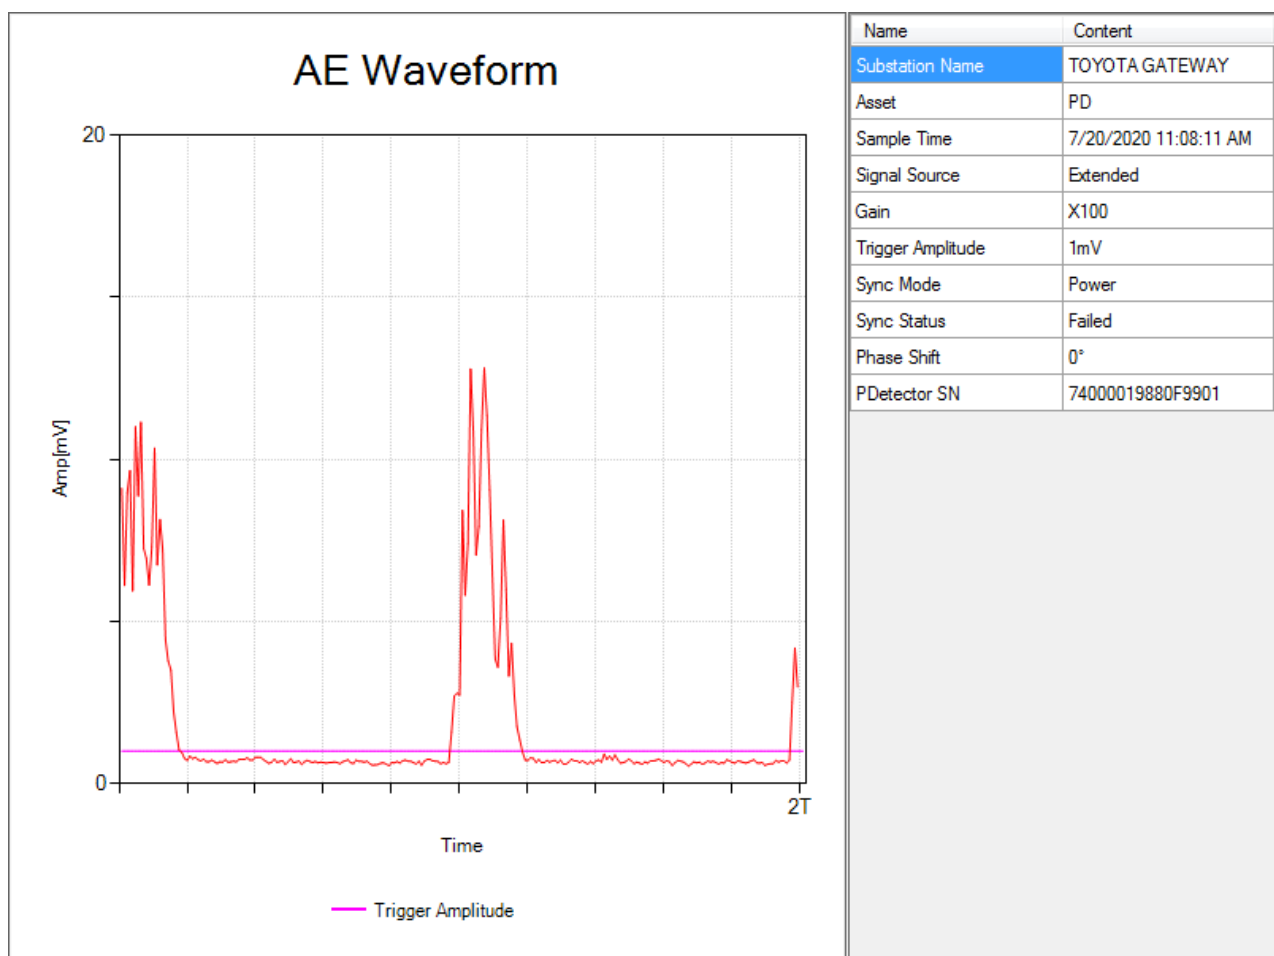
COMMENT	Partial discharge (PD) was found.
EVALUATION	Warning
SUGGESTION	The partial discharge should be inspected in the next year
TESTED AND REPORTED BY	Mr.Tukdanai Pothanak
APPROVED BY	Mr.Chanvit Crukaew

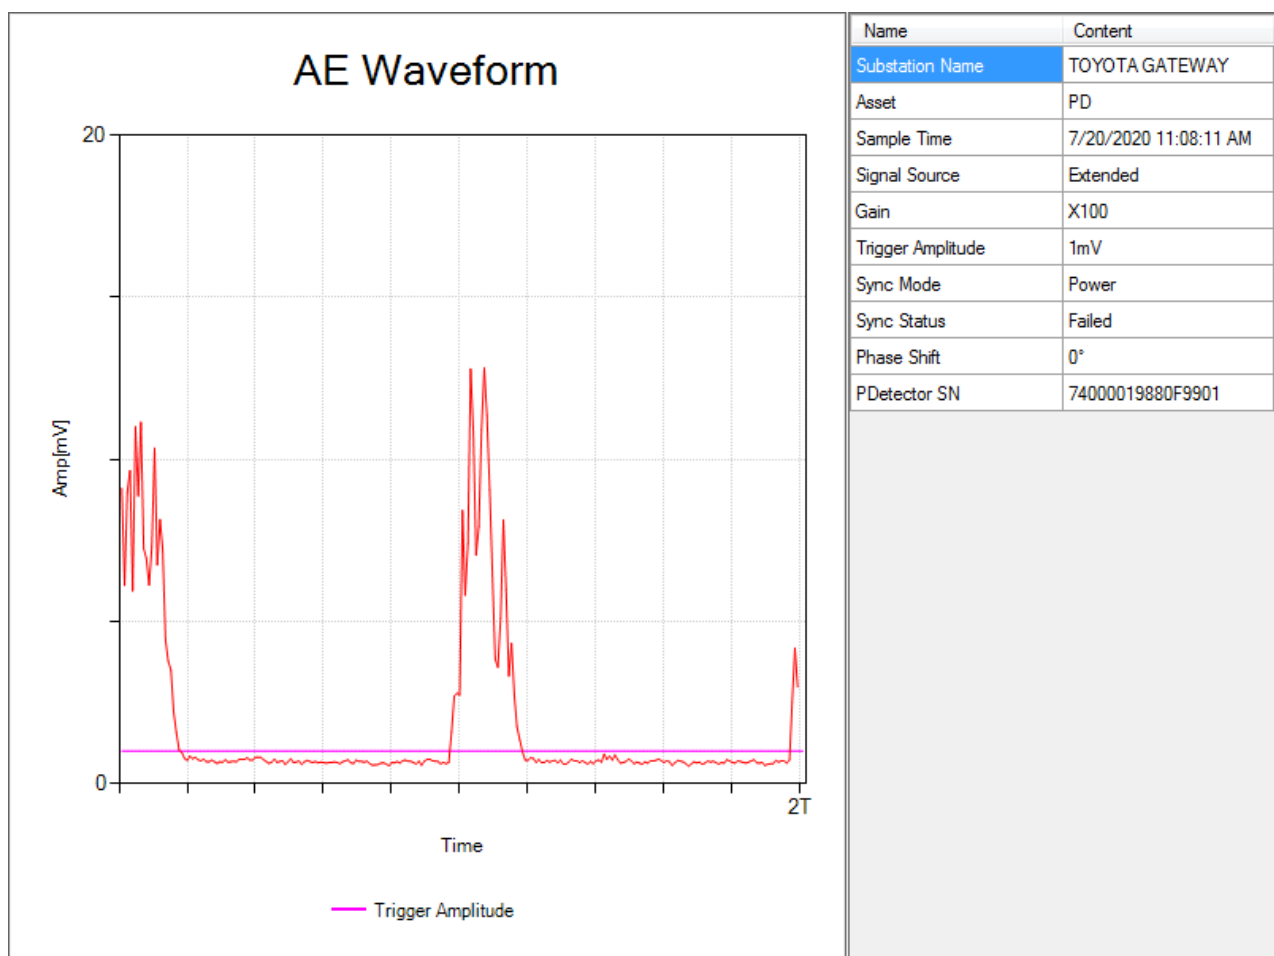
COMMENT	Partial discharge (PD) was found.
EVALUATION	Warning
SUGGESTION	No action
TESTED AND REPORTED BY	Mr.Tukdanai Pothanak
APPROVED BY	Mr.Chanvit Crukaew

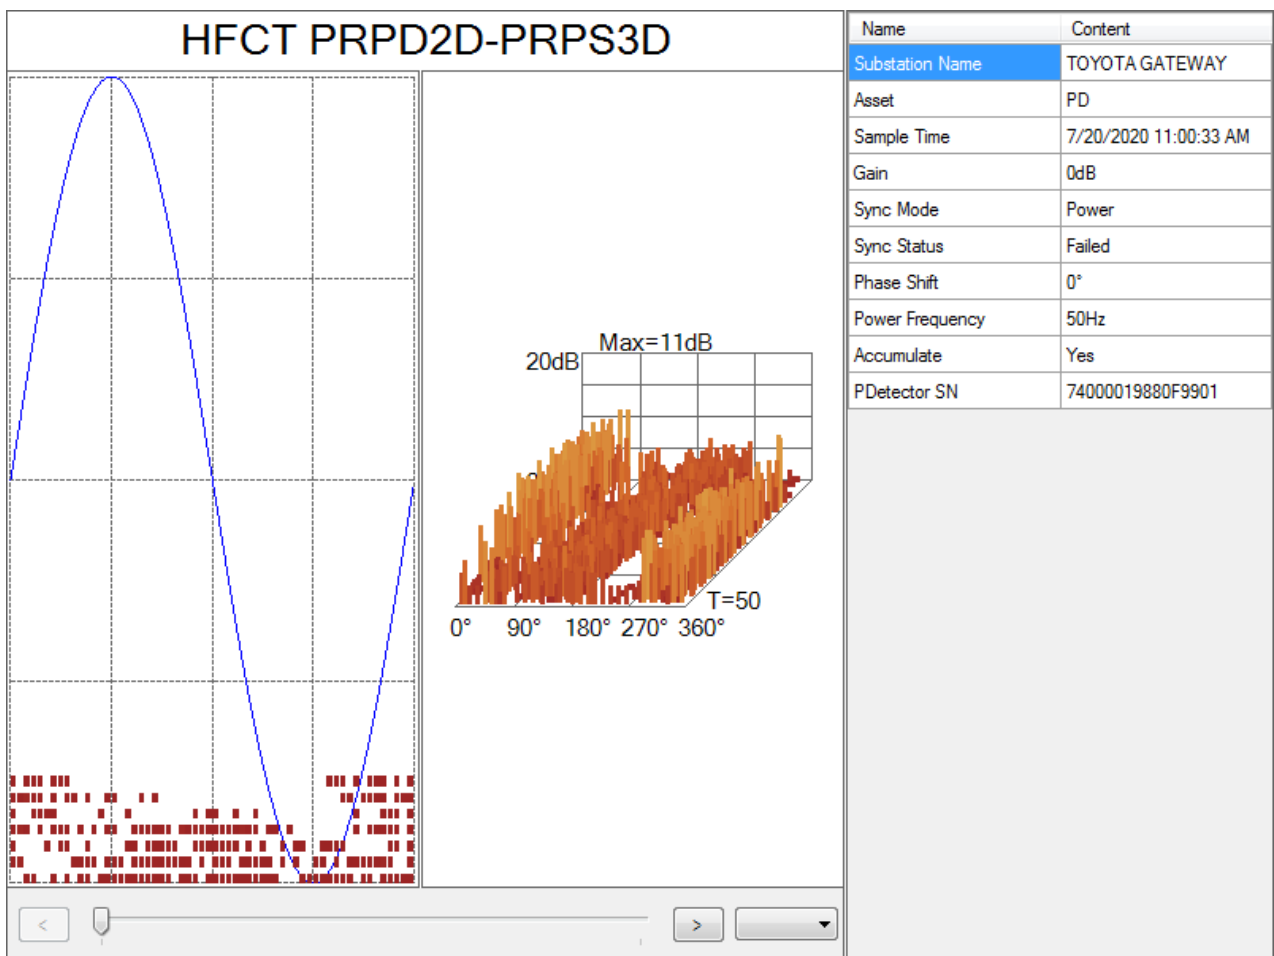
COMMENT	Partial discharge (PD) was found.
EVALUATION	Normal
SUGGESTION	The partial discharge should be inspected in the next year
TESTED AND REPORTED BY	Mr.Tukdanai Pothanak
APPROVED BY	Mr.Chanvit Crukaew

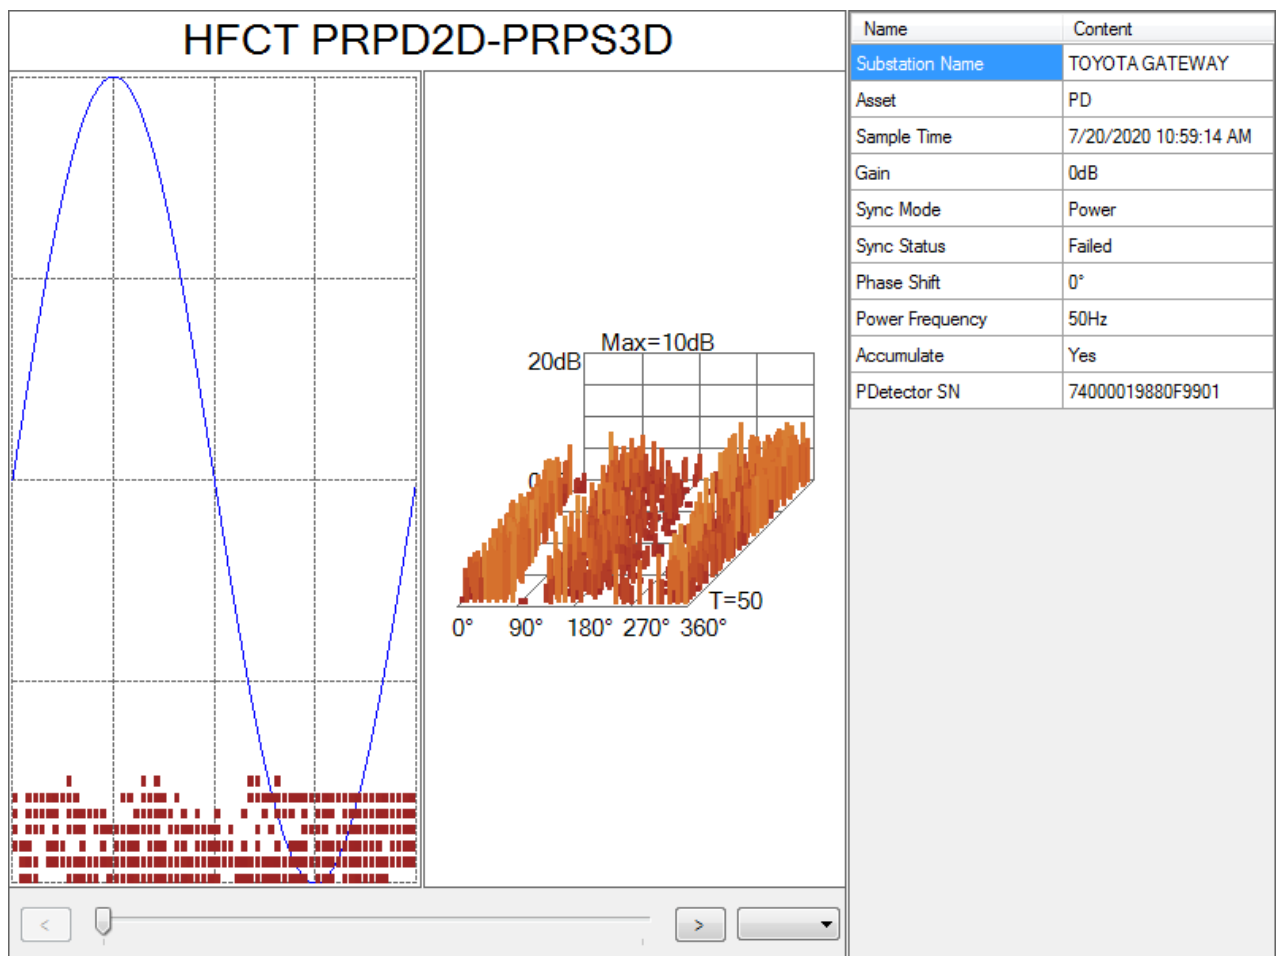
COMMENT	Partial discharge (PD) was found.
EVALUATION	Normal
SUGGESTION	The partial discharge should be inspected in the next year.
TESTED AND REPORTED BY	Mr.Tukdanai Pothanak
APPROVED BY	Mr.Chanvit Crukaew

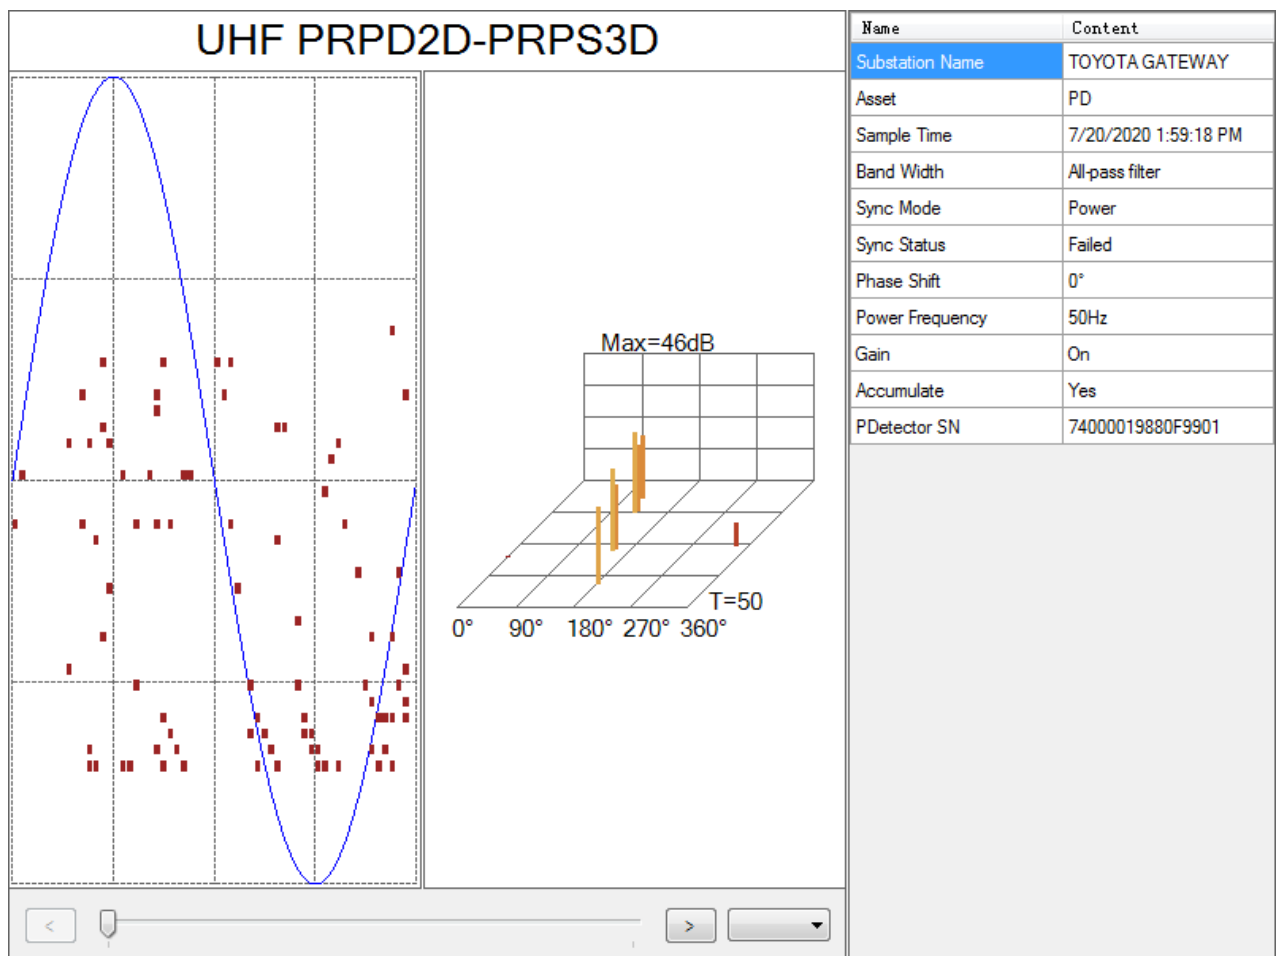
COMMENT	Partial discharge (PD) was found.
EVALUATION	Warning
SUGGESTION	The partial discharge should be inspected in the next year.
TESTED AND REPORTED BY	Mr.Tukdanai Pothanak
APPROVED BY	Mr.Chanvit Crukaew

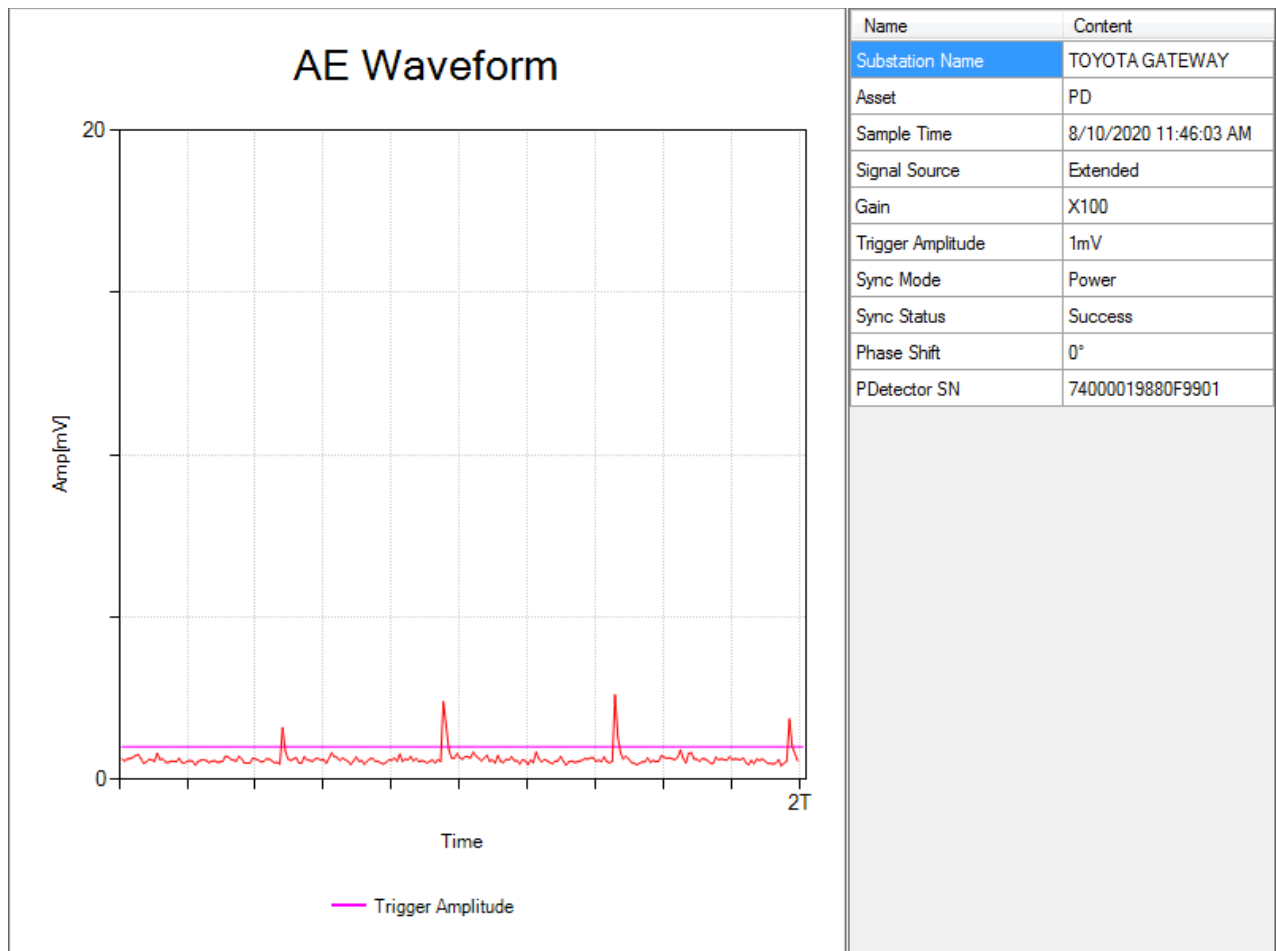
COMMENT	Partial discharge (PD) was found.
EVALUATION	Warning
SUGGESTION	No action
TESTED AND REPORTED BY	Mr.Tukdanai Pothanak
APPROVED BY	Mr.Chanvit Crukaew

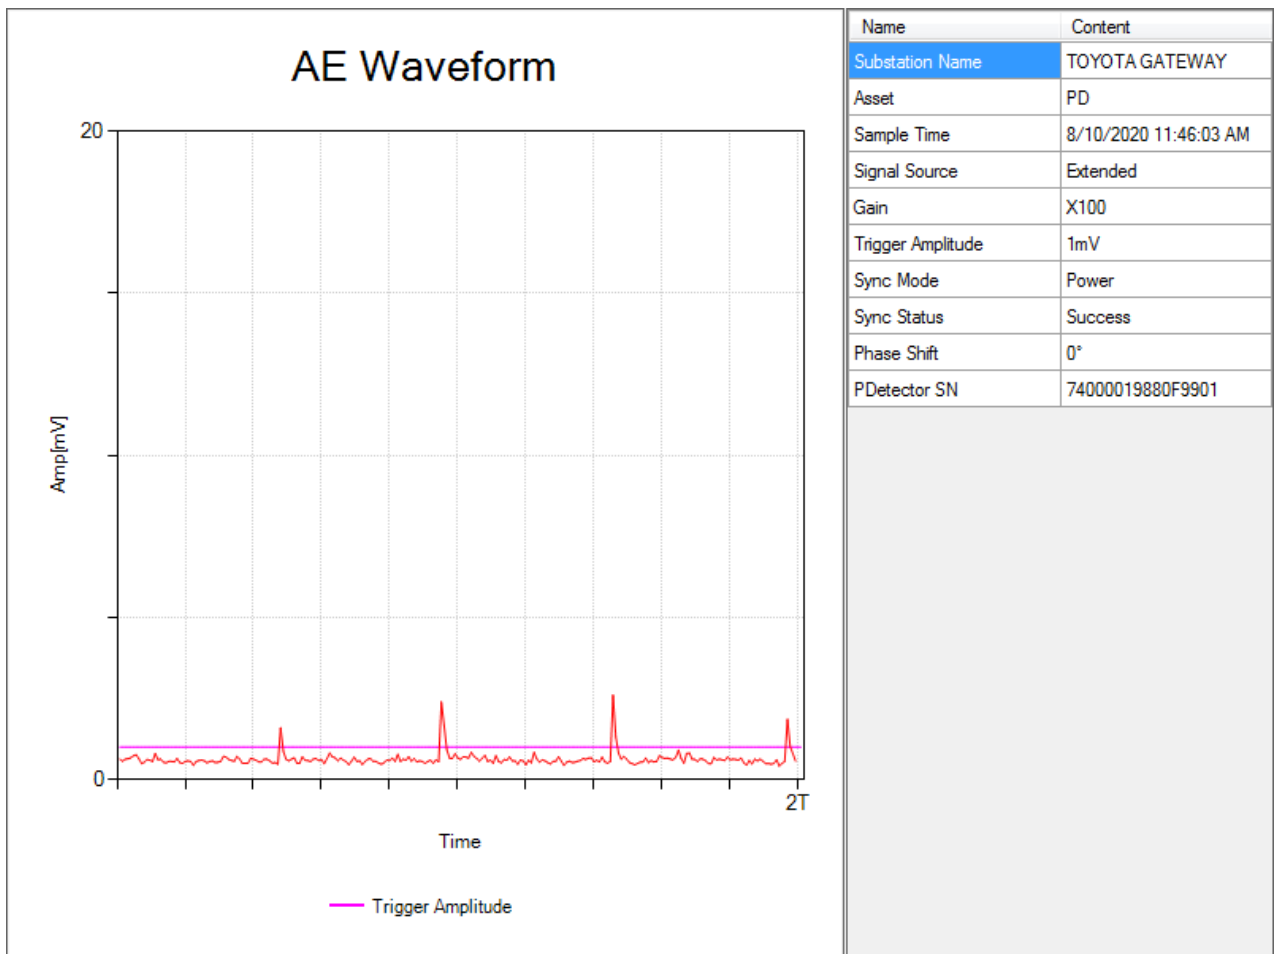
COMMENT	Partial discharge (PD) was found.
EVALUATION	Warning
SUGGESTION	No action
TESTED AND REPORTED BY	Mr.Tukdanai Pothanak
APPROVED BY	Mr.Chanvit Crukaew

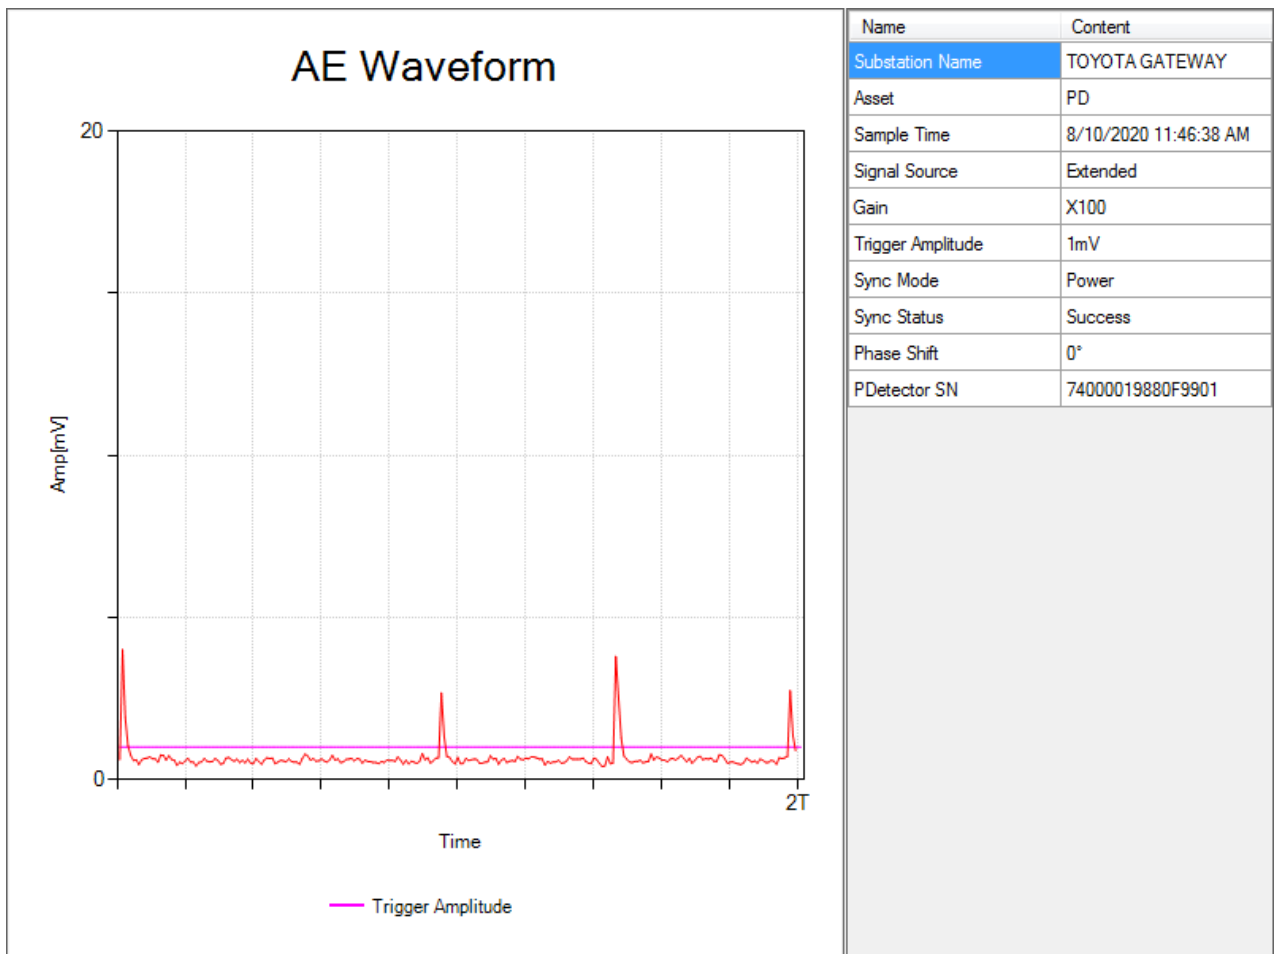
COMMENT	Partial discharge (PD) was found.
EVALUATION	Warning
SUGGESTION	No action
TESTED AND REPORTED BY	Mr.Tukdanai Pothanak
APPROVED BY	Mr.Chanvit Crukaew

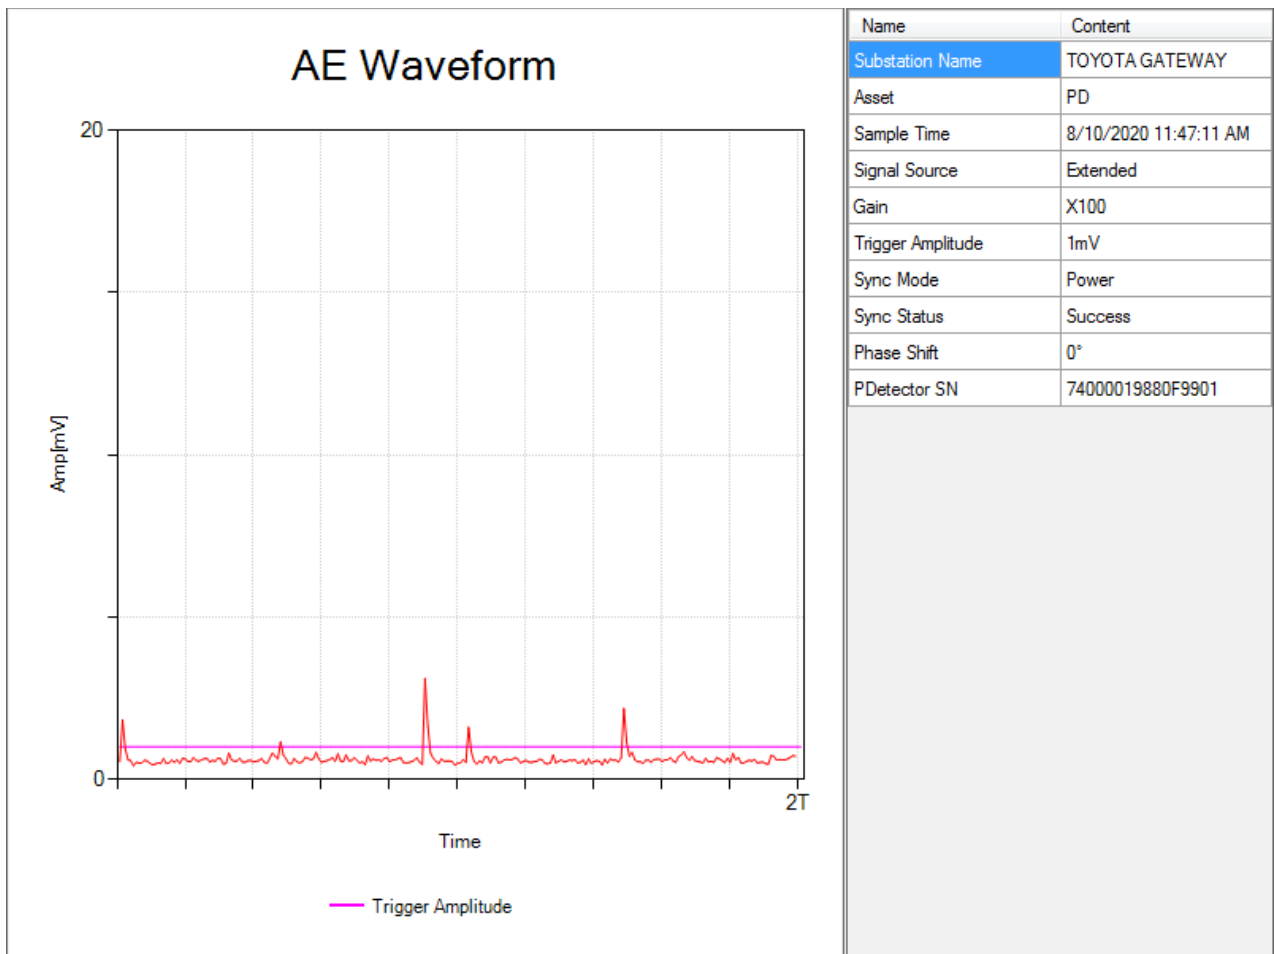
COMMENT	Partial discharge (PD) was found.
EVALUATION	Warning
SUGGESTION	No action
TESTED AND REPORTED BY	Mr.Tukdanai Pothanak
APPROVED BY	Mr.Chanvit Crukaew

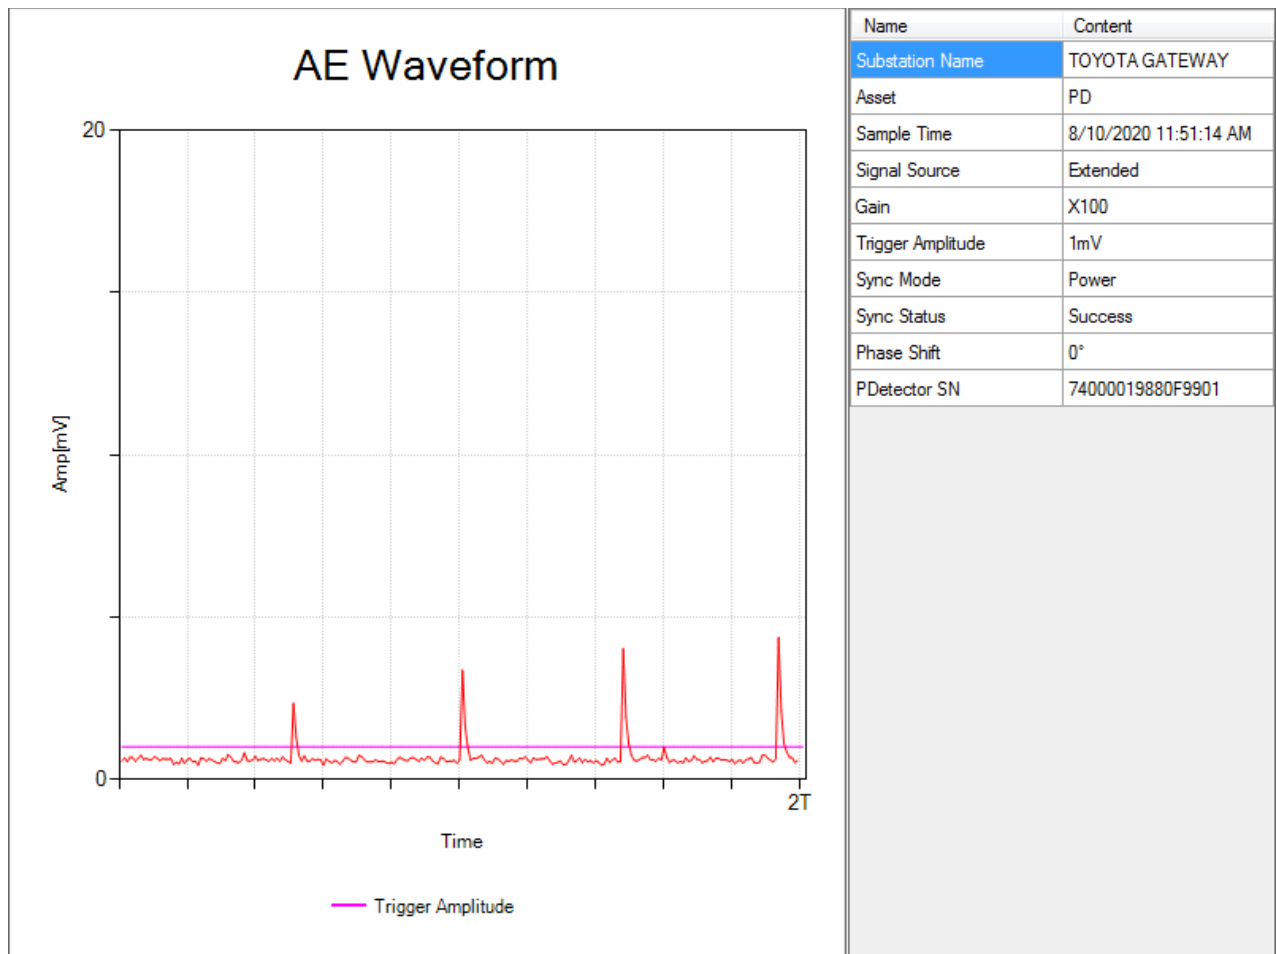
COMMENT	Partial discharge (PD) was found.
EVALUATION	Warning
SUGGESTION	The partial discharge should be inspected in the next year.
TESTED AND REPORTED BY	Mr.Tukdanai Pothanak
APPROVED BY	Mr.Chanvit Crukaew

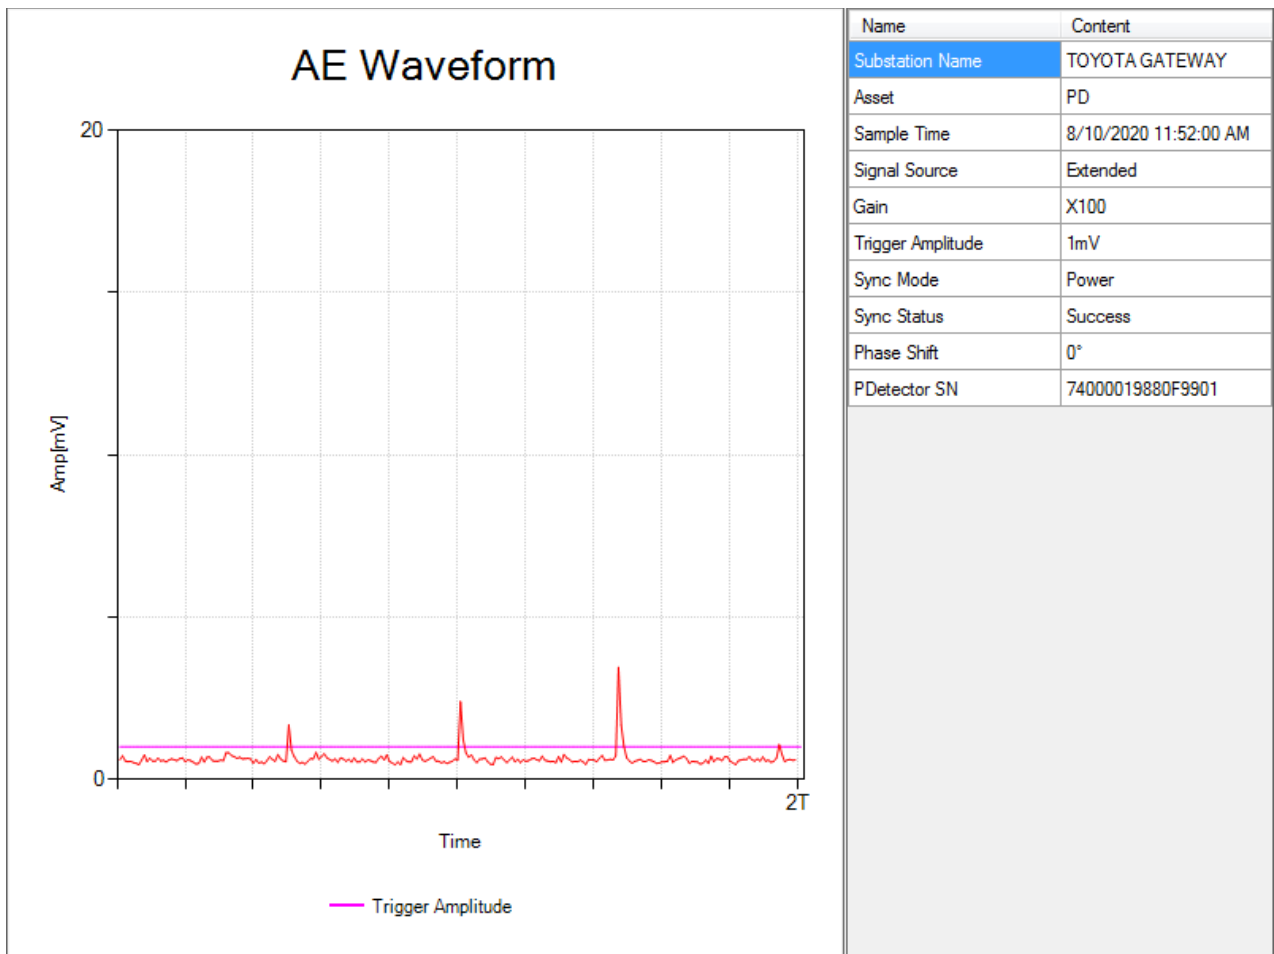
COMMENT	Partial discharge (PD) was found.
EVALUATION	Warning
SUGGESTION	The partial discharge should be inspected in the next year.
TESTED AND REPORTED BY	Mr.Tukdanai Pothanak
APPROVED BY	Mr.Chanvit Crukaew
