115 KV TRANSFORMER TESTING FOR CONFIRM

TRANSFORMER FAULT

AJINOMOTO CO., Ltd.

PLANT: KAMPHAENG PHET

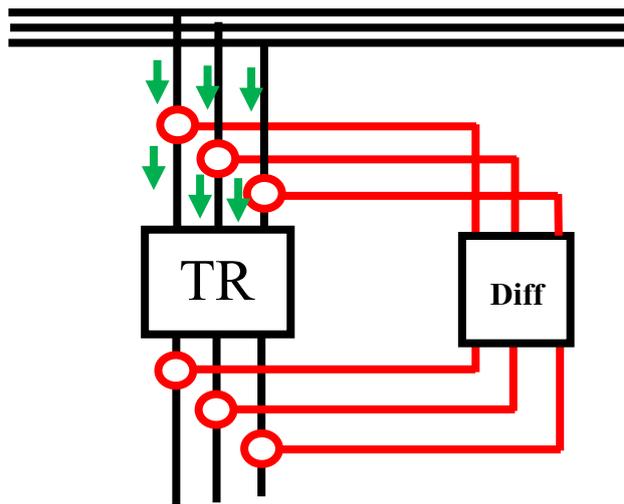
Figure3: Show Current flow in transformer

In case of a normal transformer, There is current distribution into transformer, it will have Inrush Current at 10 cycles and then will decrease to steady state.

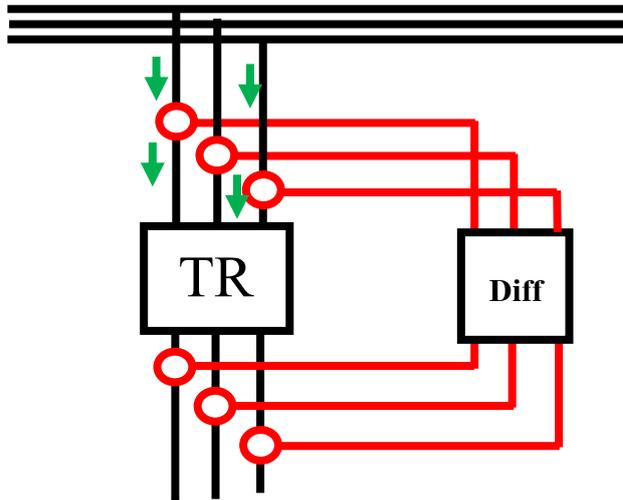
Figure5: Current at the begining state from a normal transformer

However, when energizing to transformer E0, and after 5 seconds, the Differential Relay trip occurred, along with Buchholz alarm. The current Phase R and S had opposite direction, but phase T is still in a normal state, as shown in Figure 5.

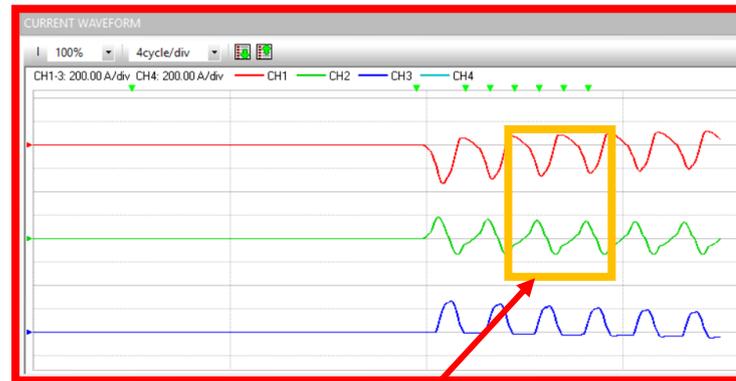
Phase R and S have opposite direction

Figure5: Opposite direction of Phase R and S

The current phase R and S did not drop after passing the Inrush Current period, which remained at around 60 A until the Relay ordered Trip, however, the slow in ordering Trip of Differential Relay was caused by the function of Second Harmonic Blocking (Relay setting 10 %). According to Figure 6 ,7 , second Harmonic dropped less than Setting and took about 5 seconds .

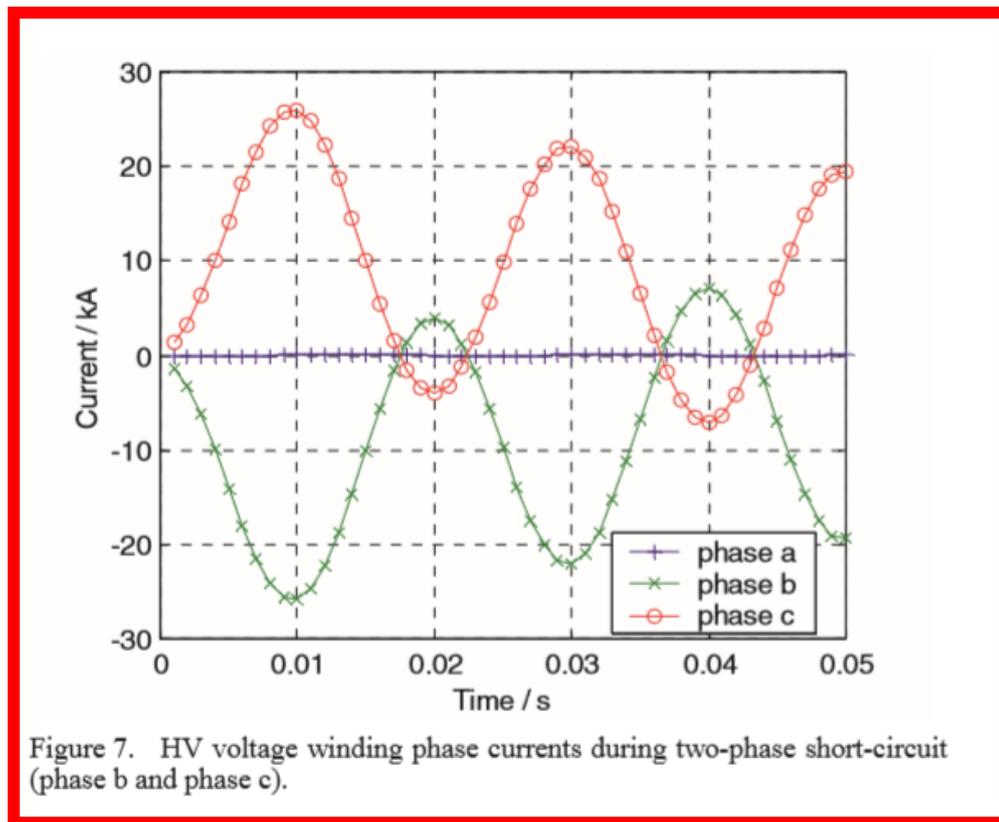
Figure 9: HV Voltage winding phase currents during two-phase short-circuit (phase b and phase c)

According to the figure, the direction of the Fault current has the opposite direction. Further details is in the attached documents.

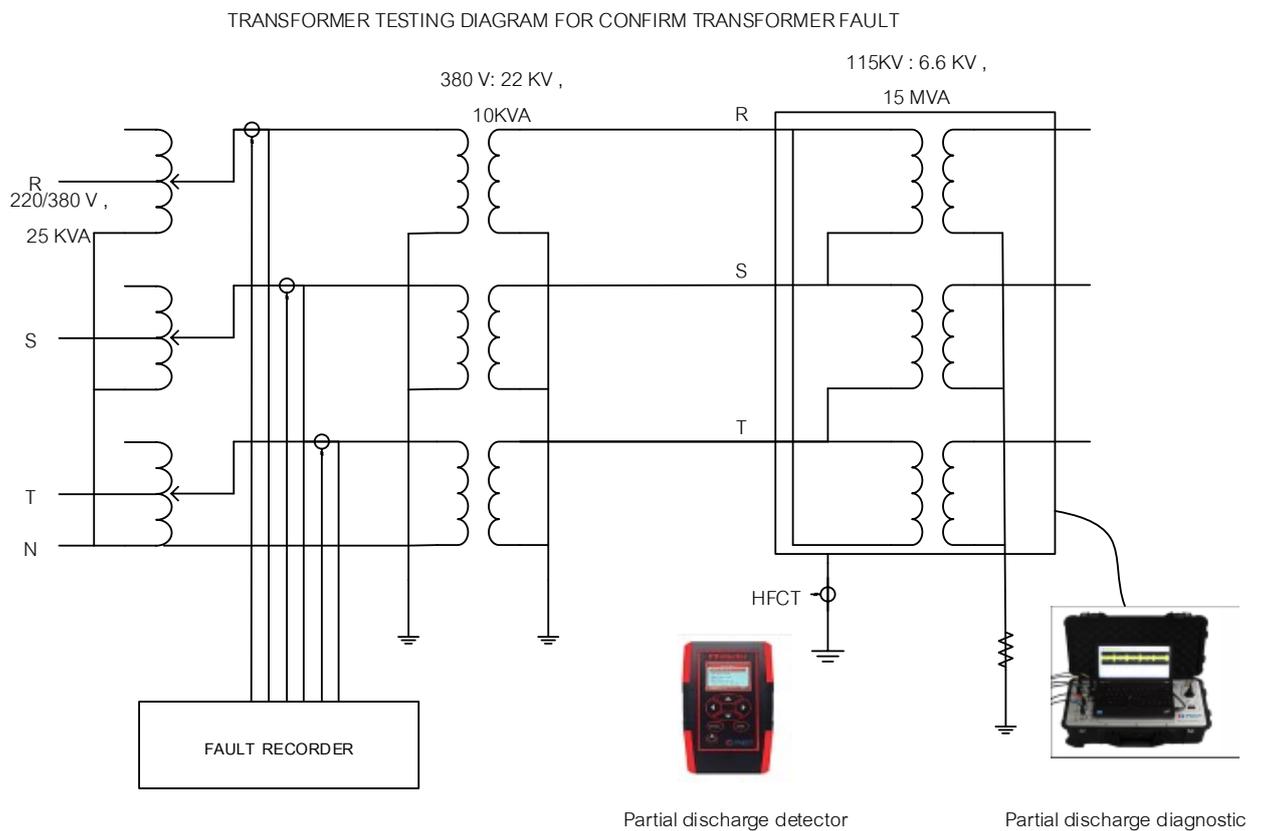
Figure10: The diagram for exciting current testing

The test was performed by gradually increasing the voltage into the transformer and observed the change of current. The connection circuit is as shown in Figure10.

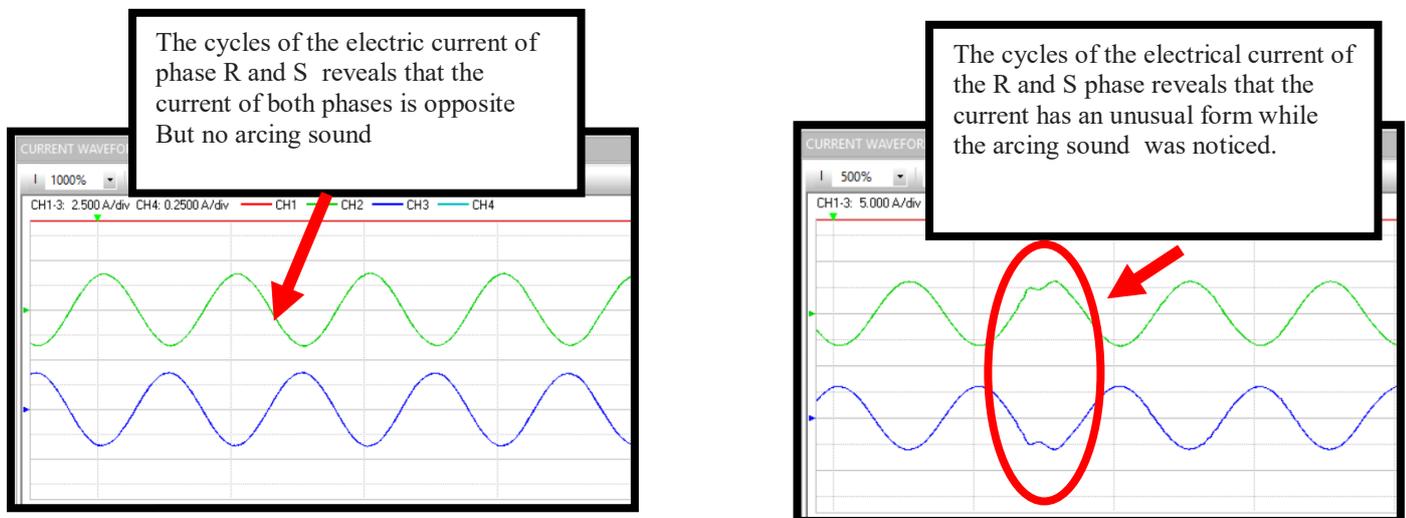
Figure 11: FROM FAULT RECORDER “ HIOKI ”

Performed by generating voltage from SOURCE by increasing the voltage up to 300 V at 115 KV Transformer Winding, there was a small current flowing through. However, when the voltage was increased to 600 V at 115 KV Transformer Winding, it was found that there was an unusual large current flow and noticed the arcing sound in the transformer. This resulted in the unusualness of electrical signal cycles of the current R and S, while the ARC was noticed in the transformer.

From the test results, it was found that there was the Fault in the transformer winding. Later, by energizing the current in the form of Line-Neutral electricity to test whether the transformer has a Single Line Fault to Ground Fault. The connected circuit is shown in Figure 12.

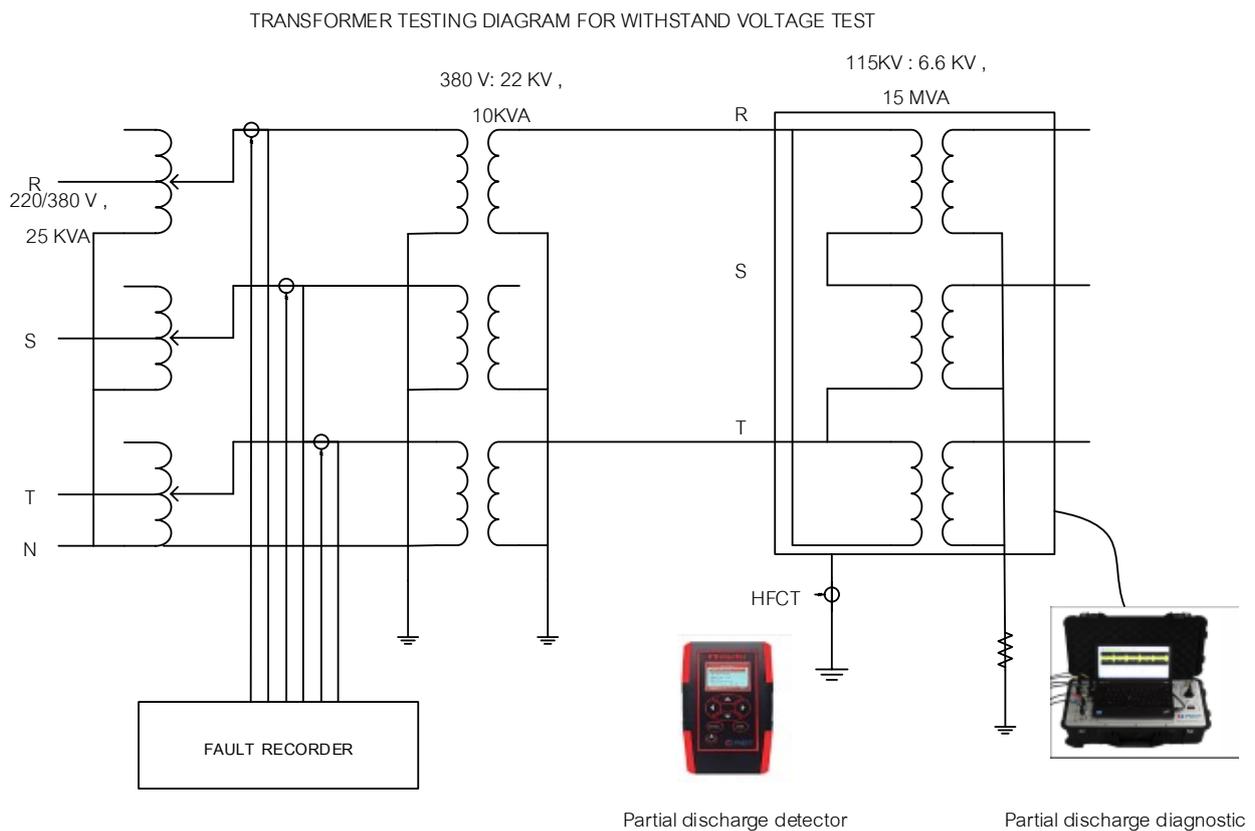
Figure 12: THE DIAGRAM FOR WITHSTAND VOLTAGE TEST

From the inspection, it was found that the voltage could be increased up to 12.7 kV on the side of 115 KV Transformer winding, and there was normal . Therefore, Transformer TR2 E0 has no Single Line Fault To Ground Fault.

In the case of withstand voltage test, it should be tested at 1-2 times of 115 KV for 1 minute. Due to the unsafety of working place, the testing was unable to proceed.

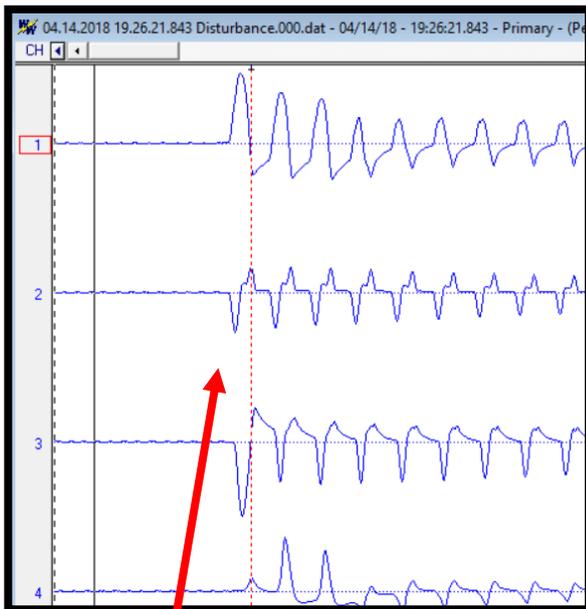
When energize into the normal transformer, there would be approximately 10 cycles of Inrush Current occurring and the current would decrease to a normal state (Figure 13). However, when the TR2 transformer be energized the current Phase R and S, both phases were not drop (Figure 14) and also remains constant until the order to trip was made (Figure 15).

Figure13: Inrush Current of a normal transformer, which clearly noticed the gradual drop in electric current.

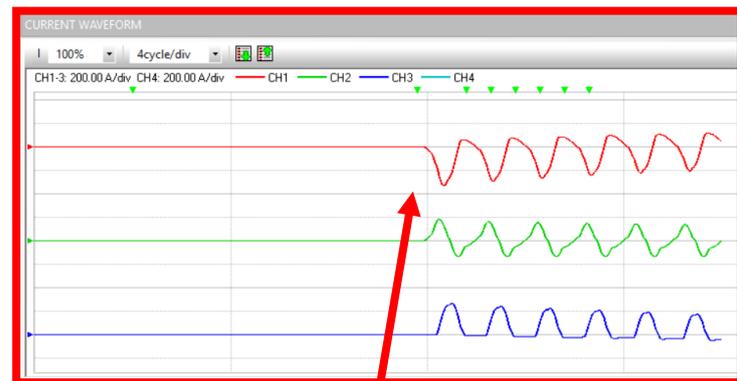
Figure 14: Inrush Current of unusual transformer TR2, which noticed the steady current of phase R and S.

1. Should not energize to the transformer due to the fault in the transformer.
2. In Preventive maintenance, Inrush current of every 115 KV transformer should be recorded to store Finger printing.

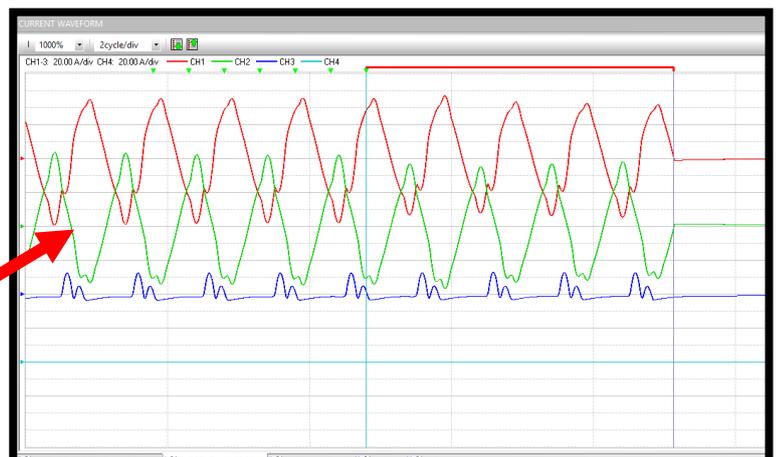
Figure 15: Electrical signal before the Trip. Phase R and S remained constant, but the phase T dropped near zero.

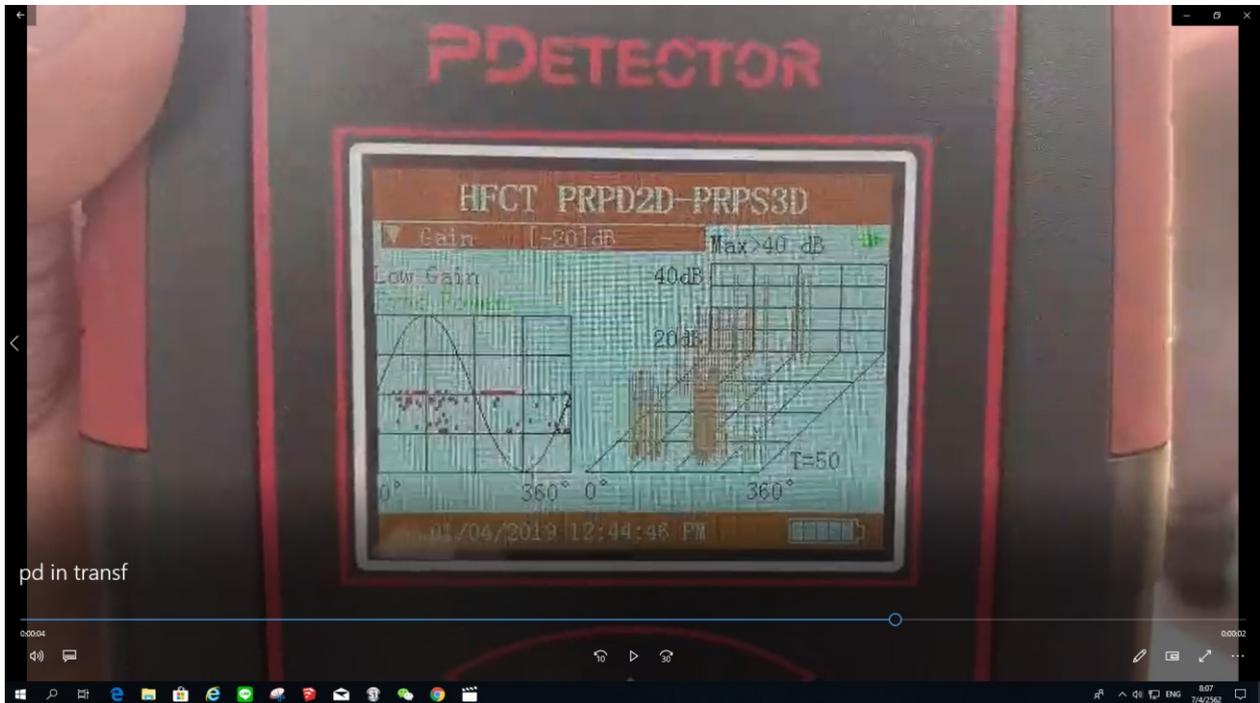
Figure 16: Partial discharge detector while Transformer Arcing

1. The damage of Stator and rotor of 6.6 KV Motor caused a single line to ground arcing fault and resulted in High frequency current in the transformer, which consequently led to the insulation of the winding deterioration and a Short turn.
2. In the case of transformer oil regeneration, In practical when filling oil to the transformer, it caused bubbles and then caused Partial discharge, which finally affect the insulation in the transformer to deteriorating.

1. Installing Ground fault Relay at 6.6 KV Motor for detect ground fault
2. Not performing Transformer oil regeneration while energizing at 115 KV

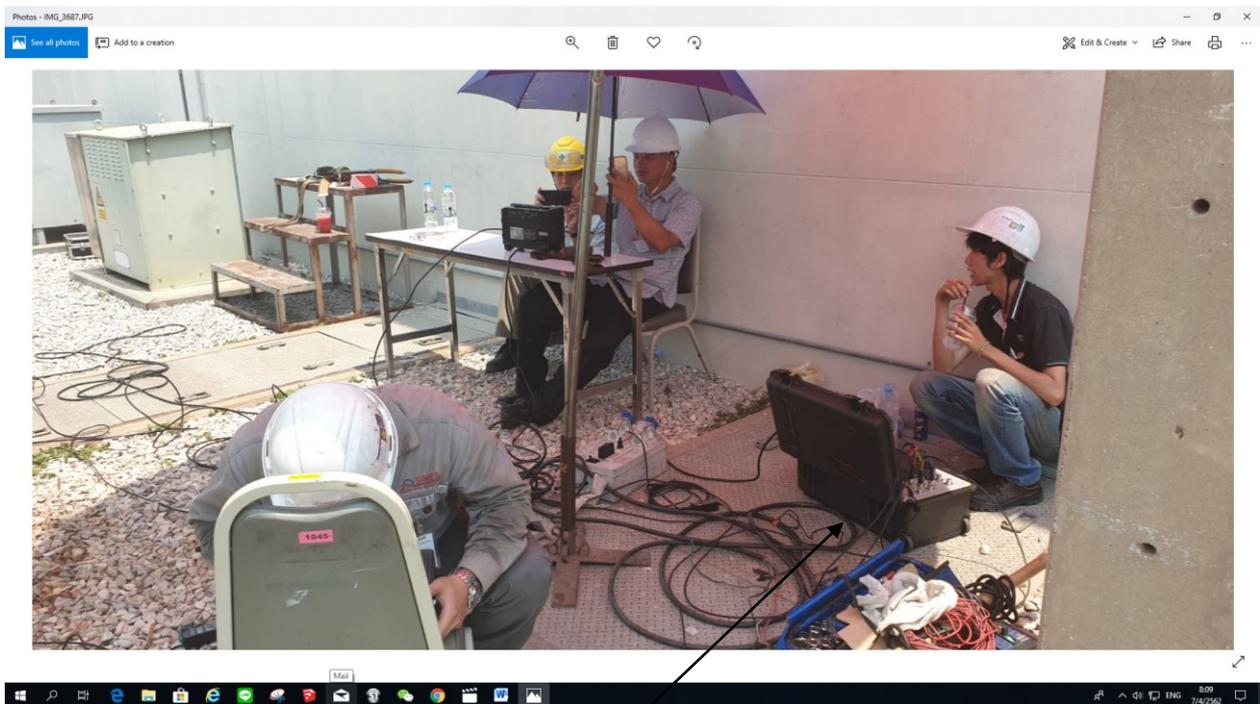
Figure 17: Partial discharge diagnostic in transformer
