PARTIAL DISCHARGE REPORT

CUSTOMER: AJINOMOTO CO., (THAILAND) LTD.

FACTORY: BIRDY

DATE: AUGUST 8th, 2019

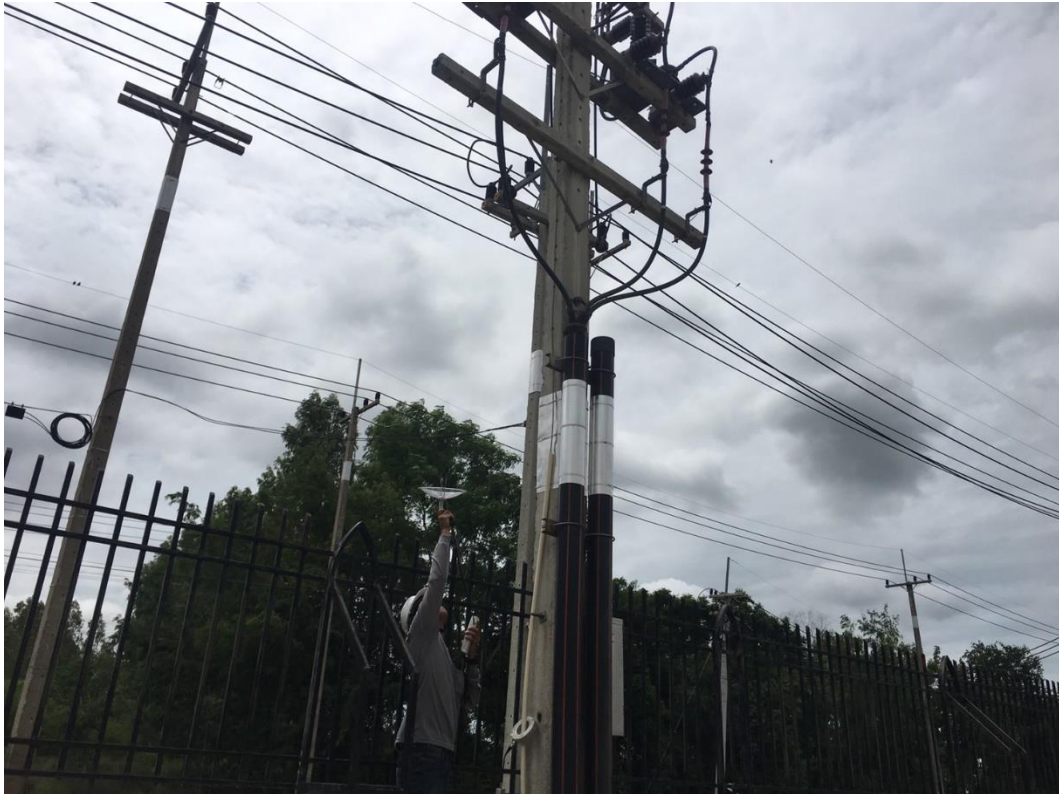
PHOTO 1 : PARTIAL DISCHARGE INSPECTION BY ULTRADISH MODE

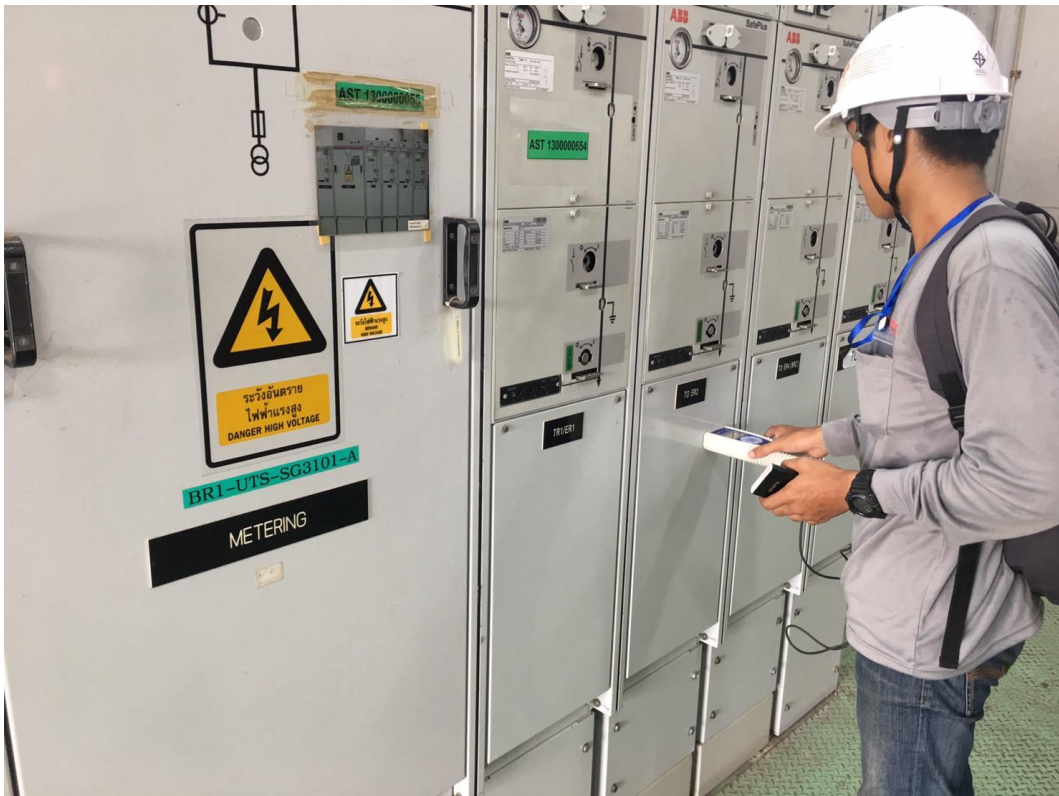
PHOTO 2 : PARTIAL DISCHARGE INSPECTION BY TEV MODE

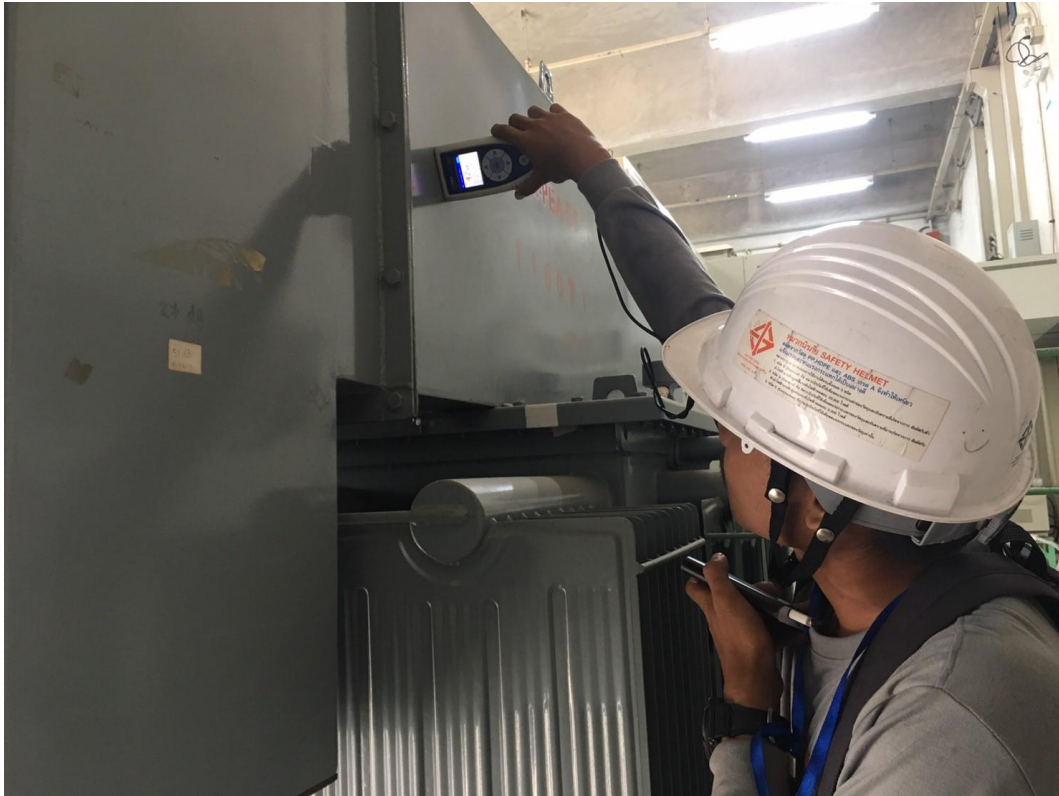
PHOTO 3 : PARTIAL DISCHARGE INSPECTION BY TEV MODE

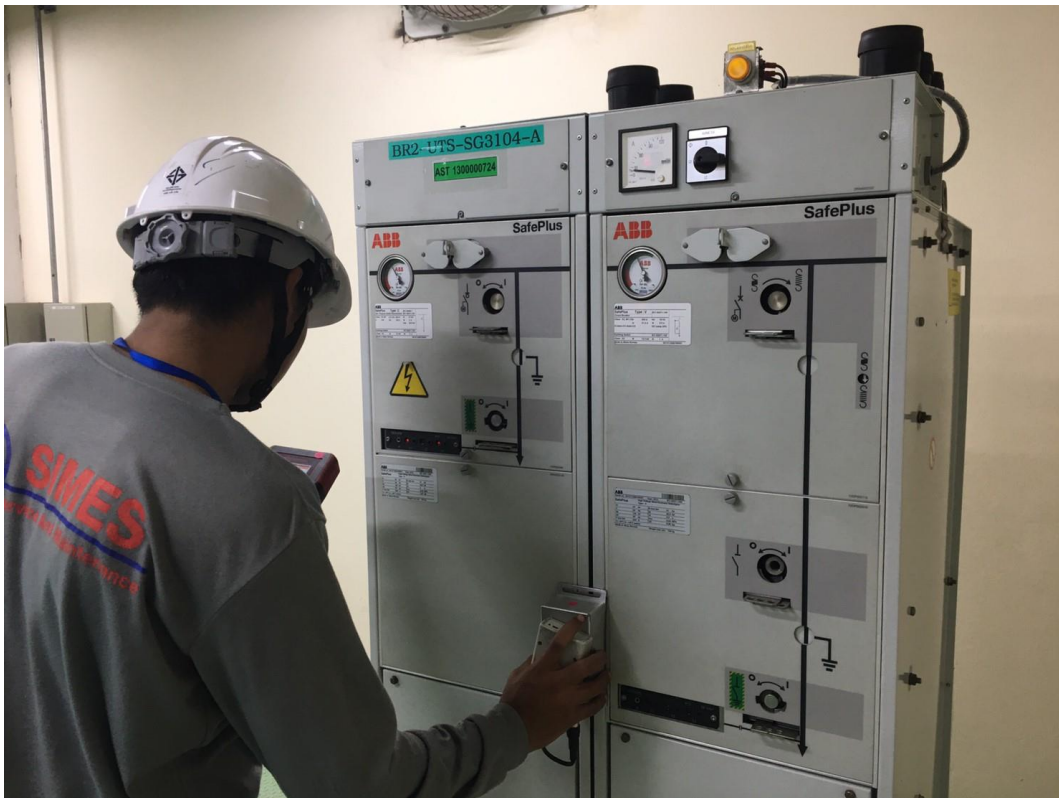
PHOTO 4 : PARTIAL DISCHARGE INSPECTION BY UHF MODE

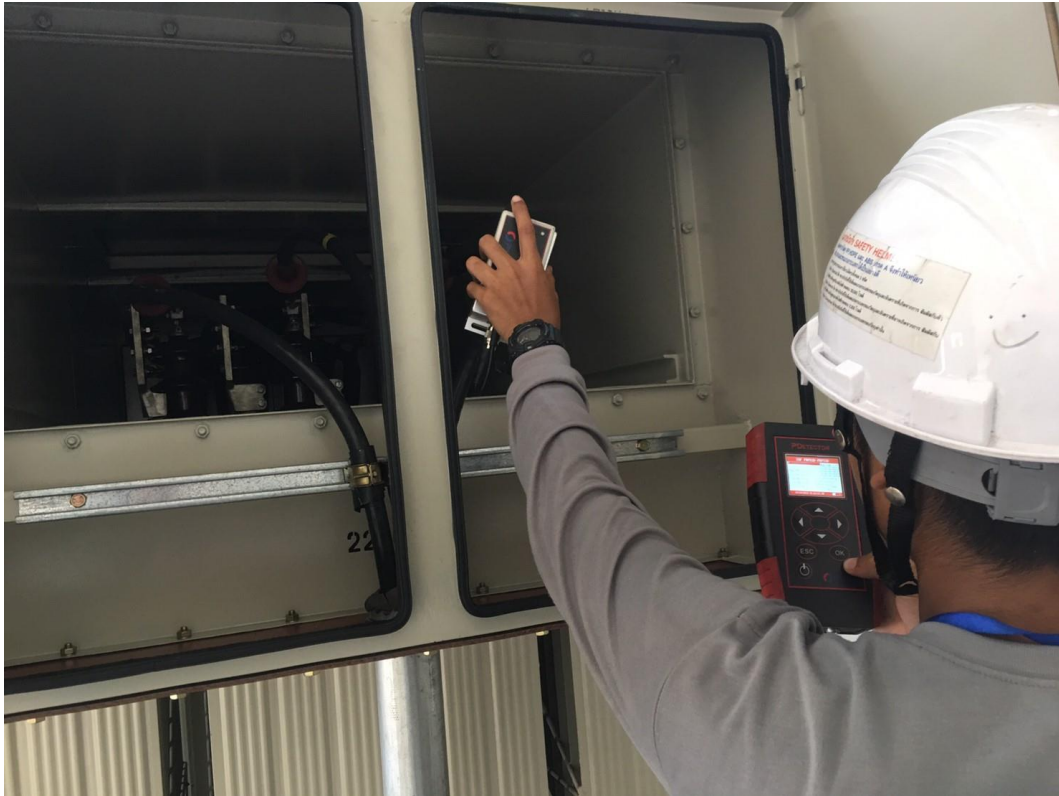
PHOTO 5 : PARTIAL DISCHARGE INSPECTION BY UHF MODE

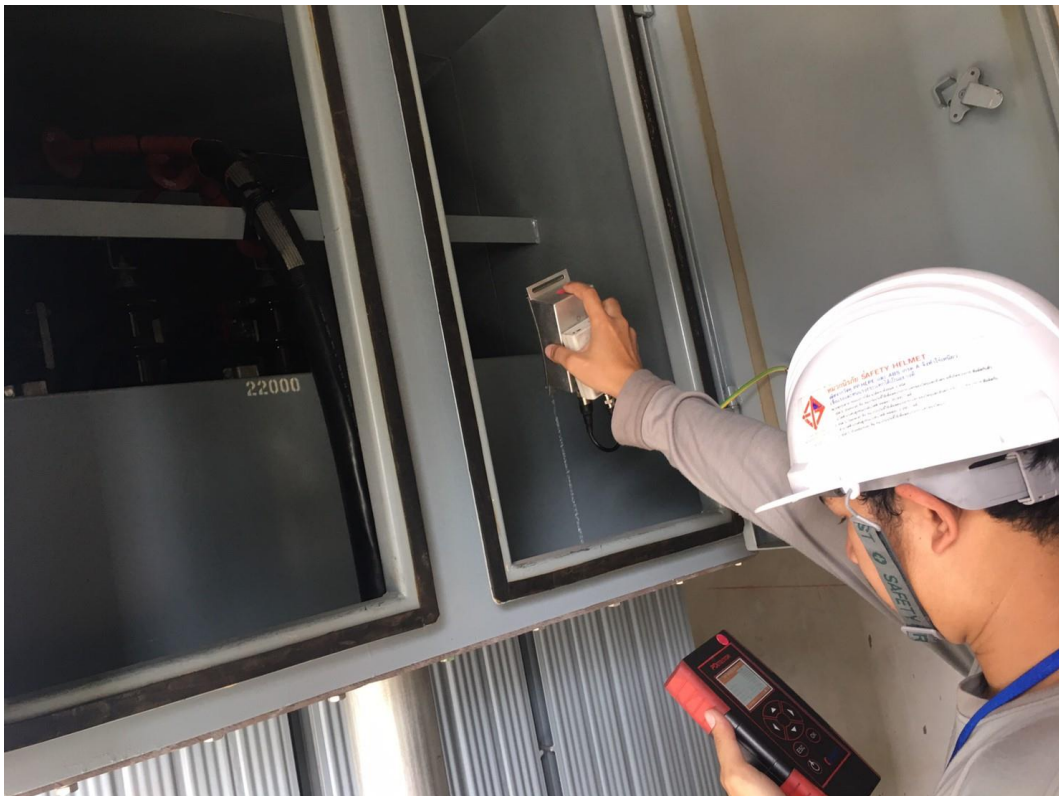
PHOTO 6 : PARTIAL DISCHARGE INSPECTION BY UHF MODE

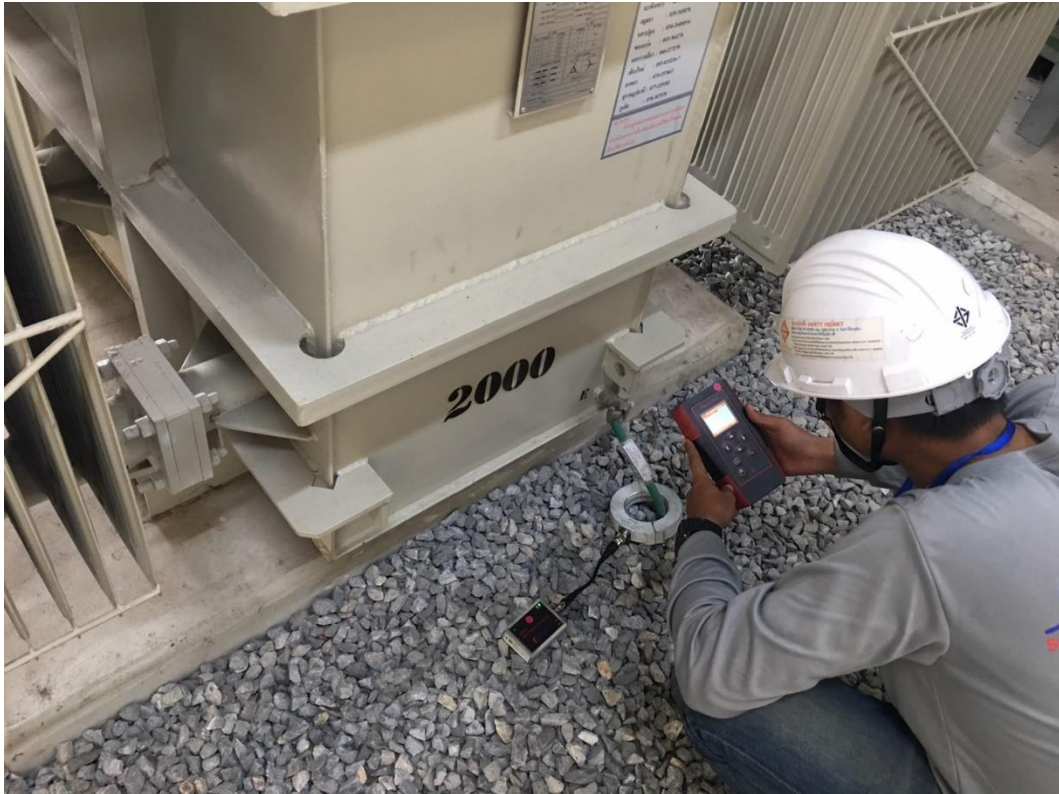
PHOTO 7 : PARTIAL DISCHARGE INSPECTION BY HFCT MODE

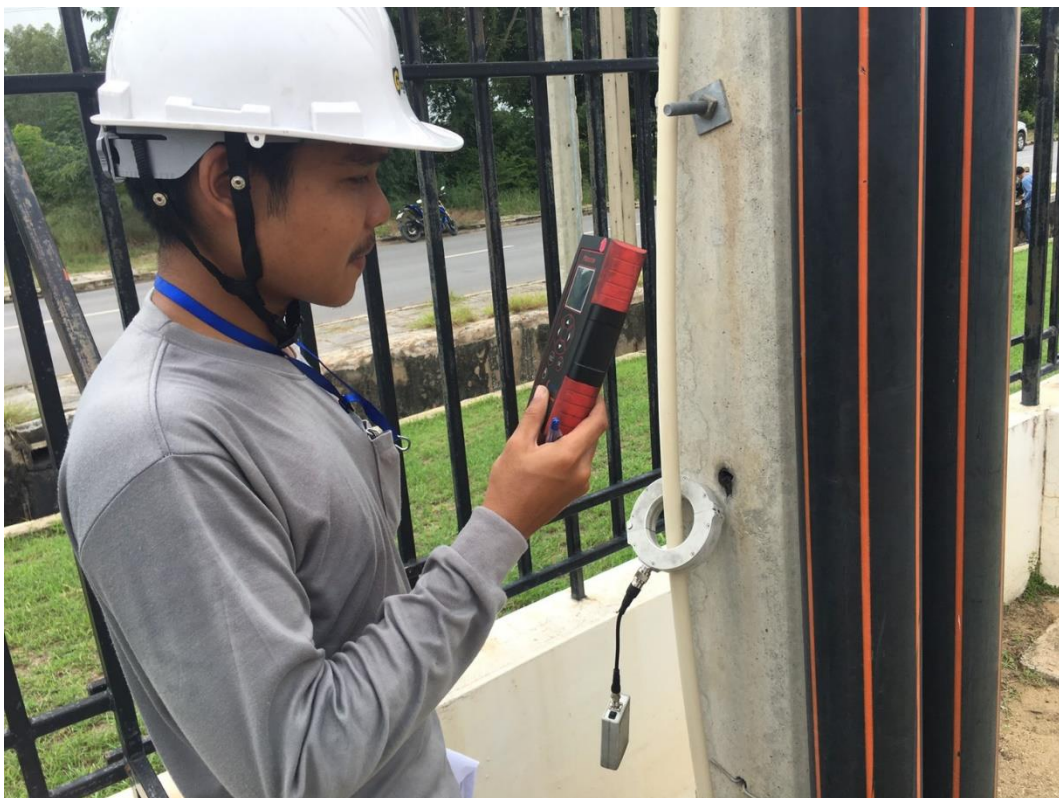
PHOTO 8 : PARTIAL DISCHARGE INSPECTION BY HFCT MODE

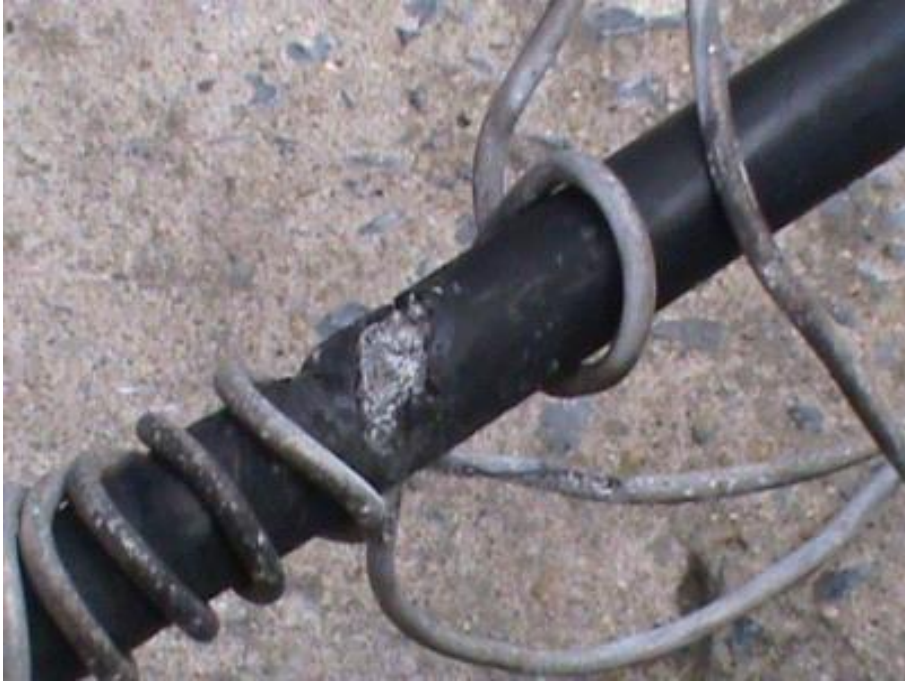
รูปที่ 2 ผลของการเกิด Partial discharge ที่สาย Cable

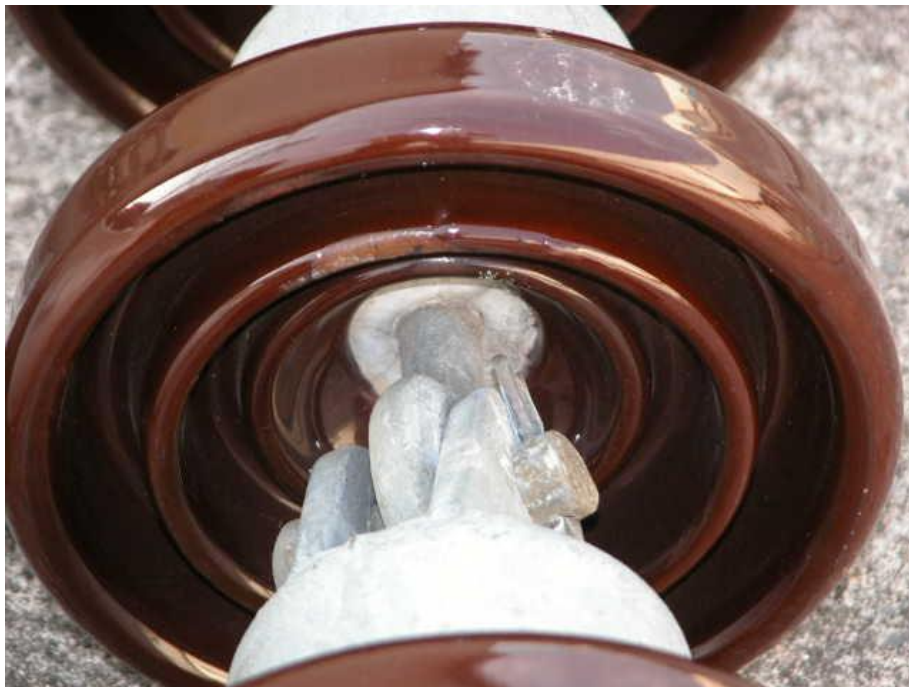
รูปที่ 3 ผลของการเกิด Partial discharge ที่ลู่กถ้วย (Insulator)
