PARTIAL DISCHARGE REPORT

CUSTOMER :CO.,LTD.

DATE : July 8th, 2020

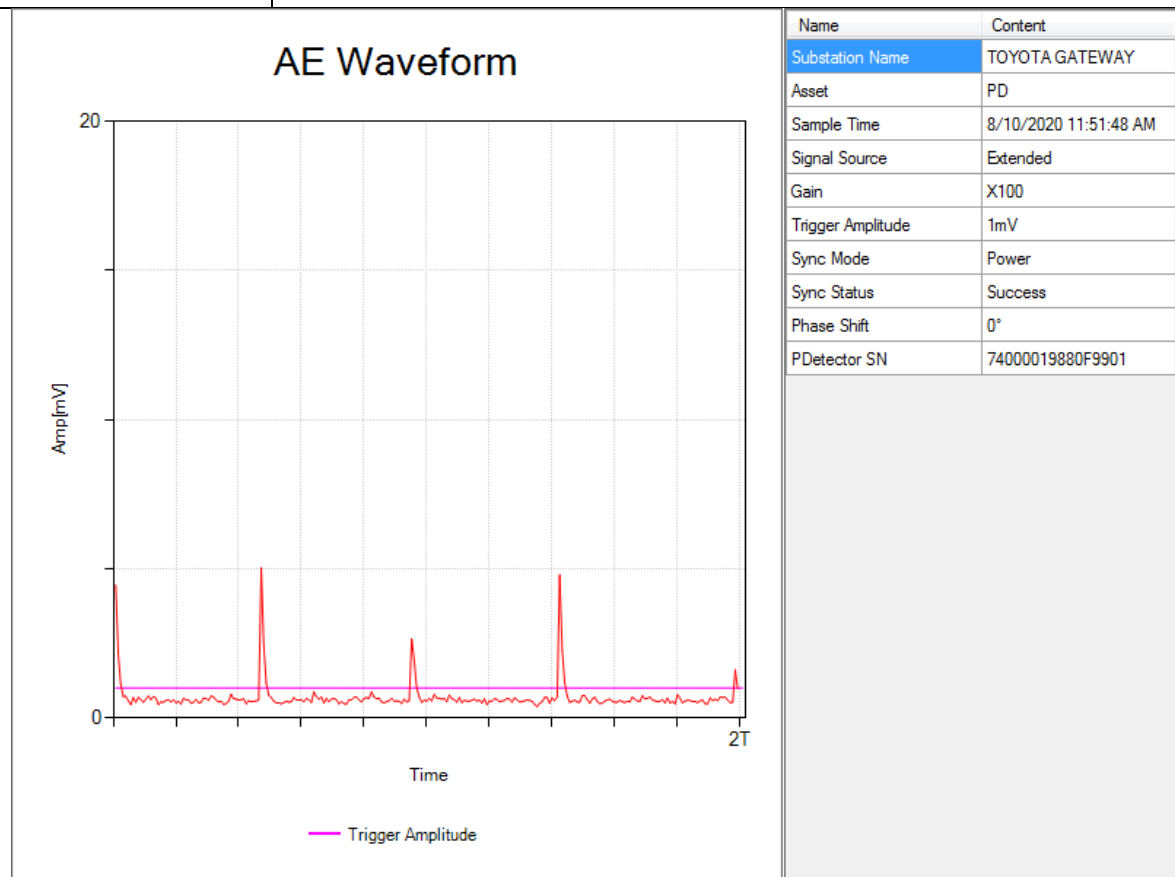
COSTOMER	TOYOTA GATEWAY (THAILAND) CO.,LTD.	PAGE 18
SUBSTATION	GIS	
POSITION	CAPACITOR NO.2 (BACK PANEL)	
VOLTAGE LEVEL	22 KV

PARTIAL DISCHARGE DETECTION METHOD BY AE Internal/Extended MODE

CRITERIA	1-5 mV
EVALUATION	Warning

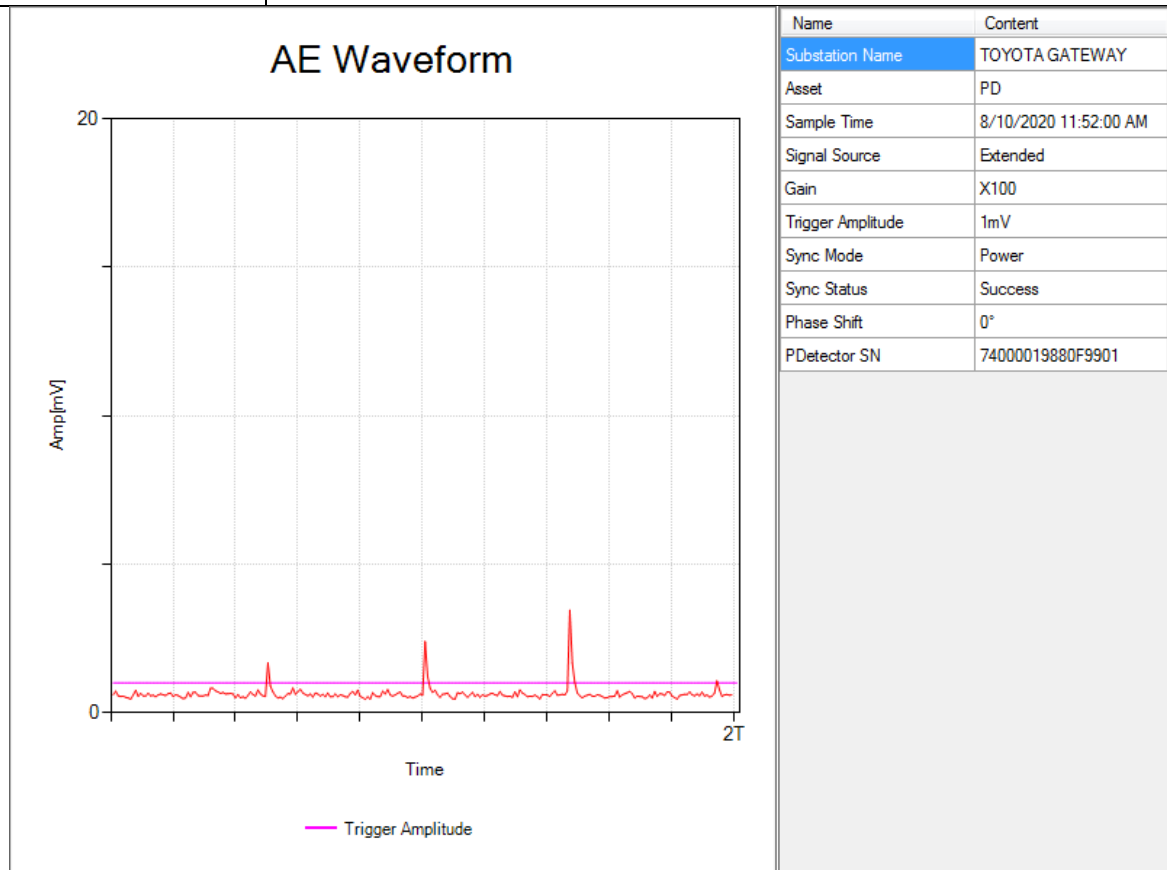
COSTOMER	TOYOTA GATEWAY (THAILAND) CO.,LTD.	PAGE 19
SUBSTATION	GIS	
POSITION	NO.2BANK BUS-TIE (BACK PANEL)	
VOLTAGE LEVEL	22 KV

PARTIAL DISCHARGE DETECTION METHOD BY AE Internal/Extended MODE

CRITERIA	1-5 mV
EVALUATION	Warning

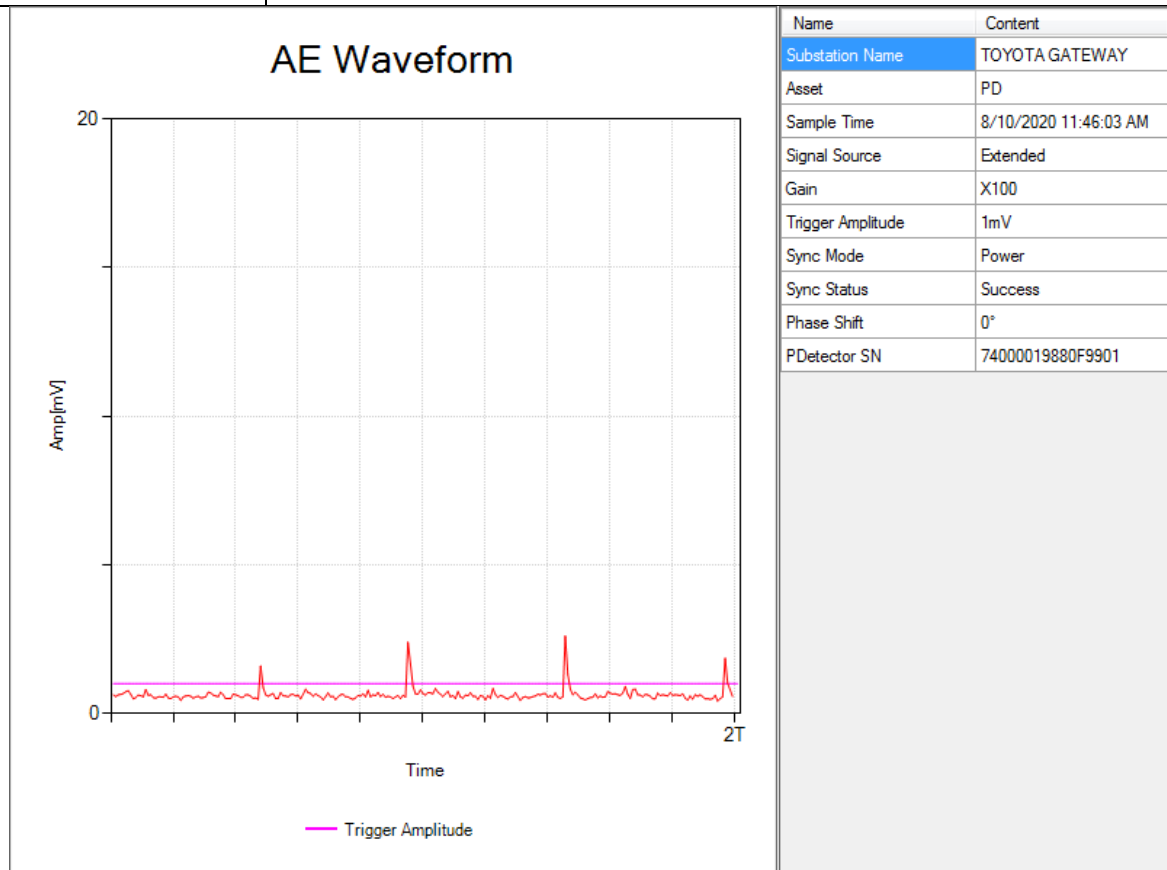
COSTOMER	TOYOTA GATEWAY (THAILAND) CO.,LTD.	PAGE 20
SUBSTATION	GIS	
POSITION	NO.1 TR.SEC. (BACK PANEL)	
VOLTAGE LEVEL	22 KV

PARTIAL DISCHARGE DETECTION METHOD BY AE Internal/Extended MODE

CRITERIA	1-5 mV
EVALUATION	Warning

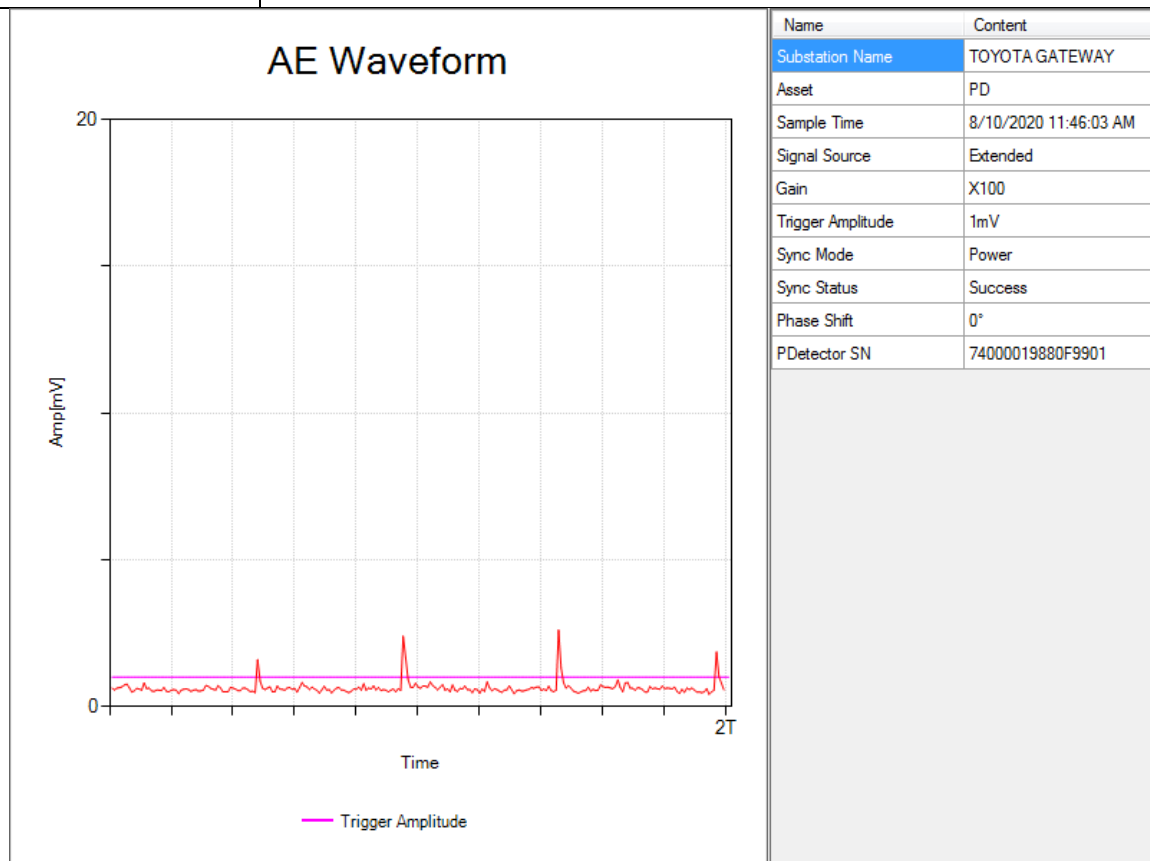
COSTOMER	TOYOTA GATEWAY (THAILAND) CO.,LTD.	PAGE 21
SUBSTATION	GIS	
POSITION	1-1 FEEDER (BACK PANEL)	
VOLTAGE LEVEL	22 KV

PARTIAL DISCHARGE DETECTION METHOD BY AE Internal/Extended MODE

CRITERIA	1-5 mV
EVALUATION	Warning

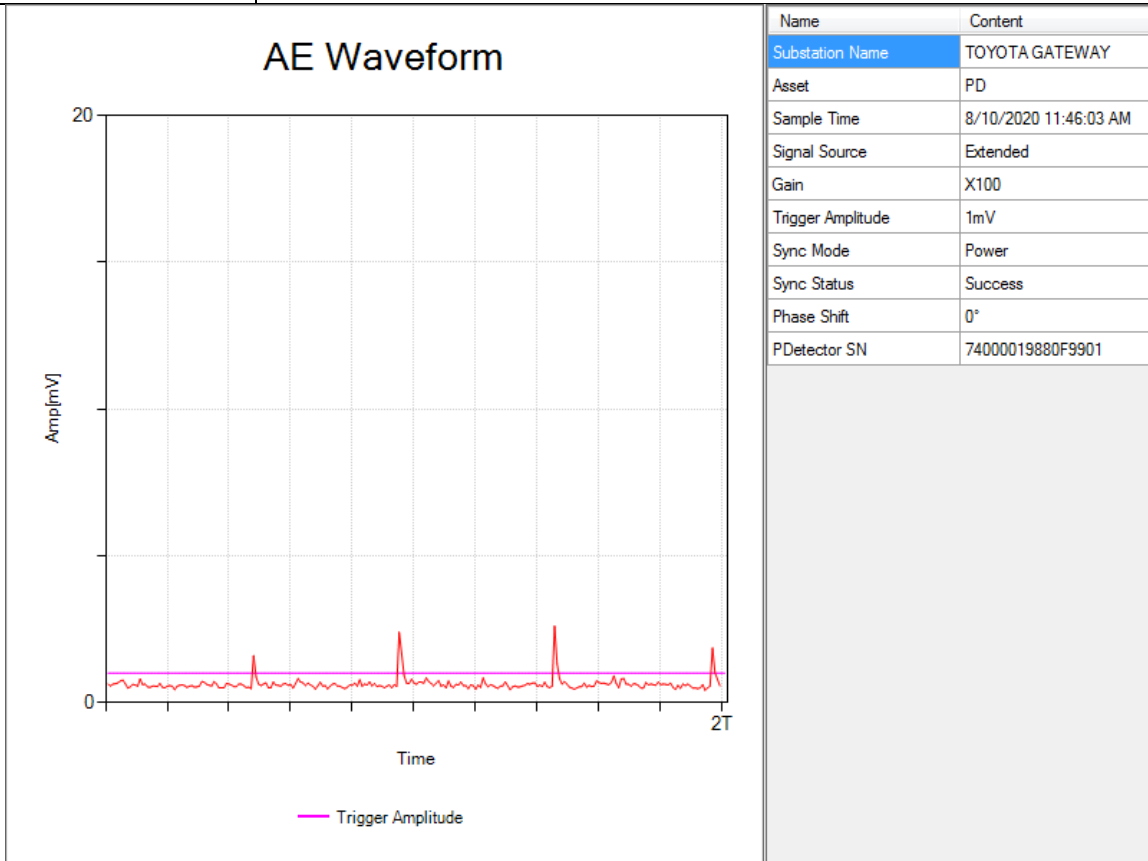
COSTOMER	TOYOTA GATEWAY (THAILAND) CO.,LTD.	PAGE 22
SUBSTATION	GIS	
POSITION	1-2 FEEDER (BACK PANEL)	
VOLTAGE LEVEL	22 KV

PARTIAL DISCHARGE DETECTION METHOD BY AE Internal/Extended MODE

CRITERIA	1-5 mV
EVALUATION	Warning

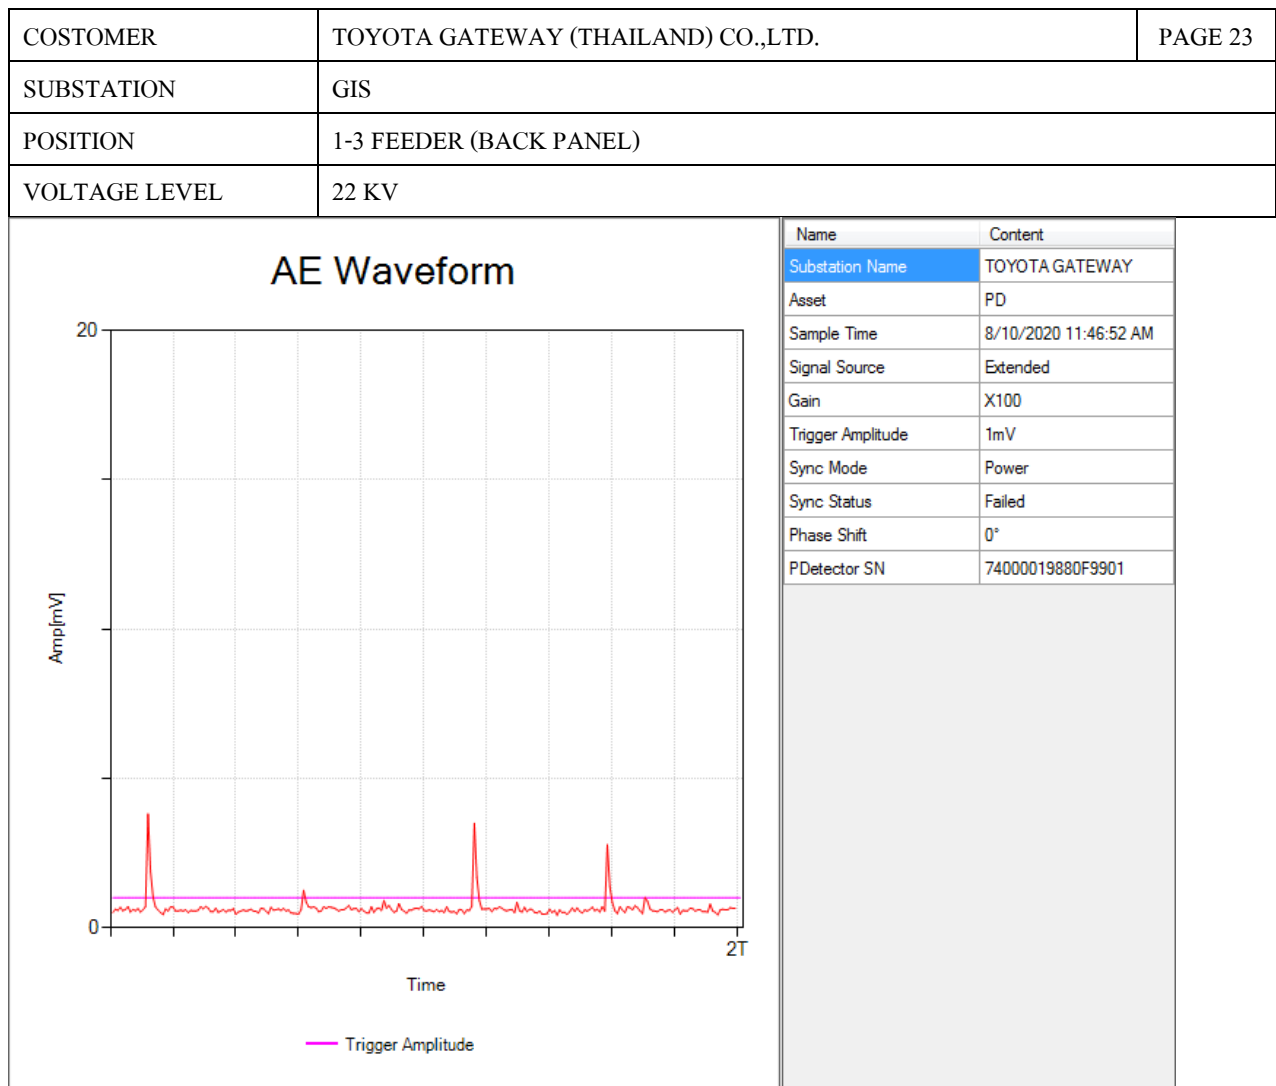
6. ตรวจพบสัญญาณการเกิด PARTIAL DISCHARGE (PD) ที่ 1-3 FEEDER (BACK PANEL)

PARTIAL DISCHARGE DETECTION METHOD BY AE Internal/Extended MODE

CRITERIA	1-5 mV
EVALUATION	Warning

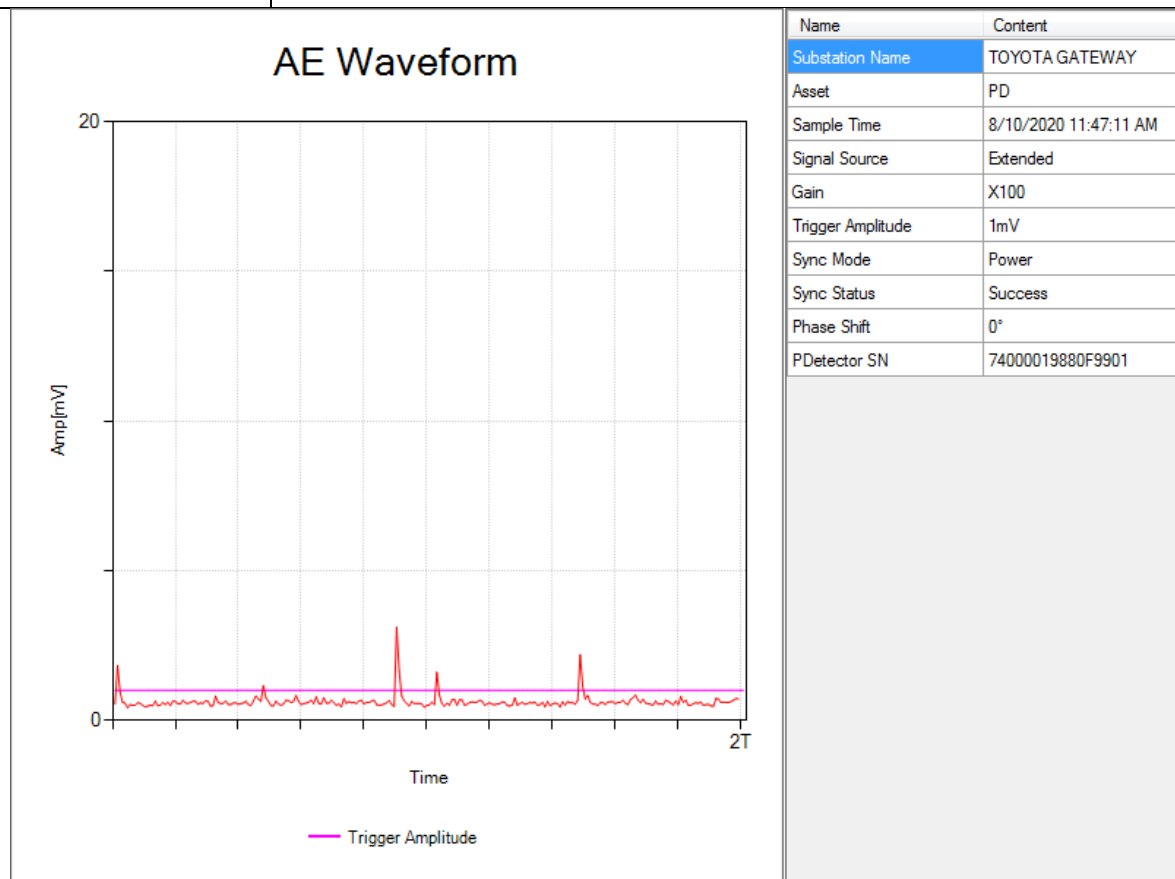
COSTOMER	TOYOTA GATEWAY (THAILAND) CO.,LTD.	PAGE 24
SUBSTATION	GIS	
POSITION	1-4 FEEDER (BACK PANEL)	
VOLTAGE LEVEL	22 KV

PARTIAL DISCHARGE DETECTION METHOD BY AE Internal/Extended MODE

CRITERIA	1-5 mV
EVALUATION	Warning

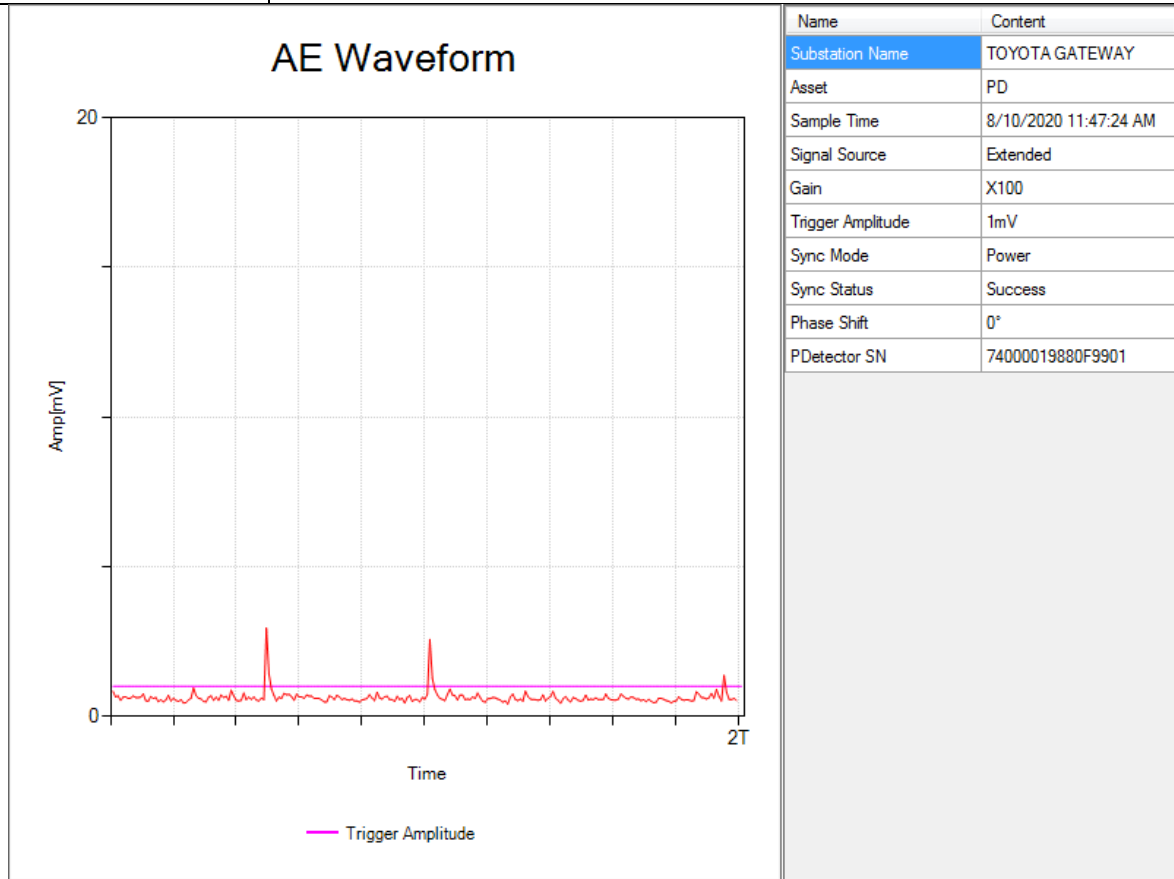
COSTOMER	TOYOTA GATEWAY (THAILAND) CO.,LTD.	PAGE 25
SUBSTATION	GIS	
POSITION	CAPACITOR (BACK PANEL)	
VOLTAGE LEVEL	22 KV

PARTIAL DISCHARGE DETECTION METHOD BY AE Internal/Extended MODE

CRITERIA	1-5 mV
EVALUATION	Warning

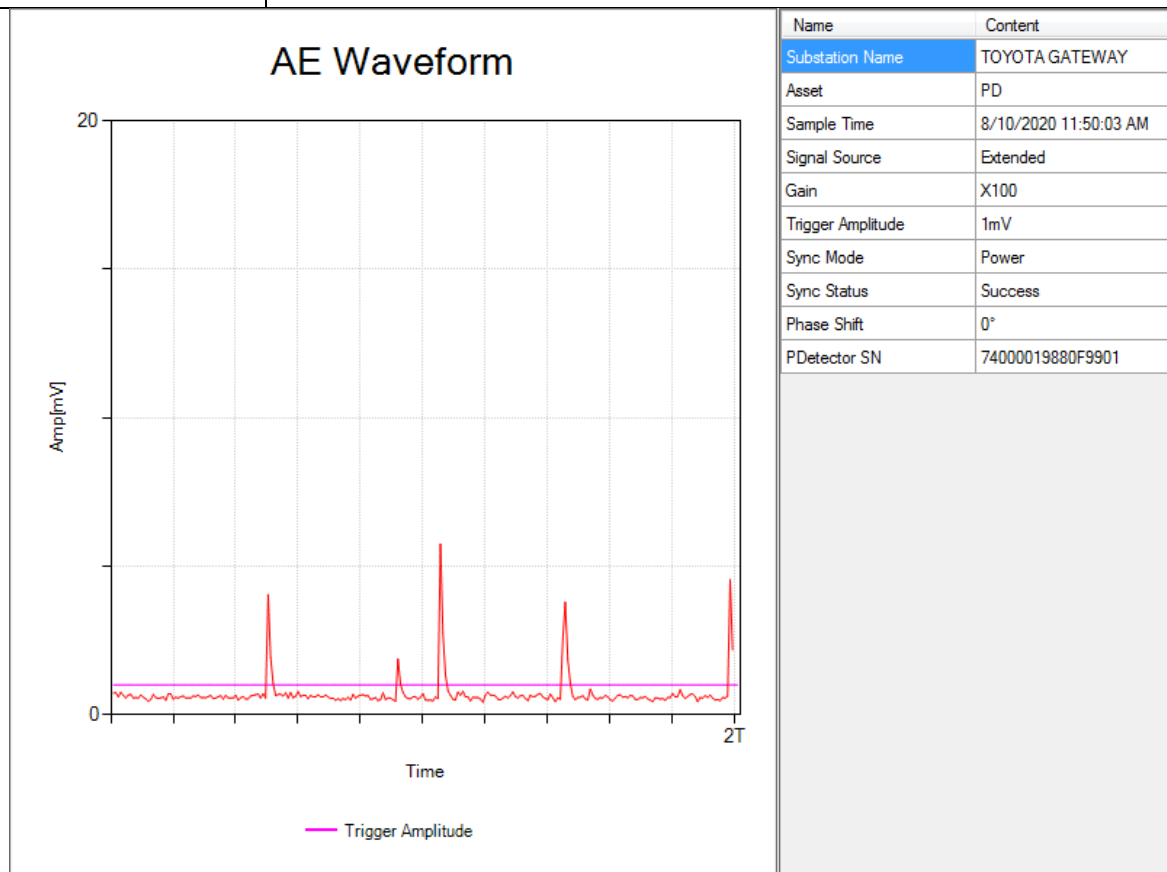
COSTOMER	TOYOTA GATEWAY (THAILAND) CO.,LTD.	PAGE 26
SUBSTATION	GIS	
POSITION	NO.2 BANK BUS VT (BACK PANEL)	
VOLTAGE LEVEL	22 KV

PARTIAL DISCHARGE DETECTION METHOD BY AE Internal/Extended MODE

CRITERIA	1-5 mV
EVALUATION	Warning

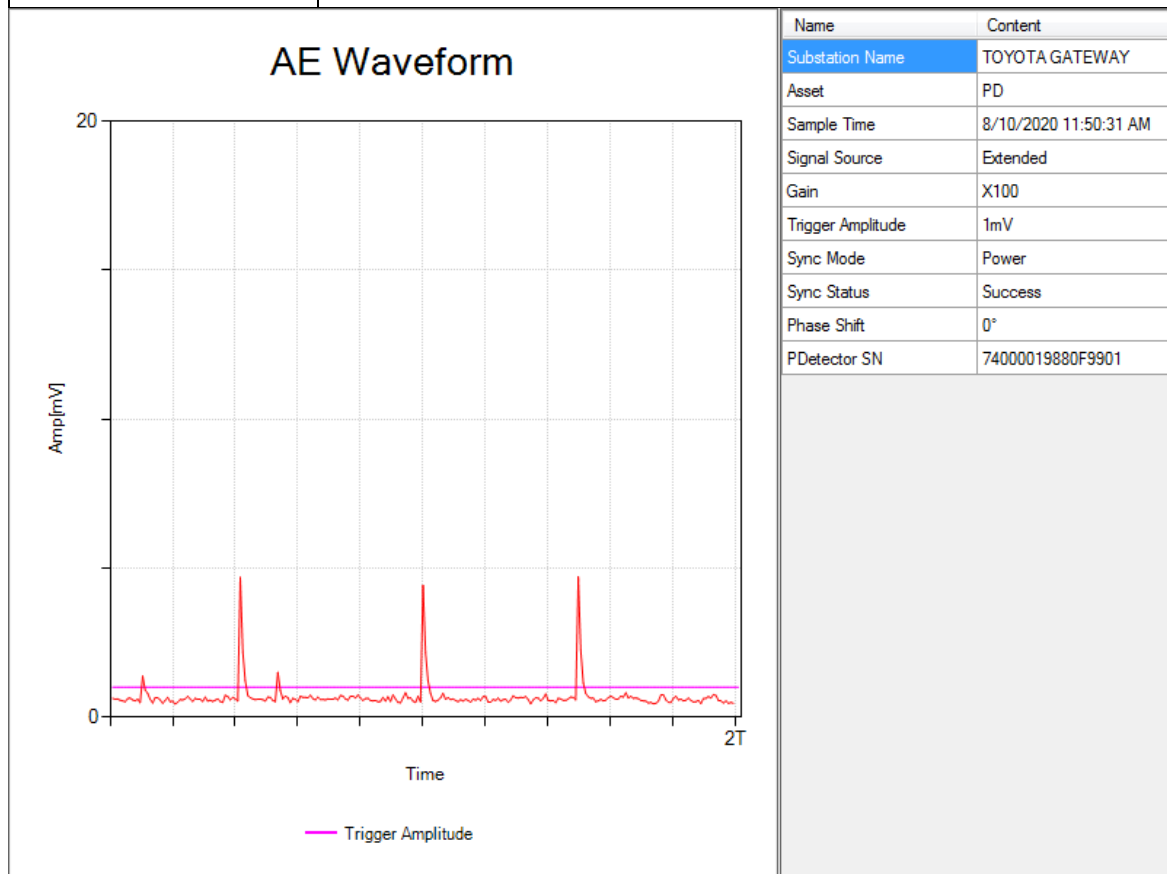
COSTOMER	TOYOTA GATEWAY (THAILAND) CO.,LTD.	PAGE 27
SUBSTATION	GIS	
POSITION	TR.2 TR SEC (BACK PANEL)	
VOLTAGE LEVEL	22 KV

PARTIAL DISCHARGE DETECTION METHOD BY AE Internal/Extended MODE

CRITERIA	1-5 mV
EVALUATION	Warning

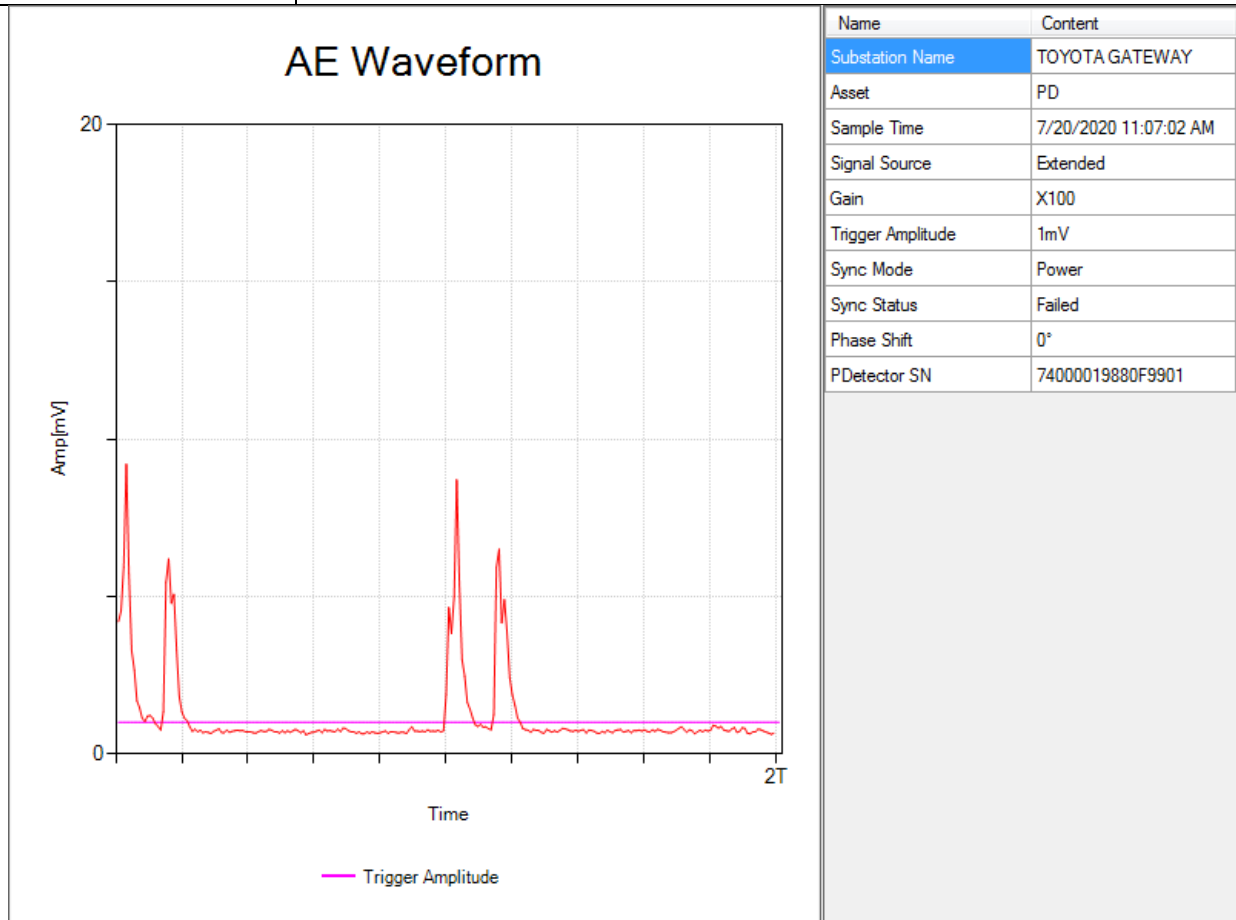
COSTOMER	TOYOTA GATEWAY (THAILAND) CO.,LTD.	PAGE 33
SUBSTATION	SUBSTATION 115 KV	
POSITION	DS PHASE R	
VOLTAGE LEVEL	115 KV

PARTIAL DISCHARGE DETECTION METHOD BY AE Ultrasonic Dish MODE

CRITERIA	5-20 mV
EVALUATION	Warning

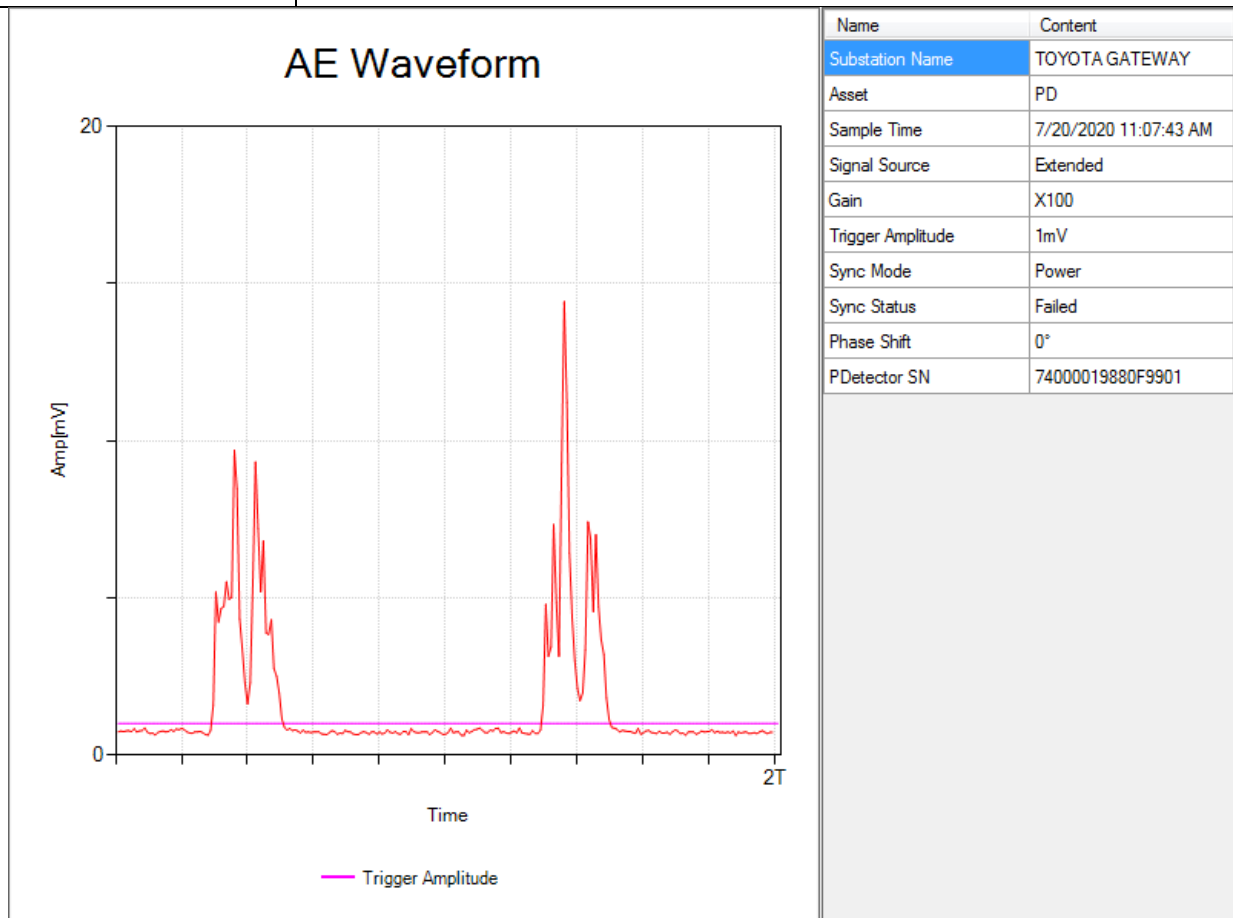
COSTOMER	TOYOTA GATEWAY (THAILAND) CO.,LTD.	PAGE 36
SUBSTATION	SUBSTATION 115 KV	
POSITION	DS PHASE Y	
VOLTAGE LEVEL	115 KV

PARTIAL DISCHARGE DETECTION METHOD BY AE Ultrasonic Dish MODE

CRITERIA	5-20 mV
EVALUATION	Warning

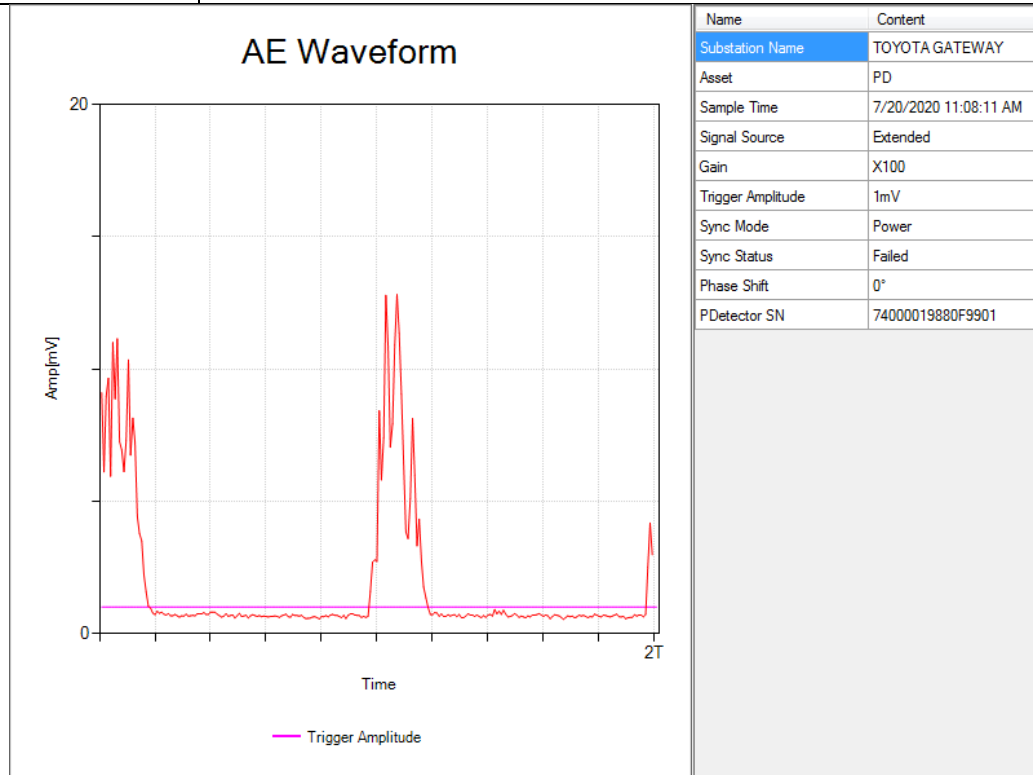
COSTOMER	TOYOTA GATEWAY (THAILAND) CO.,LTD.	PAGE 39
SUBSTATION	SUBSTATION 115 KV	
POSITION	DS PHASE B	
VOLTAGE LEVEL	115 KV

PARTIAL DISCHARGE DETECTION METHOD BY AE Ultrasonic Dish MODE

CRITERIA	5-20 mV
EVALUATION	Warning

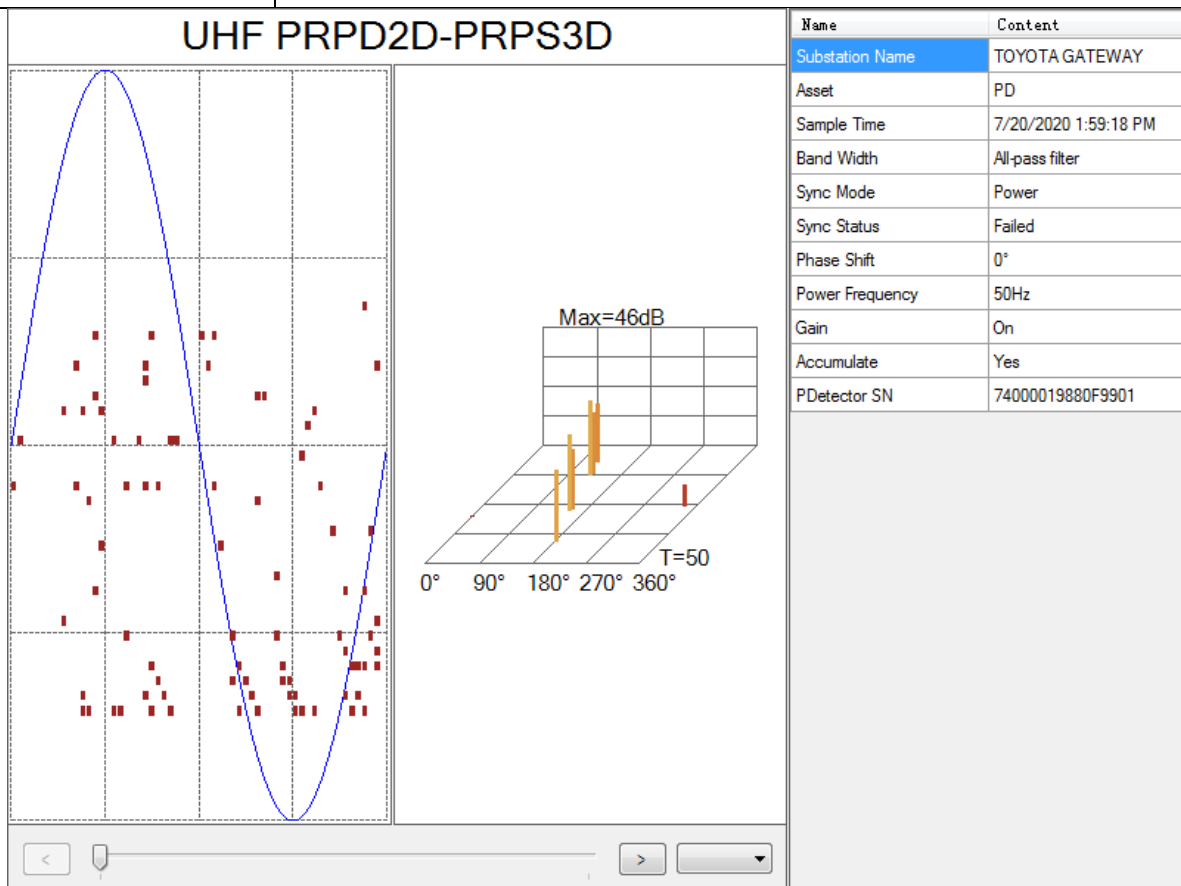
COSTOMER	TOYOTA GATEWAY (THAILAND) CO.,LTD.	PAGE 86
SUBSTATION	GIS	
POSITION	NO.2 TR SEC	
VOLTAGE LEVEL	22 KV

PARTIAL DISCHARGE DETECTION METHOD BY UHF MODE

CRITERIA	30-50 dB
EVALUATION	Warning

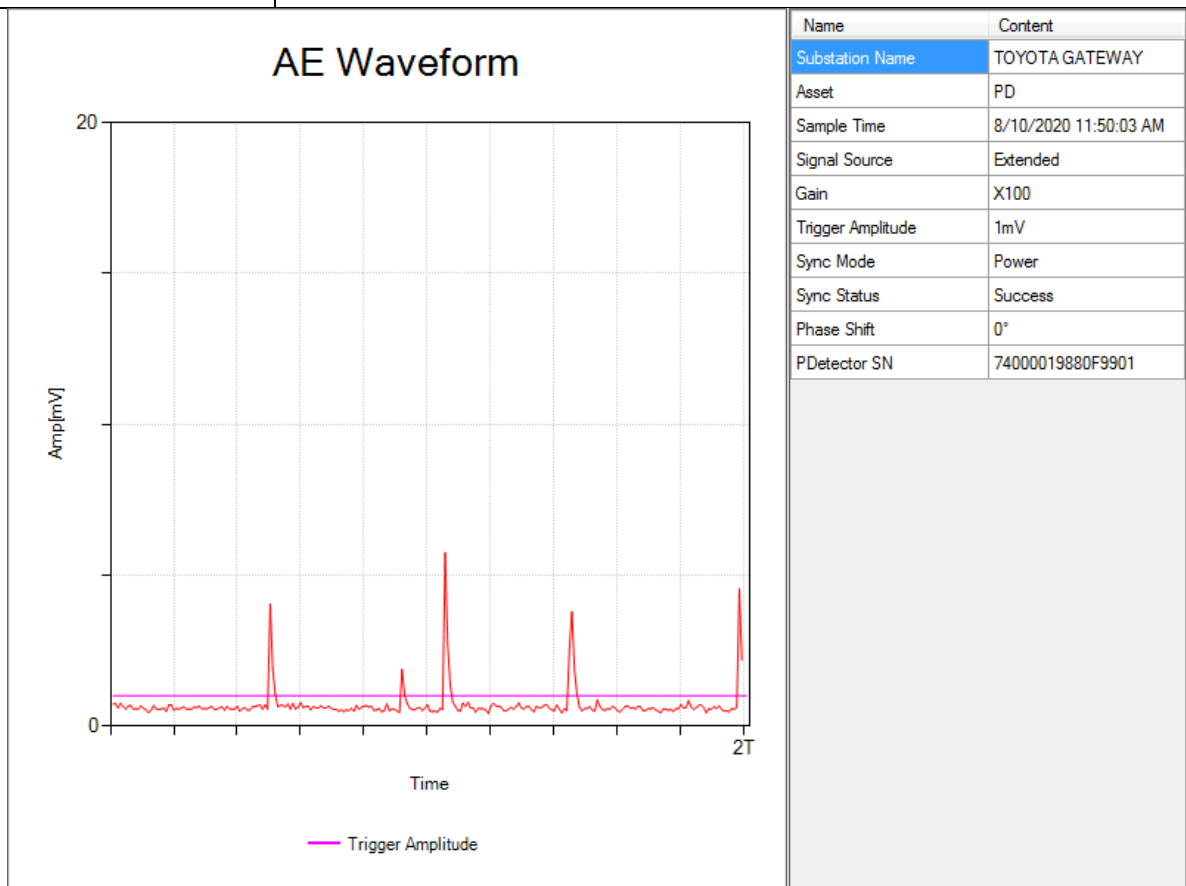
COSTOMER	TOYOTA GATEWAY (THAILAND) CO.,LTD.	PAGE 126
SUBSTATION	SUBSTATION GI	
POSITION	22 KV GIS NO.2 BANK BUS VT (BACK PANEL)	
VOLTAGE LEVEL	22 KV

PARTIAL DISCHARGE DETECTION METHOD BY AE Internal/Extended MODE

CRITERIA	>5mV
EVALUATION	Critical

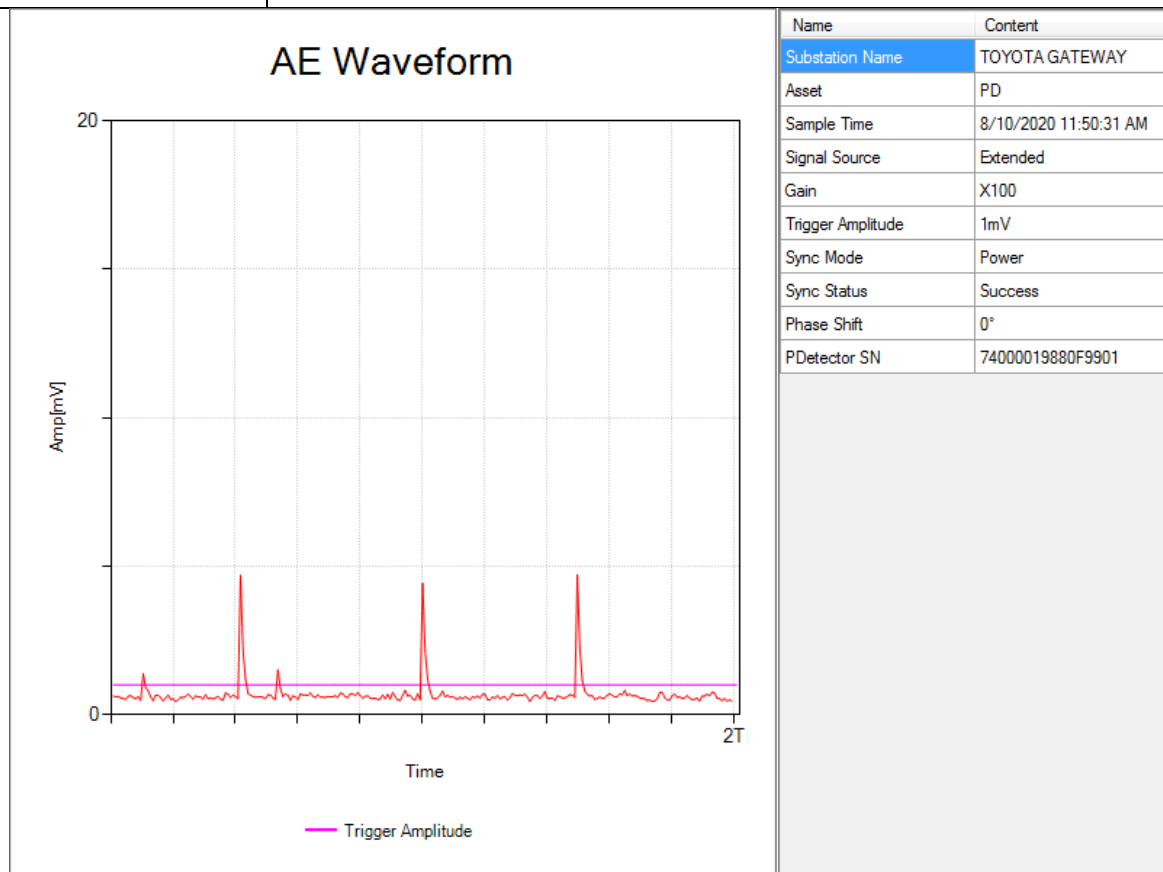
COSTOMER	TOYOTA GATEWAY (THAILAND) CO.,LTD.	PAGE 128
SUBSTATION	GIS	
POSITION	TR2 TR SEC (BACK PANEL)	
VOLTAGE LEVEL	22 KV

PARTIAL DISCHARGE DETECTION METHOD BY AE Internal/Extended MODE

CRITERIA	1-5 mV
EVALUATION	Warning

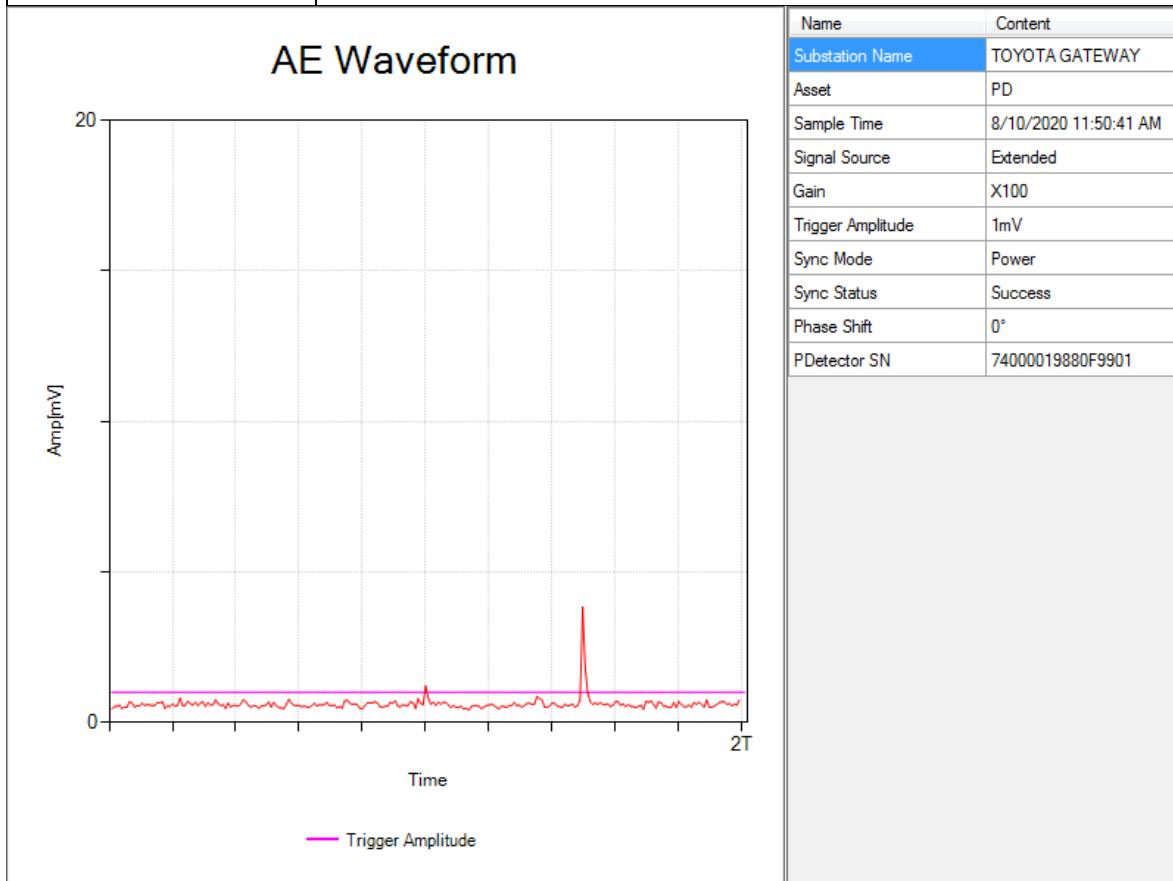
COSTOMER	TOYOTA GATEWAY (THAILAND) CO.,LTD.	PAGE 130
SUBSTATION	GIS	
POSITION	2-1 FEEDER (BACK PANEL)	
VOLTAGE LEVEL	22 KV

PARTIAL DISCHARGE DETECTION METHOD BY AE Internal/Extended MODE

CRITERIA	1-5 mV
EVALUATION	Warning

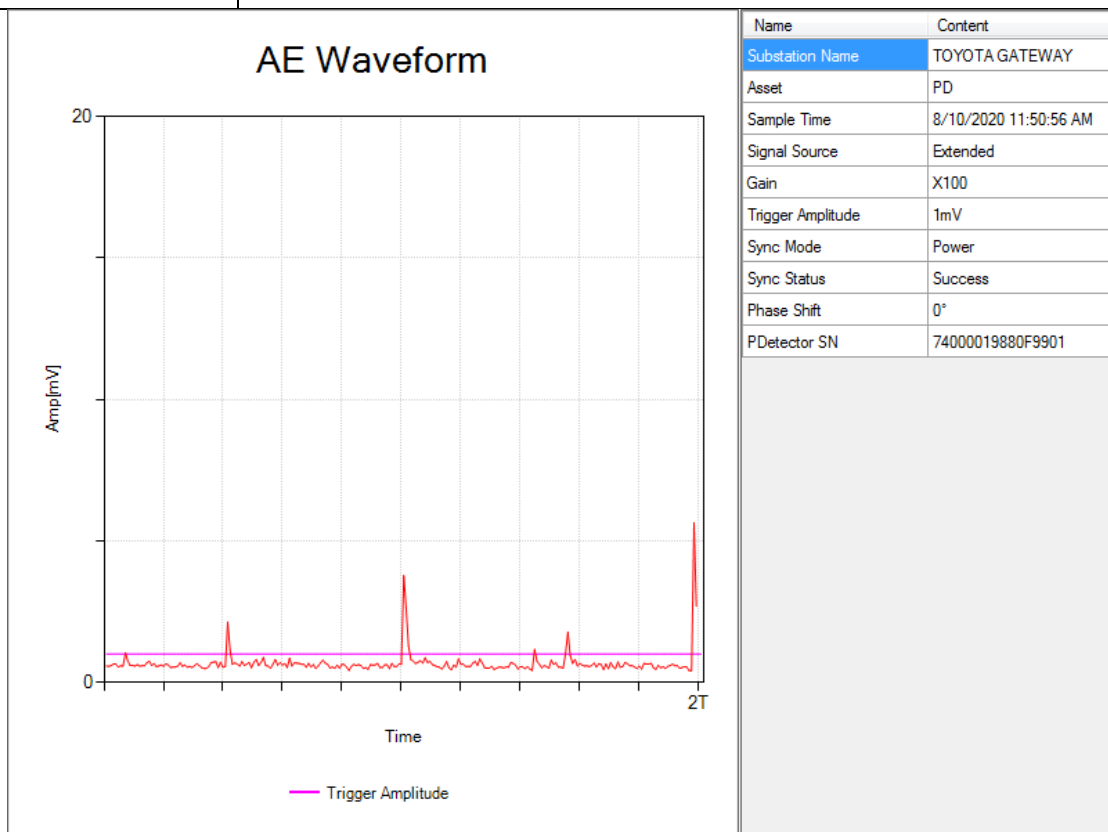
COSTOMER	TOYOTA GATEWAY (THAILAND) CO.,LTD.	PAGE 132
SUBSTATION	GIS	
POSITION	2-2 FEEDER (BACK PANEL)	
VOLTAGE LEVEL	22 KV

PARTIAL DISCHARGE DETECTION METHOD BY AE Internal/Extended MODE

CRITERIA	1-5 mV
EVALUATION	Warning

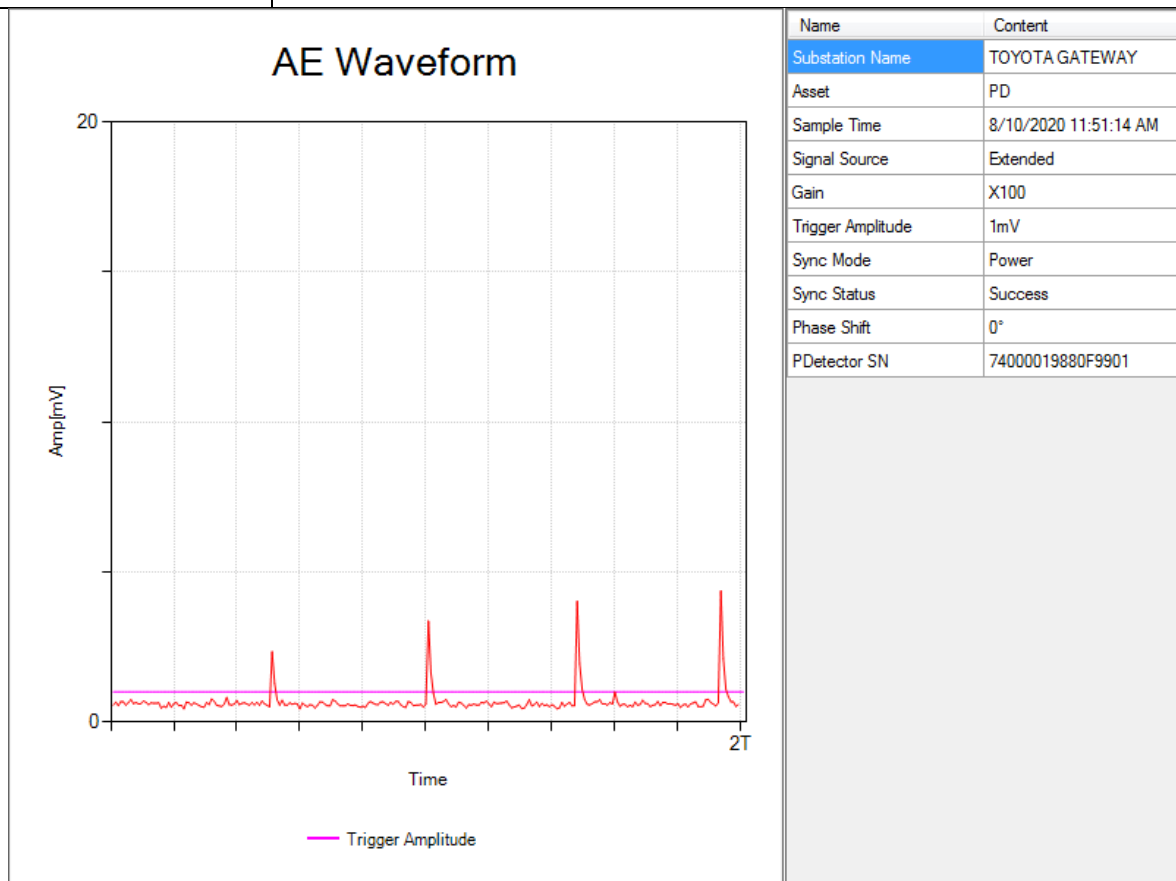
COSTOMER	TOYOTA GATEWAY (THAILAND) CO.,LTD.	PAGE 134
SUBSTATION	GIS	
POSITION	2-3 FEEDER (BACK PANEL)	
VOLTAGE LEVEL	22 KV

PARTIAL DISCHARGE DETECTION METHOD BY AE Internal/Extended MODE

CRITERIA	1-5 mV
EVALUATION	Warning

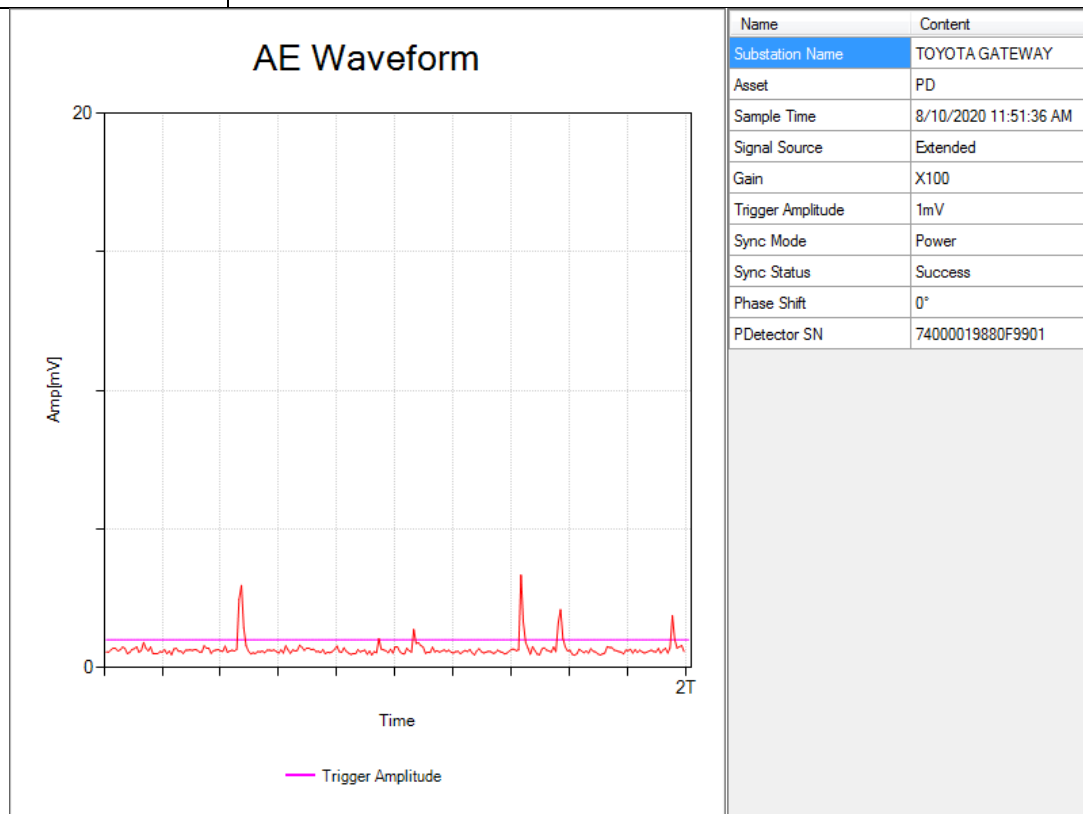
COSTOMER	TOYOTA GATEWAY (THAILAND) CO.,LTD.	PAGE 136
SUBSTATION	GIS	
POSITION	2-4 FEEDER (BACK PANEL)	
VOLTAGE LEVEL	22 KV

PARTIAL DISCHARGE DETECTION METHOD BY AE Internal/Extended MODE

CRITERIA	1-5 mV
EVALUATION	Warning

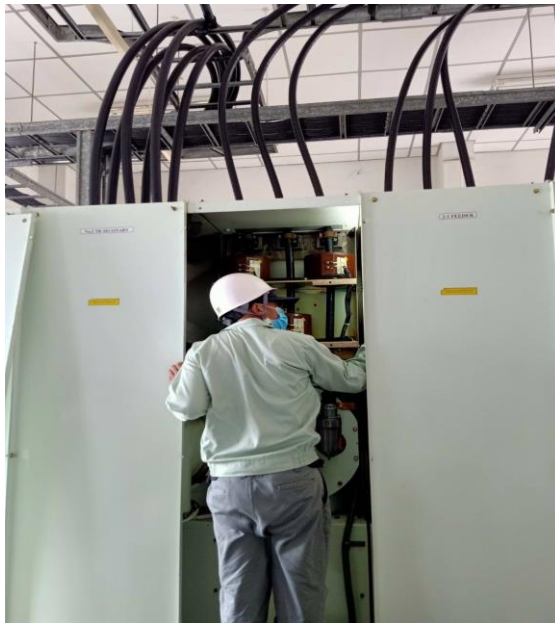
PARTIAL DISCHARGE DETECTED BY VISUALLY INSPECT

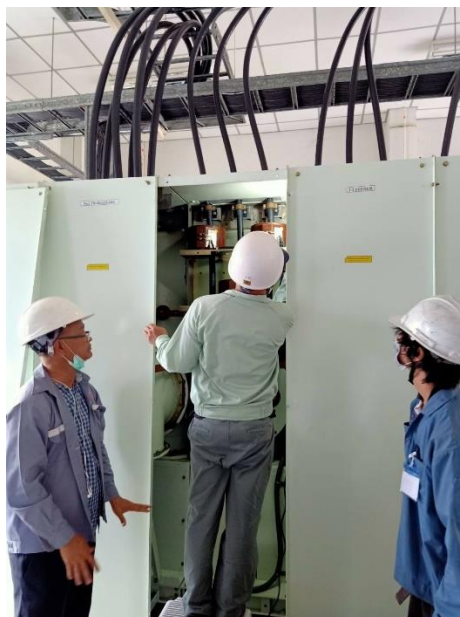
PARTIAL DISCHARGE DETECTED BY VISUALLY INSPECT

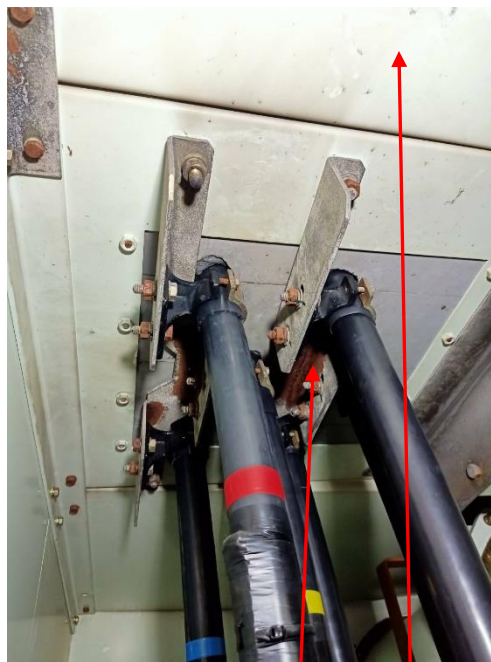
PARTIAL DISCHARGE EFFECT – MANY RUST AND HIGH SPOT OCCUR DUE TO CHEMICAL REACTION

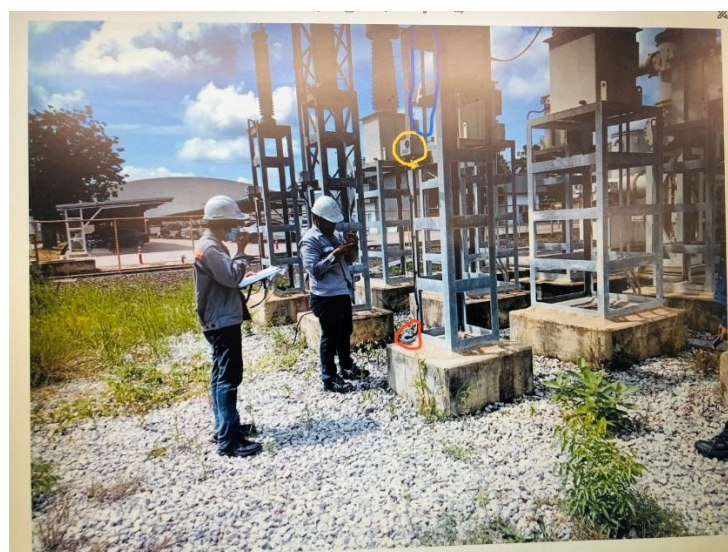
PARTIAL DISCHARGE DETECTED BY HFCT
