PARTIAL DISCHARGE REPORT

CUSTOMER :CO.,LTD.

DATE : July 8th, 2020

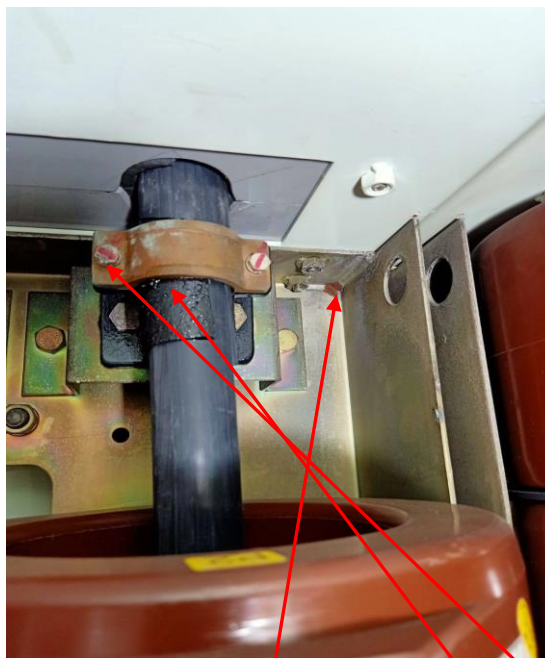
PARTIAL DISCHARGE EFFECT – MANY RUST AND HIGH SPOT TEMPERATURE OCCUR

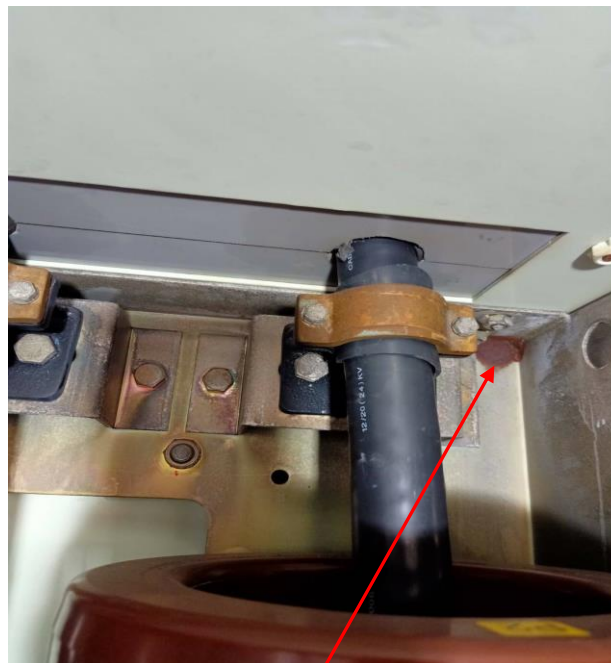
PARTIAL DISCHARGE EFFECT – MANY RUST AND HIGH SPOT TEMPERATURE OCCUR

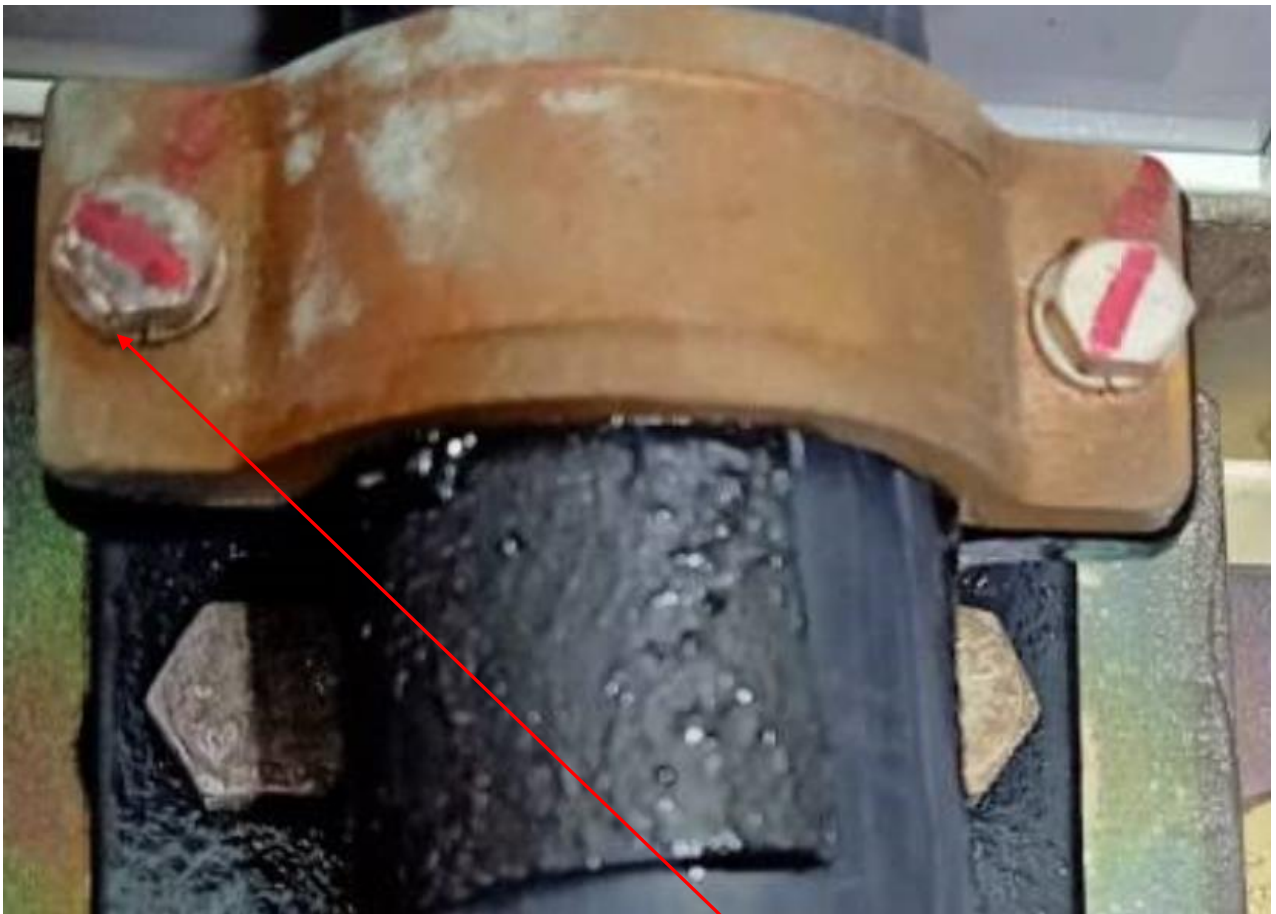
PARTIAL DISCHARGE EFFECT – MANY RUST AND HIGH SPOT TEMPERATURE OCCUR

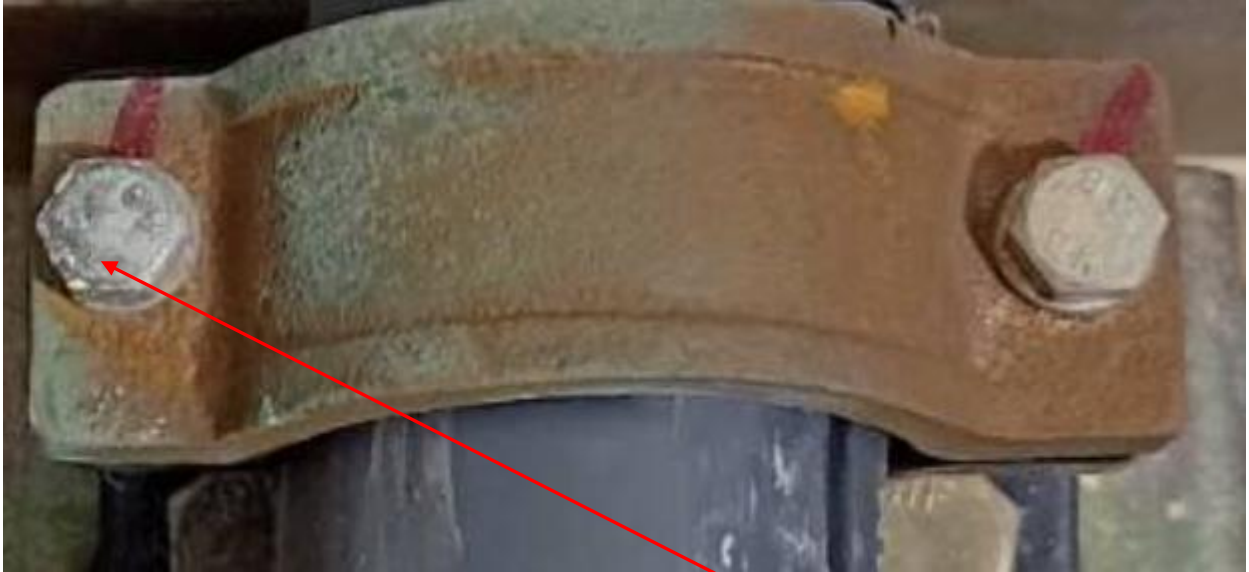
PARTIAL DISCHARGE EFFECT – MANY RUST AND HIGH SPOT TEMPERATURE OCCUR

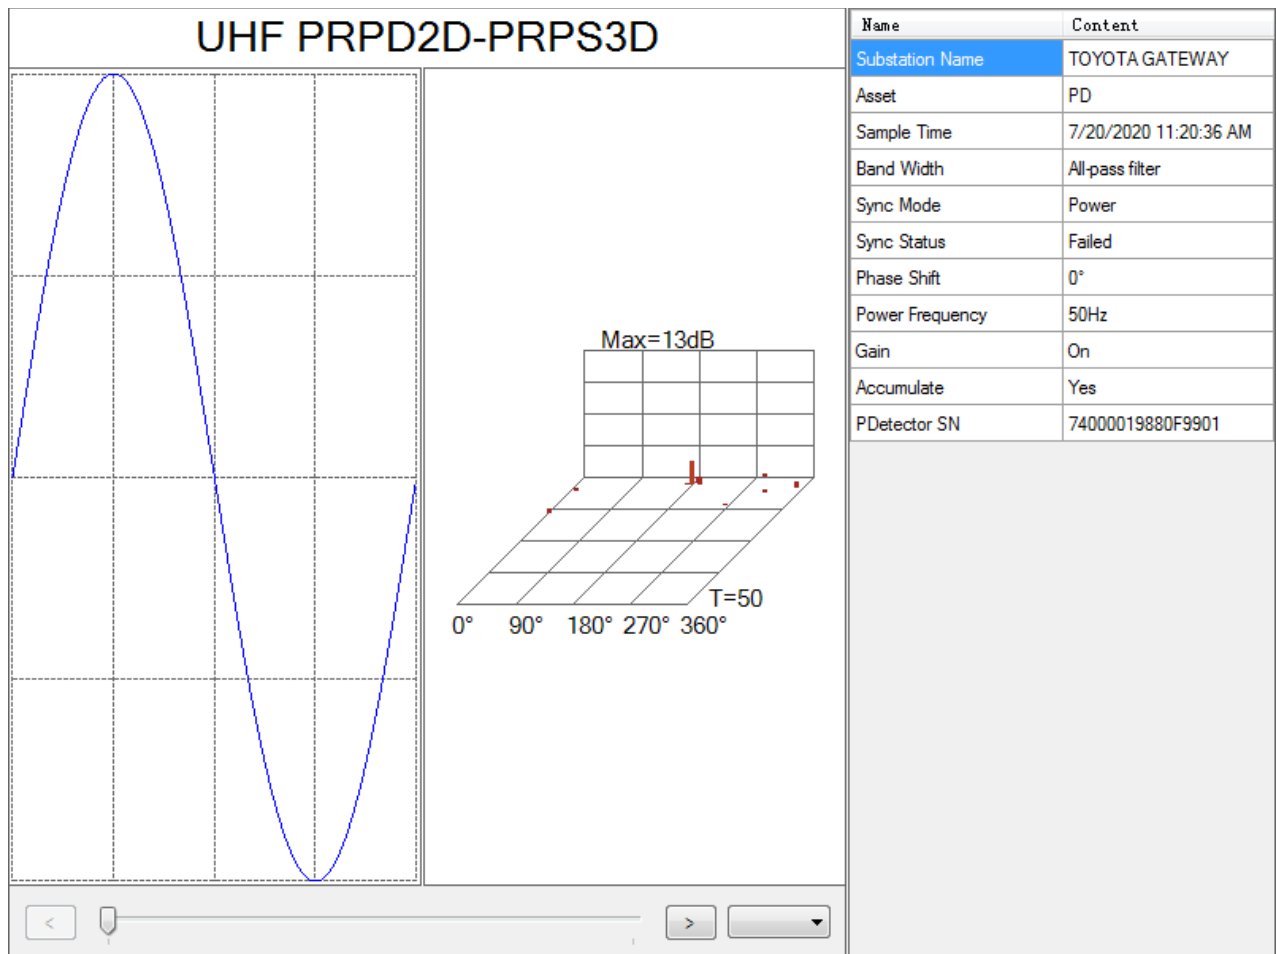
COSTOMER	TOYOTA GATEWAY (THAILAND) CO.,LTD.
SUBSTATION	SUBSTATION 115 KV
POSITION	LA 115 KV CABLE PHASE R
VOLTAGE LEVEL	115 KV

COMMENT	No Partial discharge (PD) was found.
EVALUATION	Normal
SUGGESTION	No action
TESTED AND REPORTED BY	Mr.Tukdanai Pothanak
APPROVED BY	Mr.Chanvit Crukaew

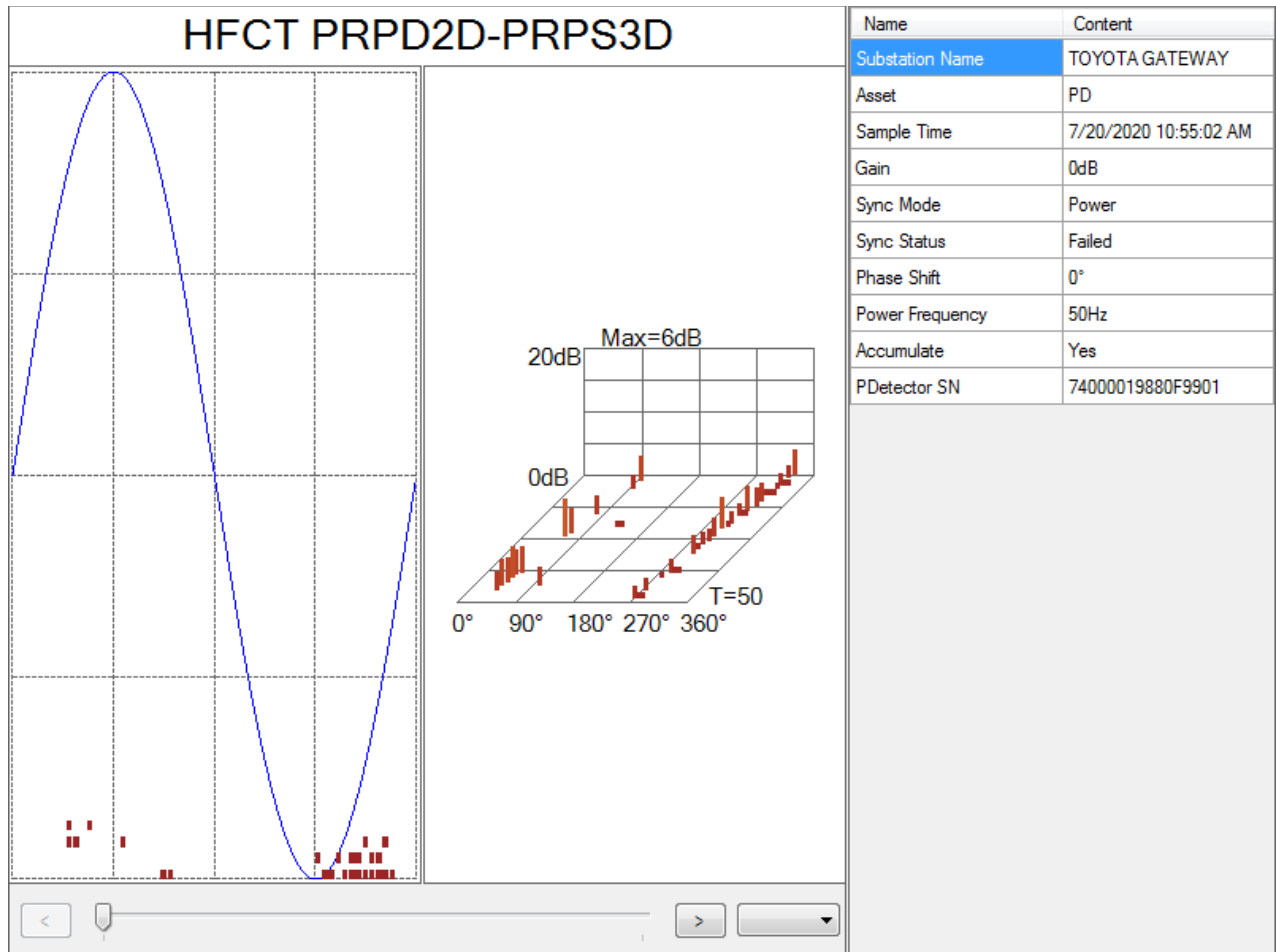
COSTOMER	TOYOTA GATEWAY (THAILAND) CO.,LTD.
SUBSTATION	SUBSTATION 115 KV
POSITION	LA 115 KV CABLE PHASE R
VOLTAGE LEVEL	115 KV

COMMENT	No Partial discharge (PD) was found.
EVALUATION	Normal
SUGGESTION	No action
TESTED AND REPORTED BY	Mr.Tukdanai Pothanak
APPROVED BY	Mr.Chanvit Crukaew

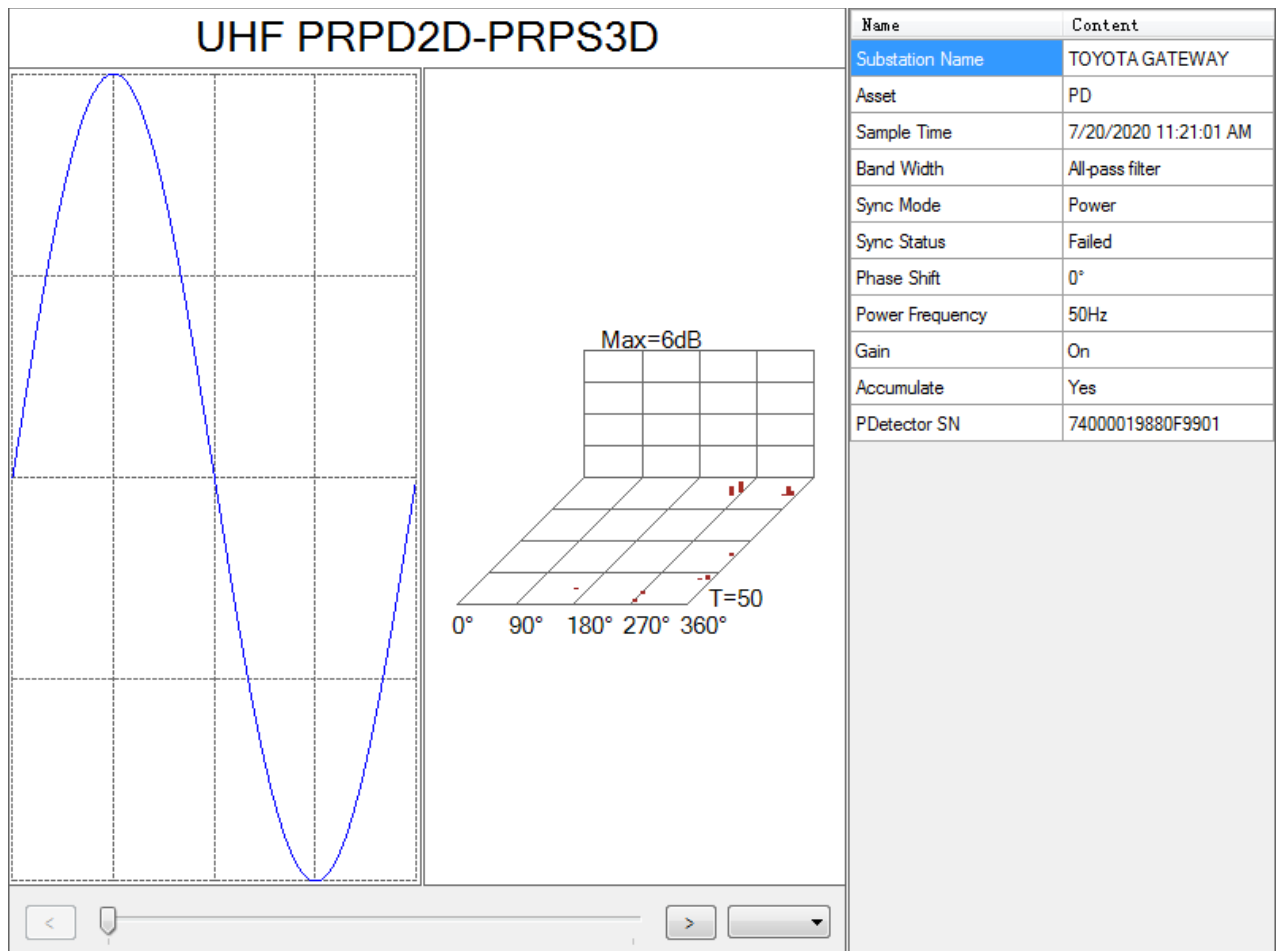
COSTOMER	TOYOTA GATEWAY (THAILAND) CO.,LTD.
SUBSTATION	SUBSTATION 115 KV
POSITION	LA 115 KV CABLE PHASE Y
VOLTAGE LEVEL	115 KV

COMMENT	No Partial discharge (PD) was found.
EVALUATION	Normal
SUGGESTION	No action
TESTED AND REPORTED BY	Mr.Tukdanai Pothanak
APPROVED BY	Mr.Chanvit Crukaew

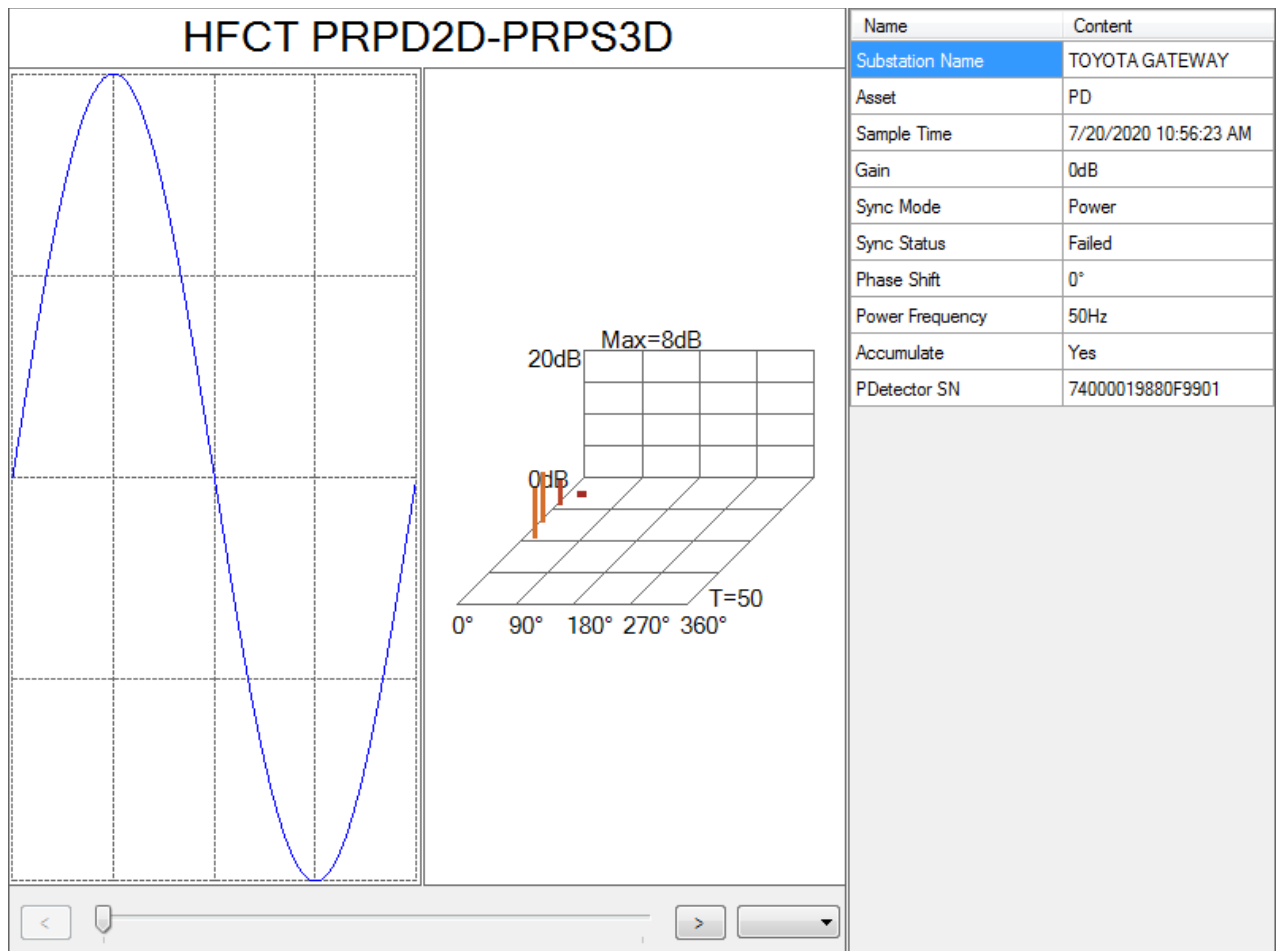
COSTOMER	TOYOTA GATEWAY (THAILAND) CO.,LTD.
SUBSTATION	SUBSTATION 115 KV
POSITION	LA 115 KV CABLE PHASE Y
VOLTAGE LEVEL	115 KV

COMMENT	No Partial discharge (PD) was found.
EVALUATION	Normal
SUGGESTION	No action
TESTED AND REPORTED BY	Mr.Tukdanai Pothanak
APPROVED BY	Mr.Chanvit Crukaew

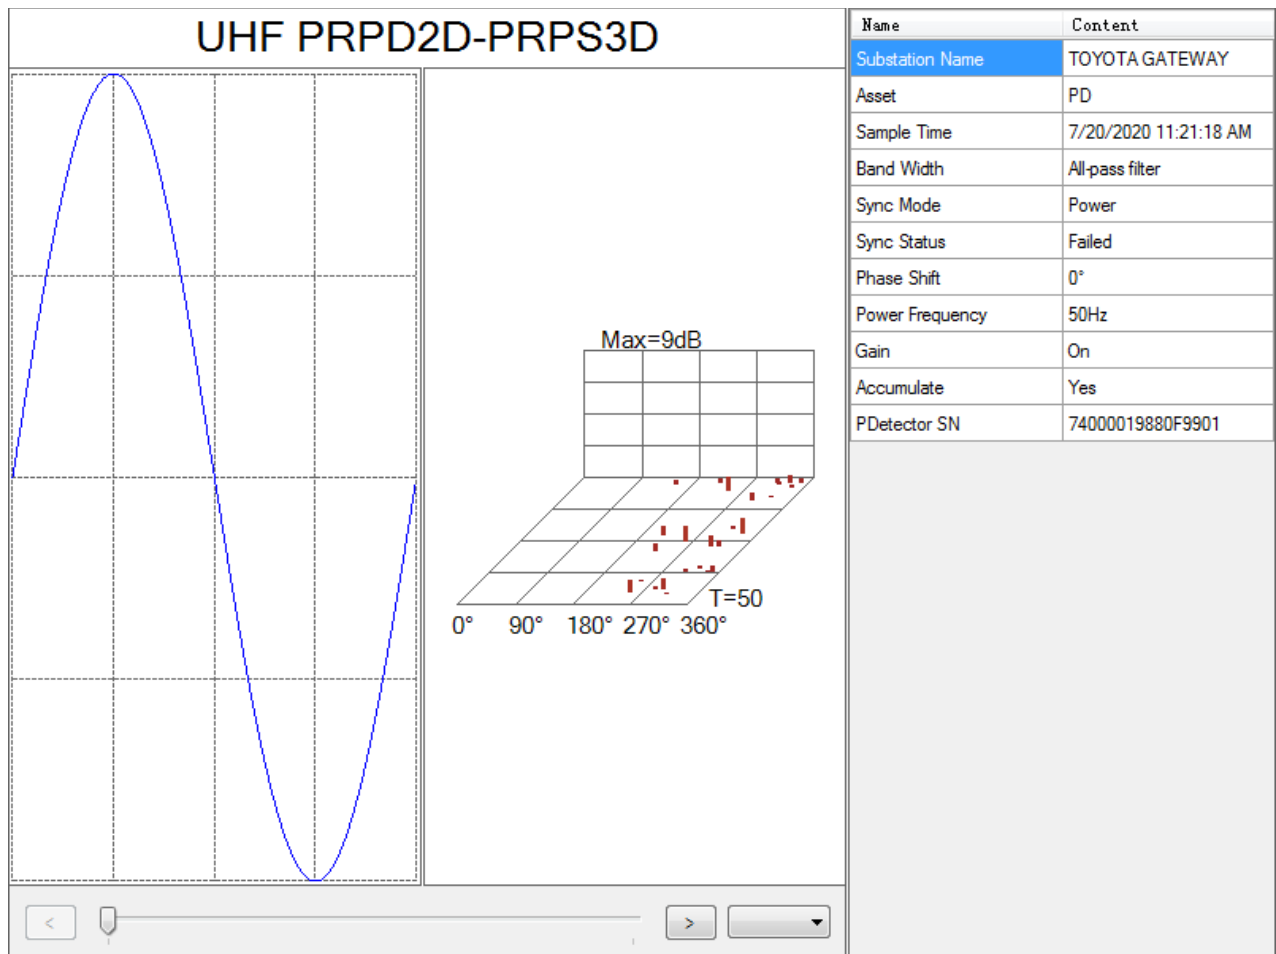
COSTOMER	TOYOTA GATEWAY (THAILAND) CO.,LTD.
SUBSTATION	SUBSTATION 115 KV
POSITION	LA 115 KV CABLE PHASE B
VOLTAGE LEVEL	115 KV

COMMENT	No Partial discharge (PD) was found.
EVALUATION	Normal
SUGGESTION	No action
TESTED AND REPORTED BY	Mr.Tukdanai Pothanak
APPROVED BY	Mr.Chanvit Crukaew

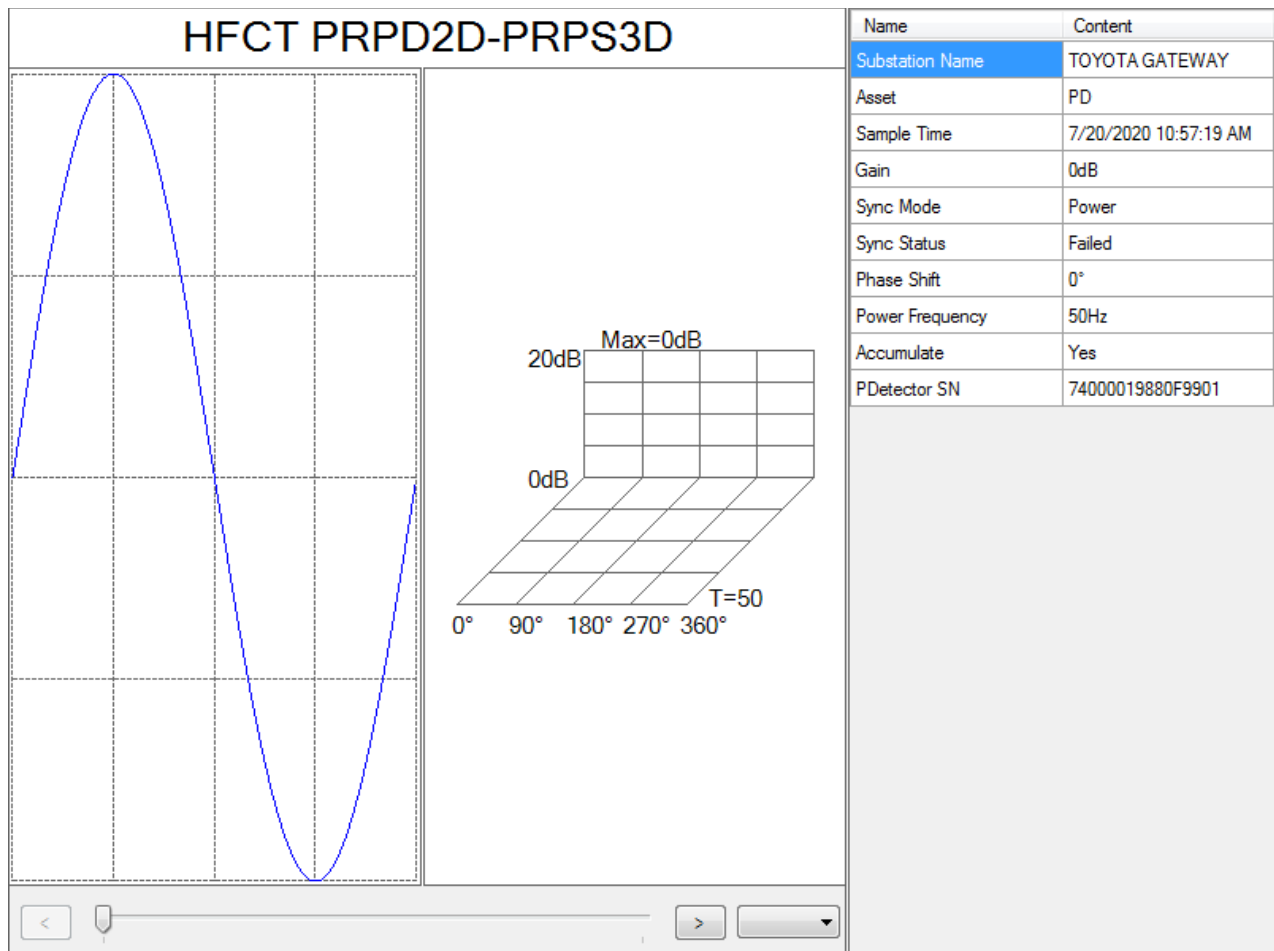
COSTOMER	TOYOTA GATEWAY (THAILAND) CO.,LTD.
SUBSTATION	SUBSTATION 115 KV
POSITION	LA 115 KV CABLE PHASE B
VOLTAGE LEVEL	115 KV

COMMENT	No Partial discharge (PD) was found.
EVALUATION	Normal
SUGGESTION	No action
TESTED AND REPORTED BY	Mr.Tukdanai Pothanak
APPROVED BY	Mr.Chanvit Crukaew

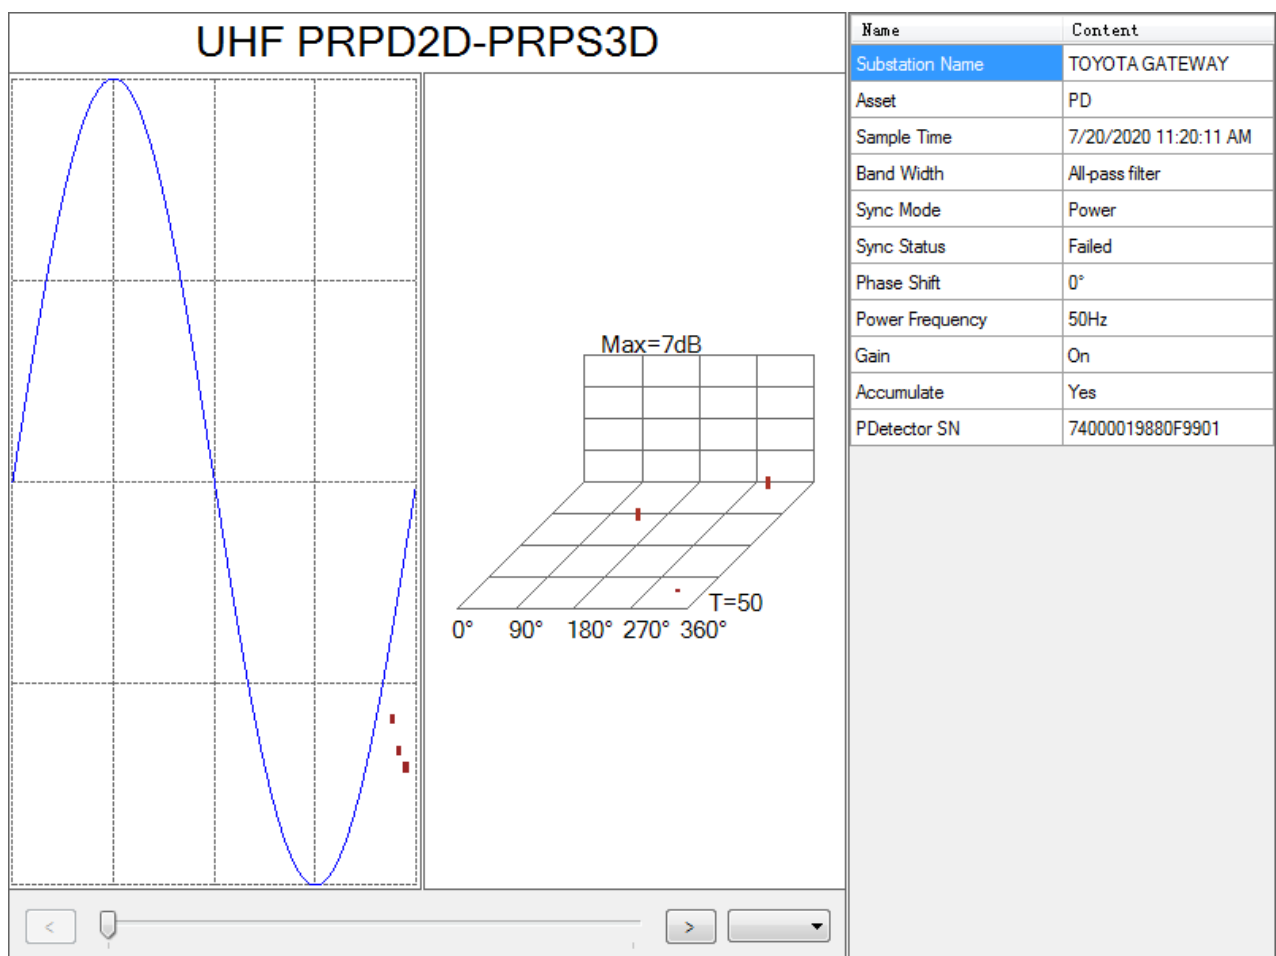
COSTOMER	TOYOTA GATEWAY (THAILAND) CO.,LTD.
SUBSTATION	SUBSTATION 115 KV
POSITION	POLE 115 KV (1)
VOLTAGE LEVEL	115 KV

COMMENT	No Partial discharge (PD) was found.
EVALUATION	Normal
SUGGESTION	No action
TESTED AND REPORTED BY	Mr.Tukdanai Pothanak
APPROVED BY	Mr.Chanvit Crukaew

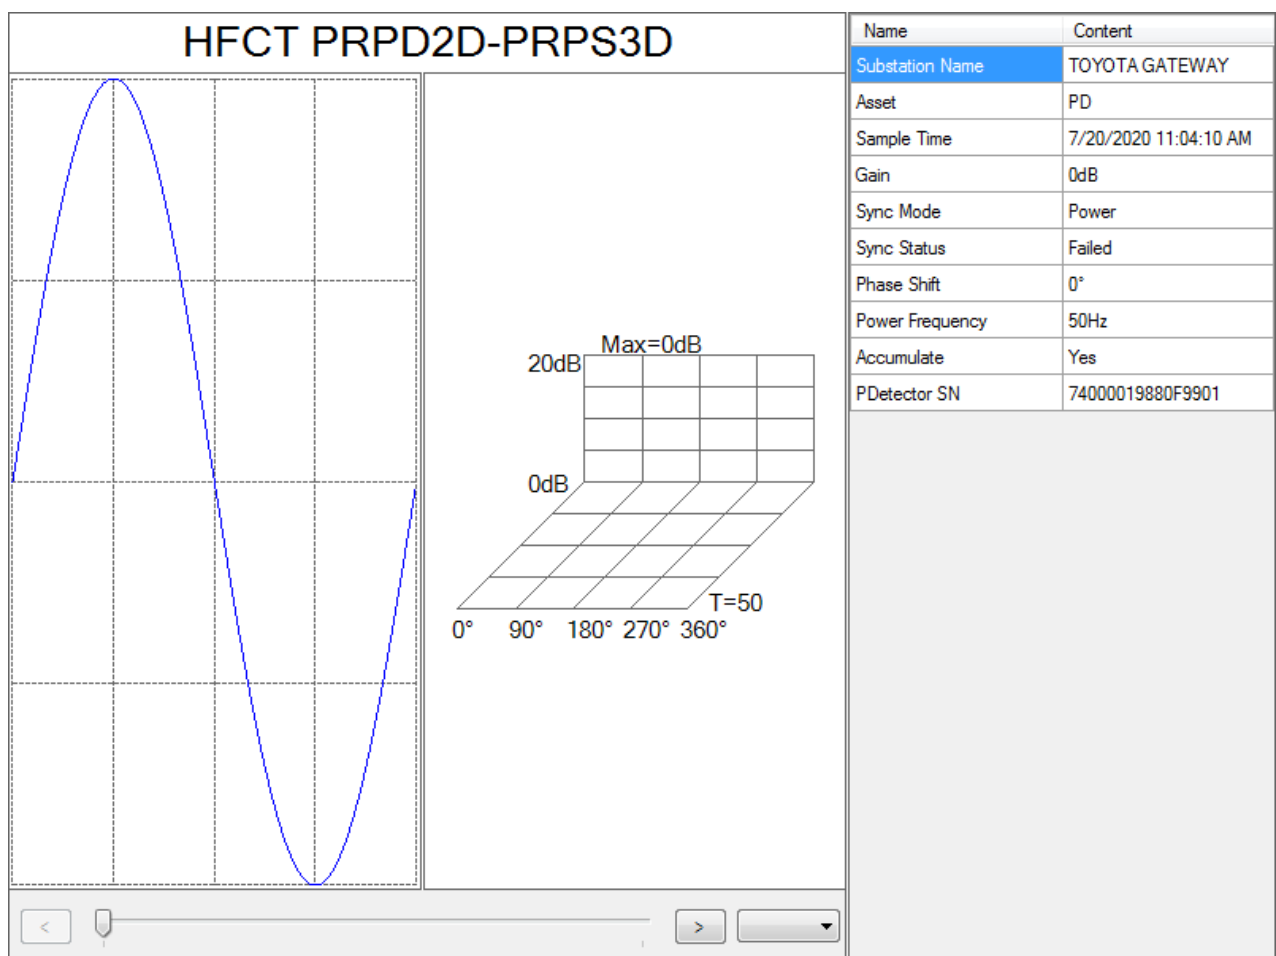
COSTOMER	TOYOTA GATEWAY (THAILAND) CO.,LTD.
SUBSTATION	SUBSTATION 115 KV
POSITION	POLE 115 KV (2)
VOLTAGE LEVEL	115 KV

COMMENT	No Partial discharge (PD) was found.
EVALUATION	Normal
SUGGESTION	No action
TESTED AND REPORTED BY	Mr.Tukdanai Pothanak
APPROVED BY	Mr.Chanvit Crukaew

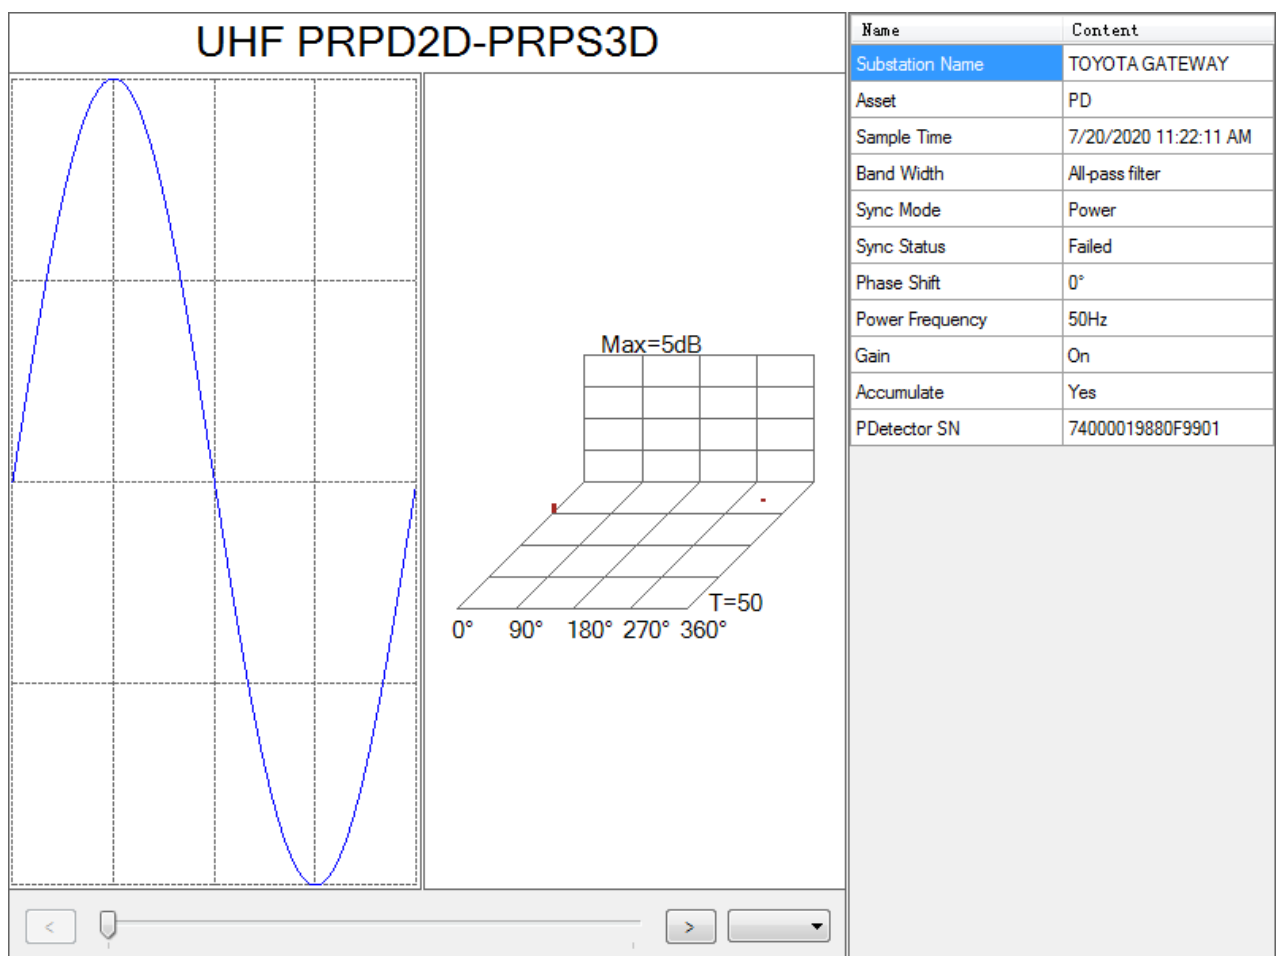
COSTOMER	TOYOTA GATEWAY (THAILAND) CO.,LTD.
SUBSTATION	SUBSTATION 115 KV
POSITION	PT PHASE R
VOLTAGE LEVEL	115 KV

COMMENT	No Partial discharge (PD) was found.
EVALUATION	Normal
SUGGESTION	No action
TESTED AND REPORTED BY	Mr.Tukdanai Pothanak
APPROVED BY	Mr.Chanvit Crukaew

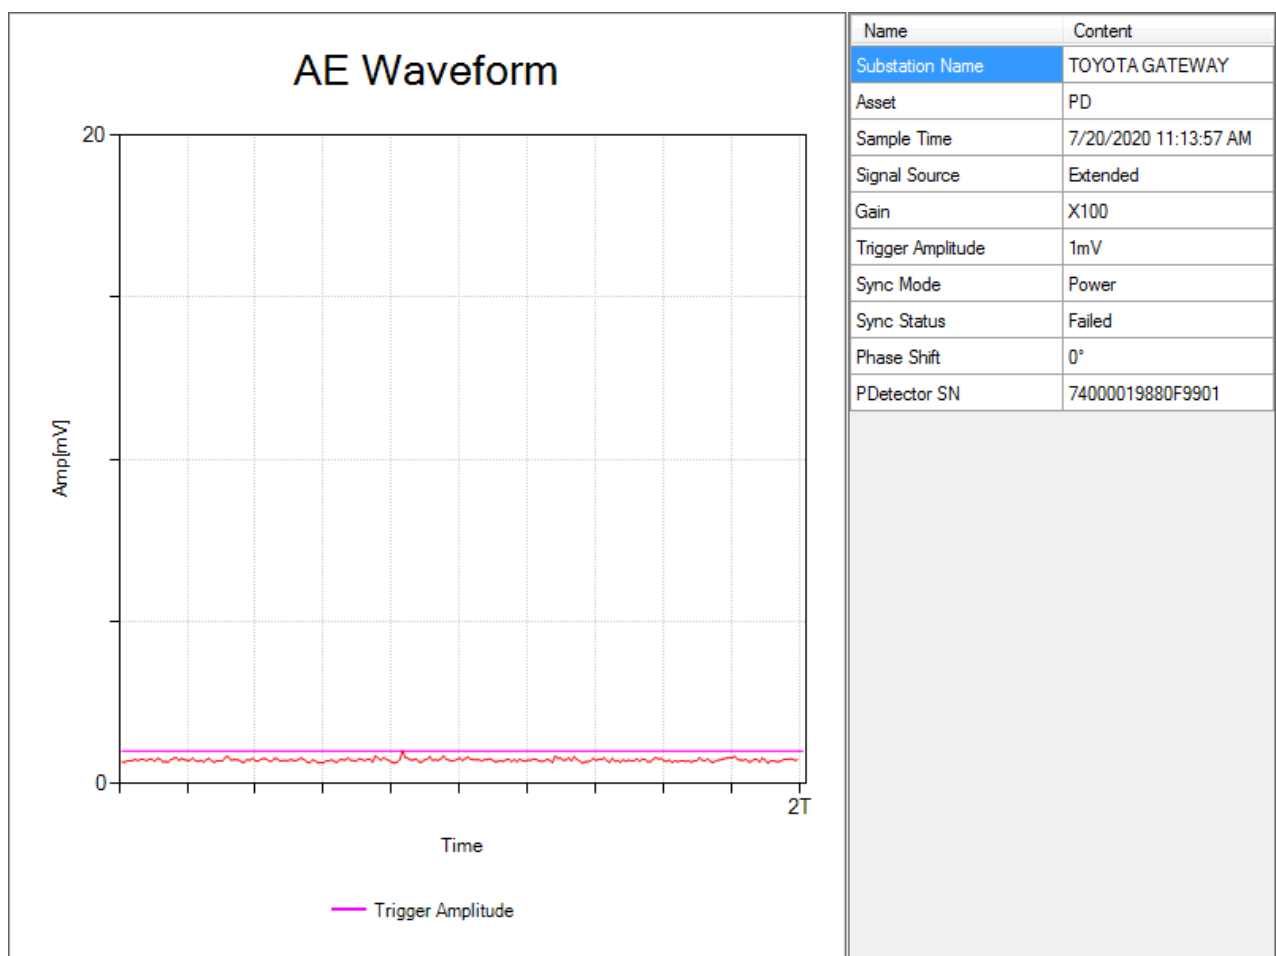
COSTOMER	TOYOTA GATEWAY (THAILAND) CO.,LTD.
SUBSTATION	SUBSTATION 115 KV
POSITION	PT PHASE Y
VOLTAGE LEVEL	115 KV

COMMENT	No Partial discharge (PD) was found.
EVALUATION	Normal
SUGGESTION	No action
TESTED AND REPORTED BY	Mr.Tukdanai Pothanak
APPROVED BY	Mr.Chanvit Crukaew

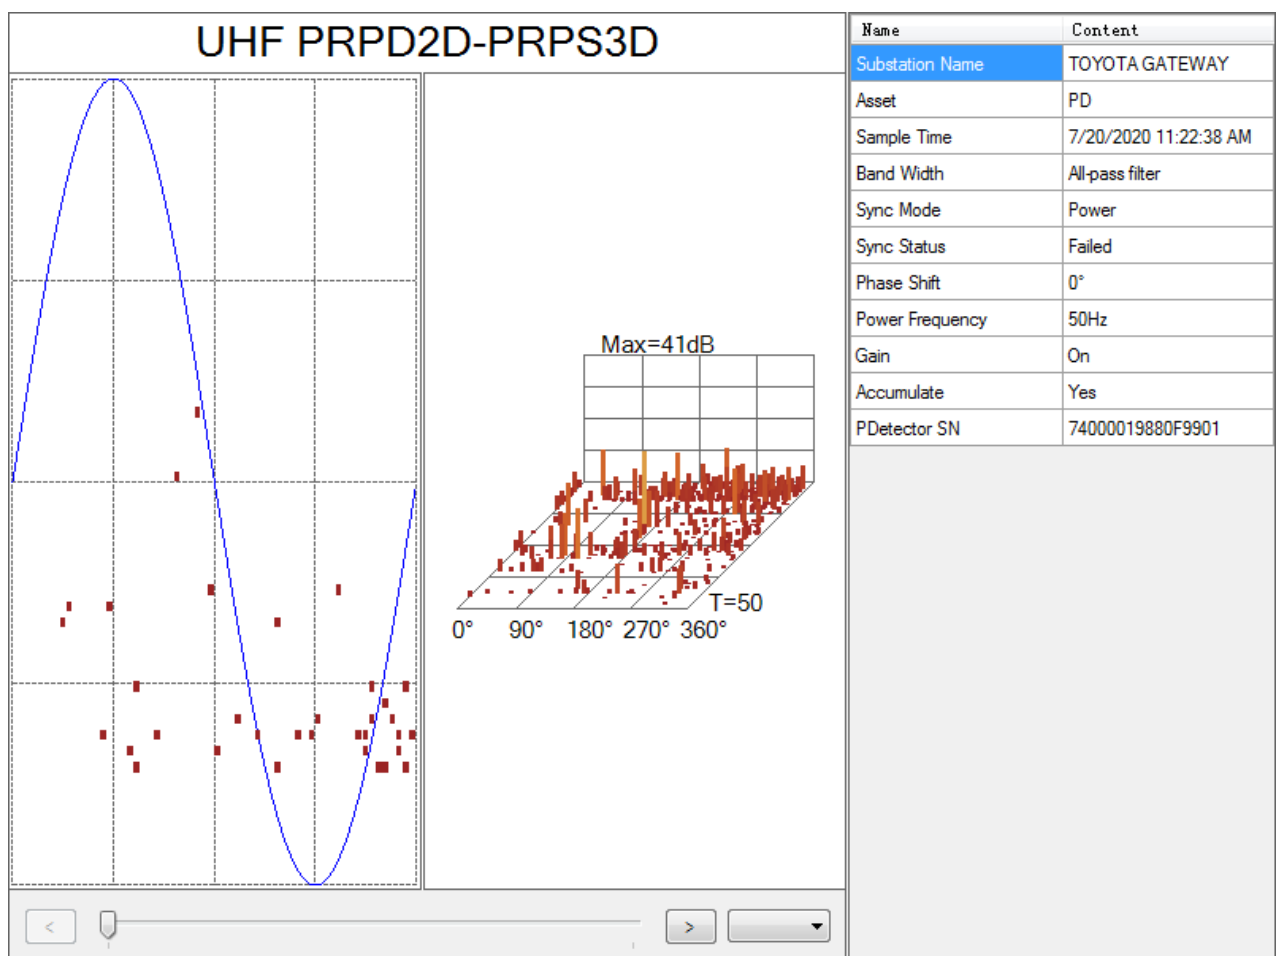
COSTOMER	TOYOTA GATEWAY (THAILAND) CO.,LTD.
SUBSTATION	SUBSTATION 115 KV
POSITION	PT PHASE Y
VOLTAGE LEVEL	115 KV

COMMENT	No Partial discharge (PD) was found.
EVALUATION	Normal
SUGGESTION	No action
TESTED AND REPORTED BY	Mr.Tukdanai Pothanak
APPROVED BY	Mr.Chanvit Crukaew

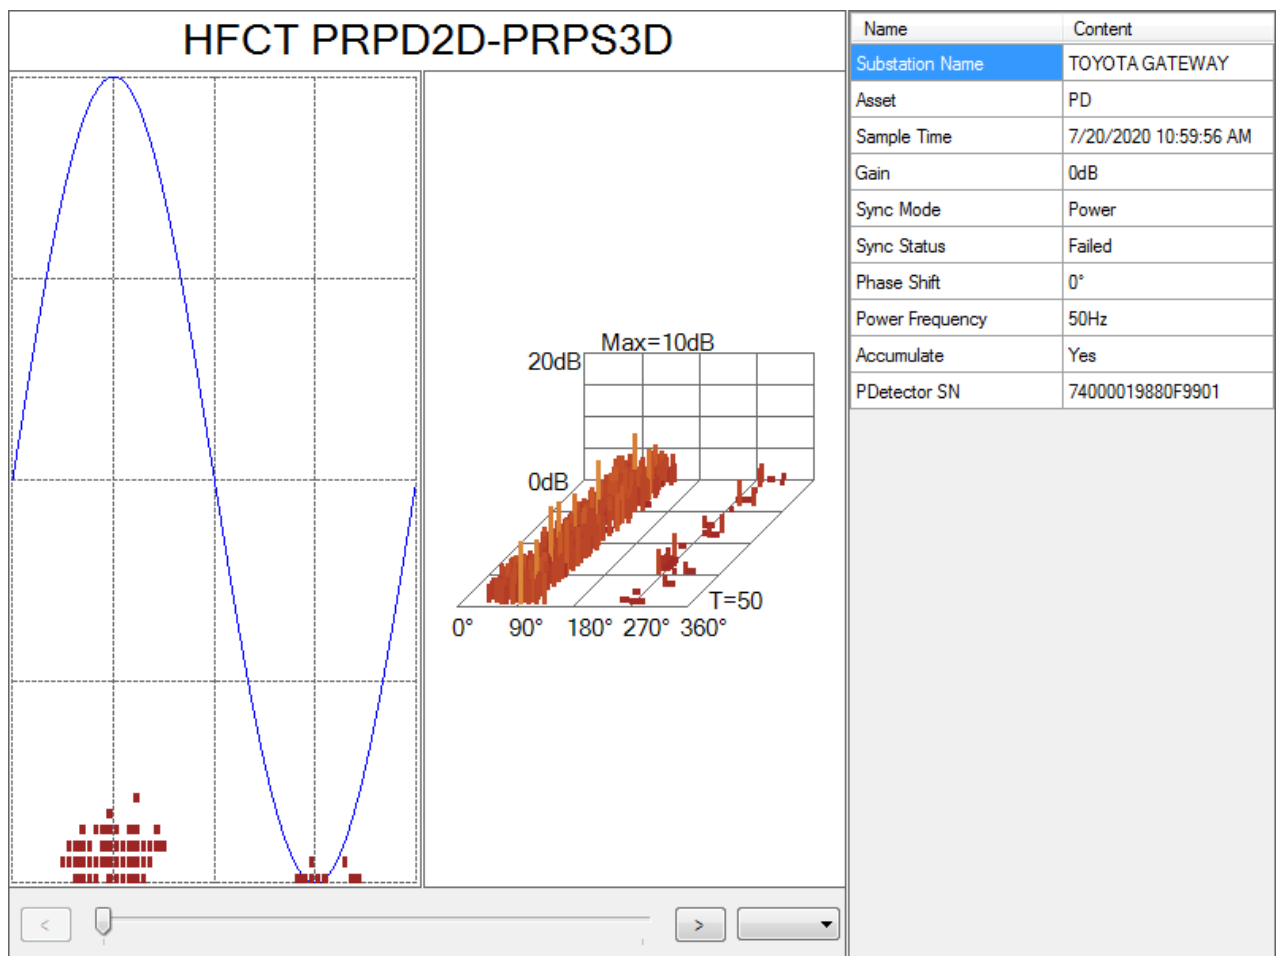
COSTOMER	TOYOTA GATEWAY (THAILAND) CO.,LTD.
SUBSTATION	SUBSTATION 115 KV
POSITION	PT PHASE Y
VOLTAGE LEVEL	115 KV

COMMENT	No Partial discharge (PD) was found.
EVALUATION	Normal
SUGGESTION	No action
TESTED AND REPORTED BY	Mr.Tukdanai Pothanak
APPROVED BY	Mr.Chanvit Crukaew

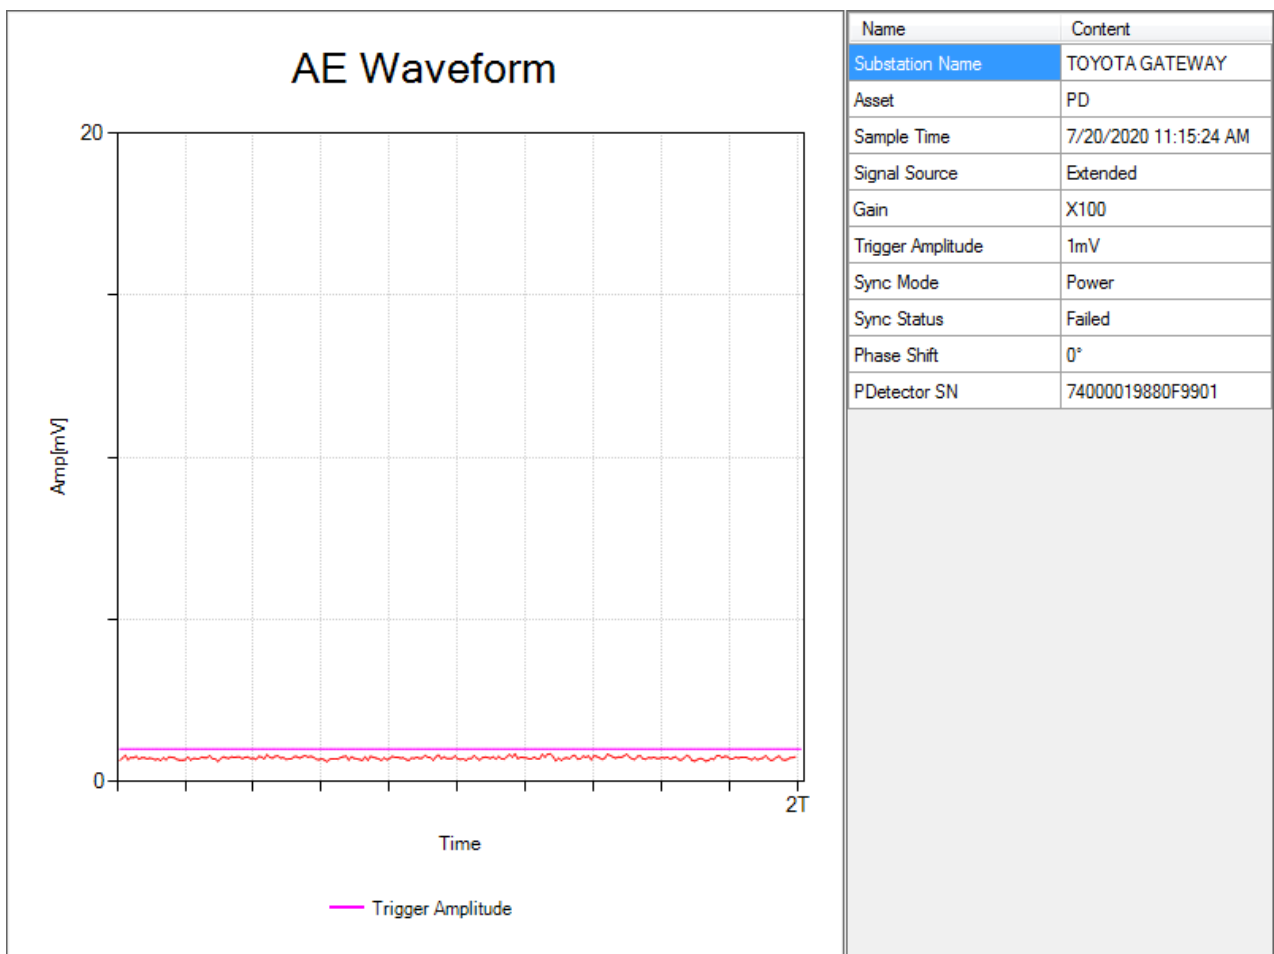
COSTOMER	TOYOTA GATEWAY (THAILAND) CO.,LTD.
SUBSTATION	SUBSTATION 115 KV
POSITION	PT PHASE B
VOLTAGE LEVEL	115 KV

COMMENT	No Partial discharge (PD) was found.
EVALUATION	Normal
SUGGESTION	No action
TESTED AND REPORTED BY	Mr.Tukdanai Pothanak
APPROVED BY	Mr.Chanvit Crukaew

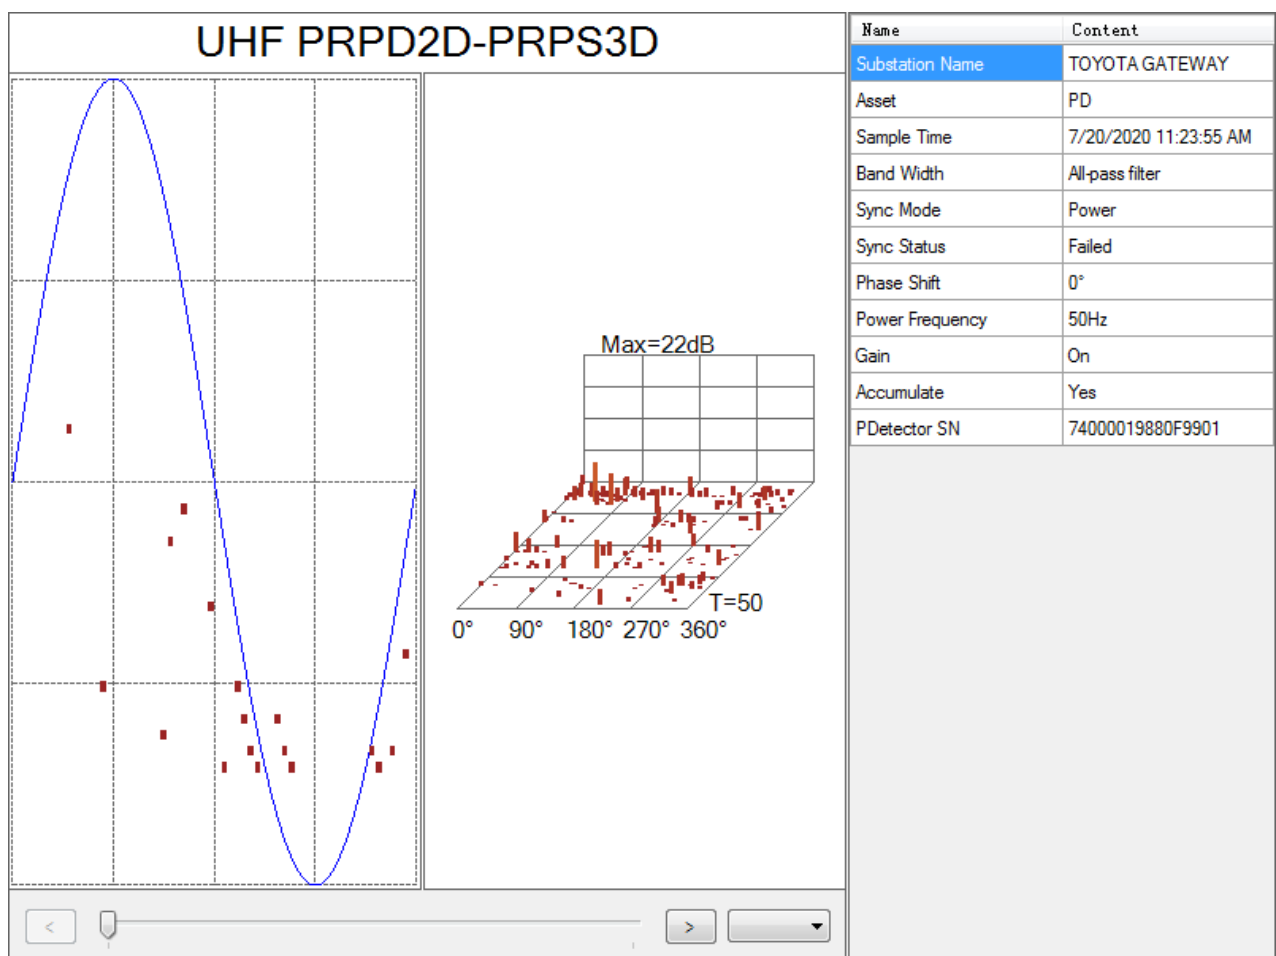
COSTOMER	TOYOTA GATEWAY (THAILAND) CO.,LTD.
SUBSTATION	SUBSTATION 115 KV
POSITION	PT PHASE B
VOLTAGE LEVEL	115 KV

COMMENT	No Partial discharge (PD) was found.
EVALUATION	Normal
SUGGESTION	No action
TESTED AND REPORTED BY	Mr.Tukdanai Pothanak
APPROVED BY	Mr.Chanvit Crukaew

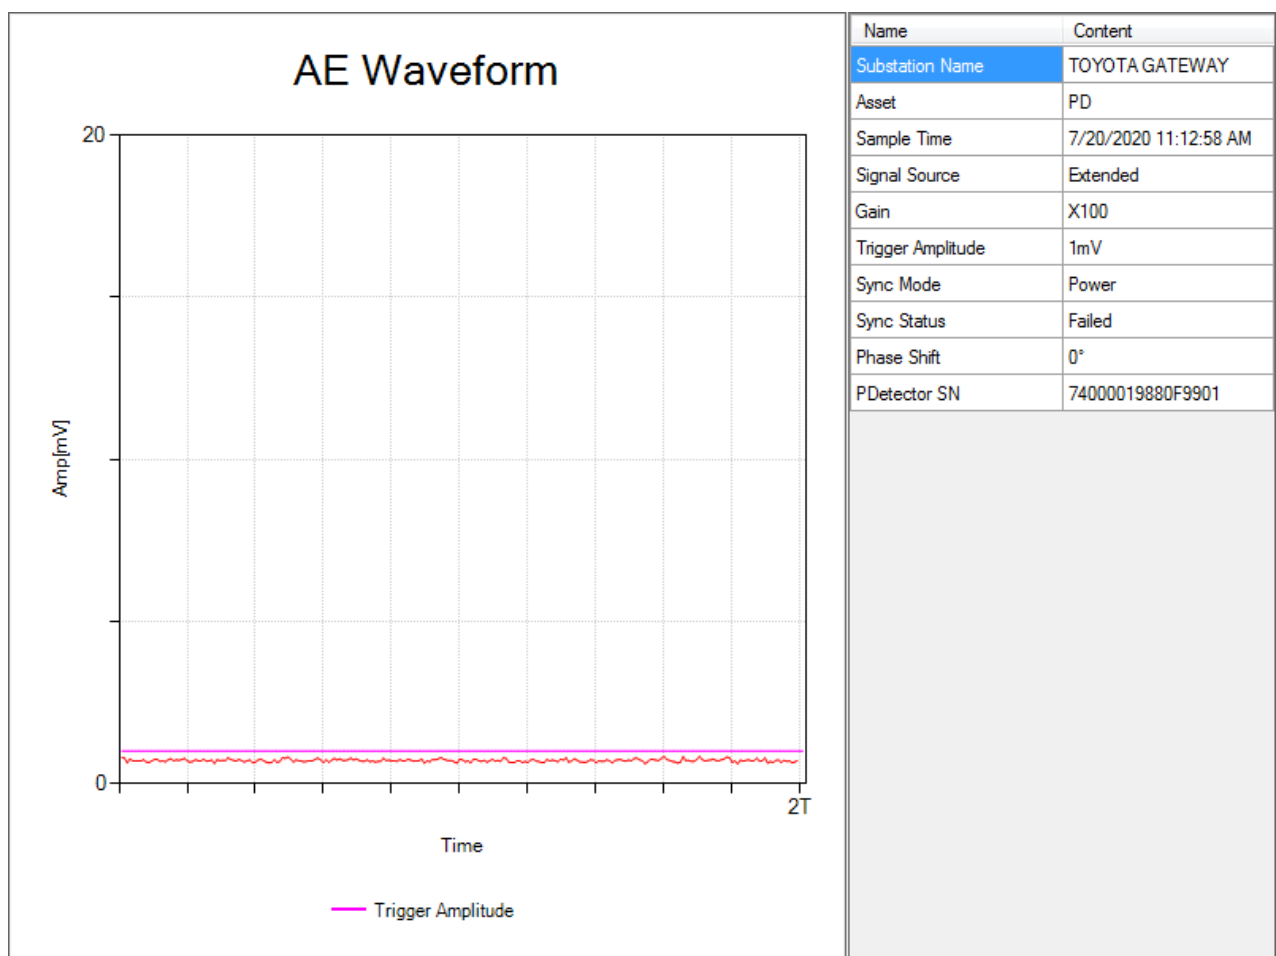
COSTOMER	TOYOTA GATEWAY (THAILAND) CO.,LTD.
SUBSTATION	SUBSTATION 115 KV
POSITION	CT PHASE R
VOLTAGE LEVEL	115 KV

COMMENT	No Partial discharge (PD) was found.
EVALUATION	Normal
SUGGESTION	No action
TESTED AND REPORTED BY	Mr.Tukdanai Pothanak
APPROVED BY	Mr.Chanvit Crukaew
