PARTIAL DISCHARGE REPORT

CUSTOMER :CO.,LTD.

DATE : July 8th, 2020

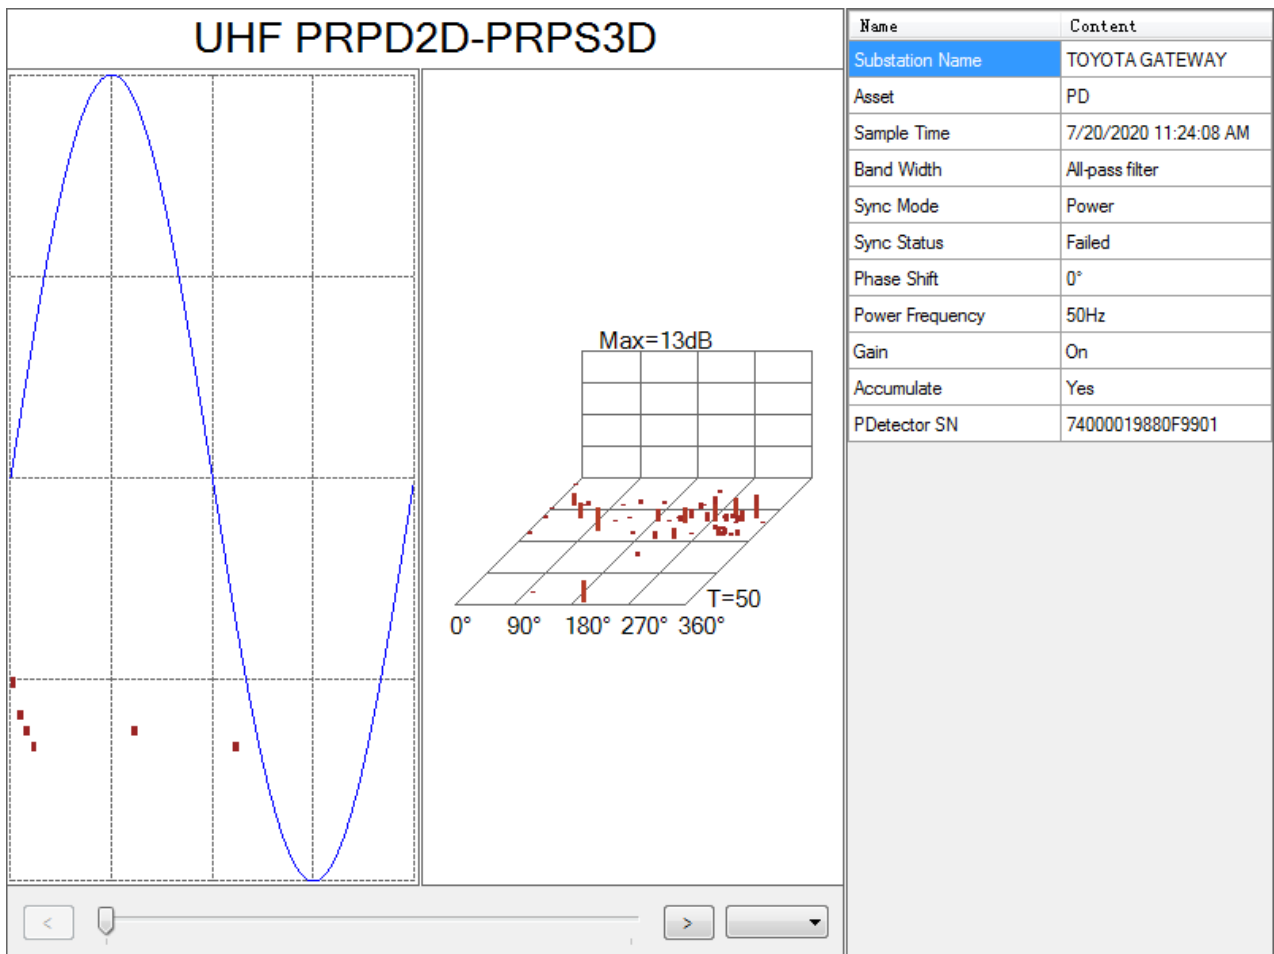
COSTOMER	TOYOTA GATEWAY (THAILAND) CO.,LTD.
SUBSTATION	SUBSTATION 115 KV
POSITION	CT PHASE R
VOLTAGE LEVEL	115 KV

COMMENT	No Partial discharge (PD) was found.
EVALUATION	Normal
SUGGESTION	No action
TESTED AND REPORTED BY	Mr.Tukdanai Pothanak
APPROVED BY	Mr.Chanvit Crukaew

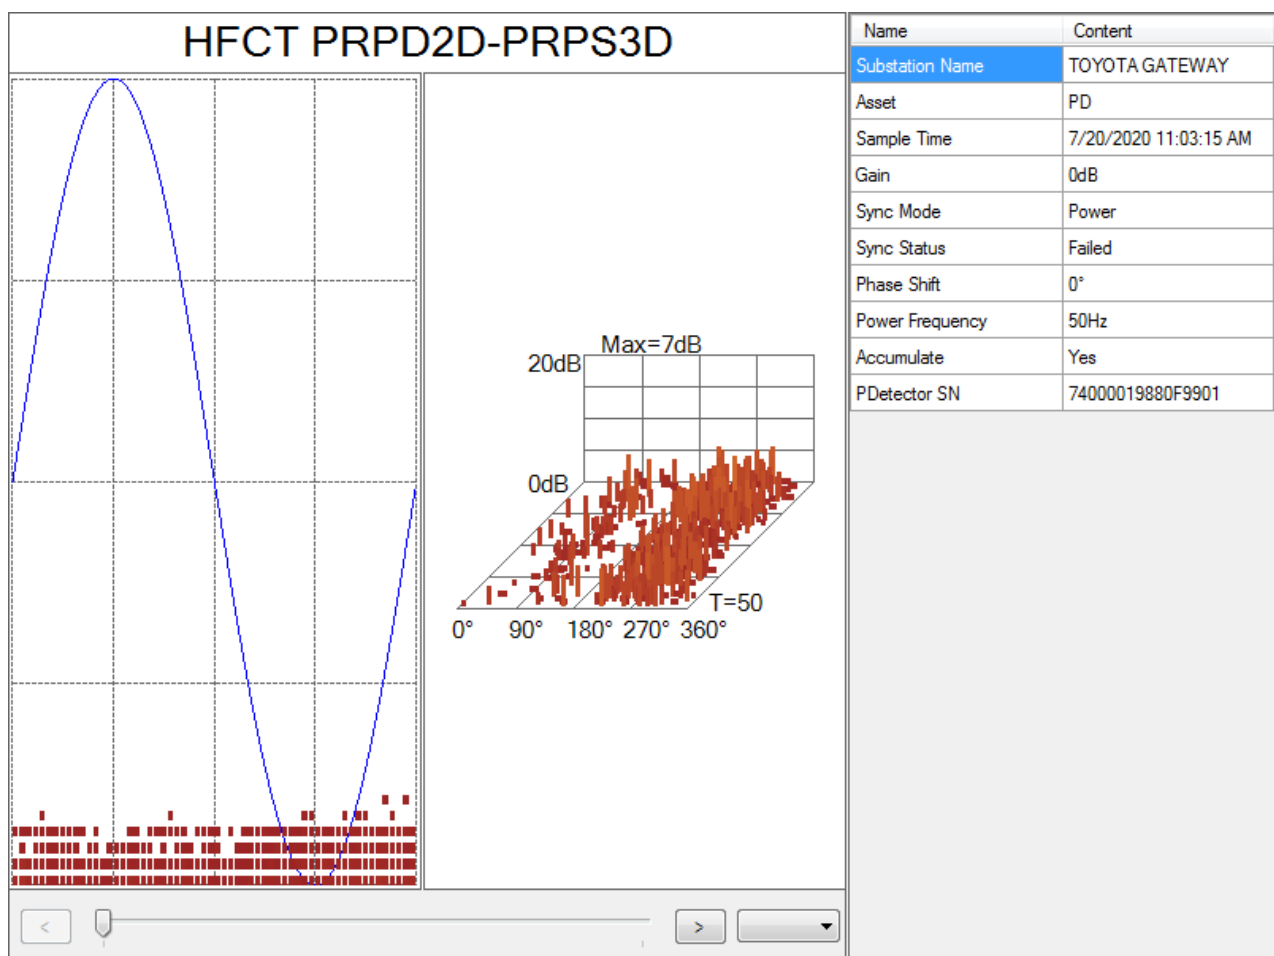
COSTOMER	TOYOTA GATEWAY (THAILAND) CO.,LTD.
SUBSTATION	SUBSTATION 115 KV
POSITION	PT PHASE R
VOLTAGE LEVEL	115 KV

COMMENT	No Partial discharge (PD) was found.
EVALUATION	Normal
SUGGESTION	No action
TESTED AND REPORTED BY	Mr.Tukdanai Pothanak
APPROVED BY	Mr.Chanvit Crukaew

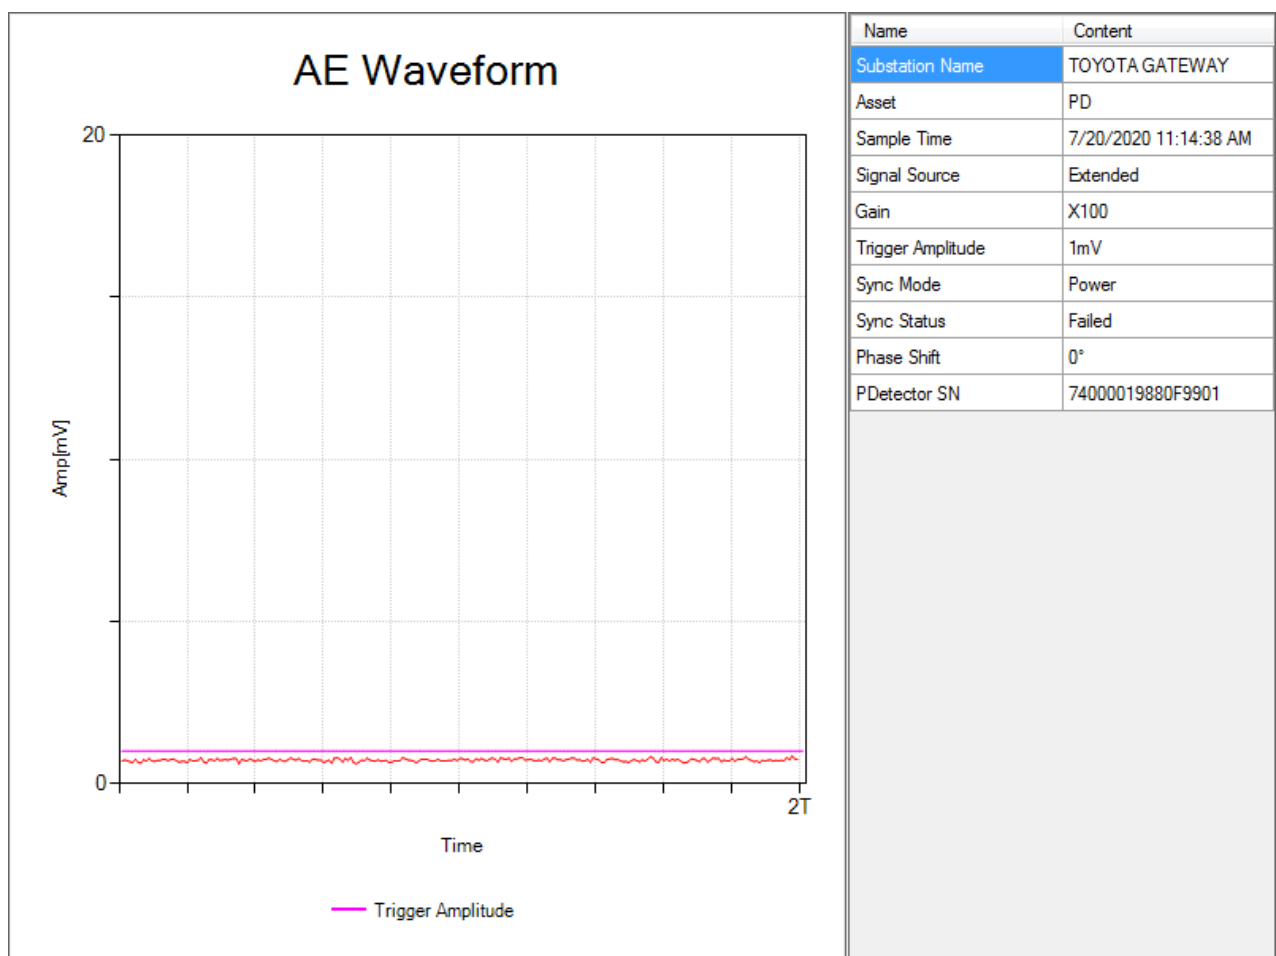
COSTOMER	TOYOTA GATEWAY (THAILAND) CO.,LTD.
SUBSTATION	SUBSTATION 115 KV
POSITION	CT PHASE Y
VOLTAGE LEVEL	115 KV

COMMENT	No Partial discharge (PD) was found.
EVALUATION	Normal
SUGGESTION	No action
TESTED AND REPORTED BY	Mr.Tukdanai Pothanak
APPROVED BY	Mr.Chanvit Crukaew

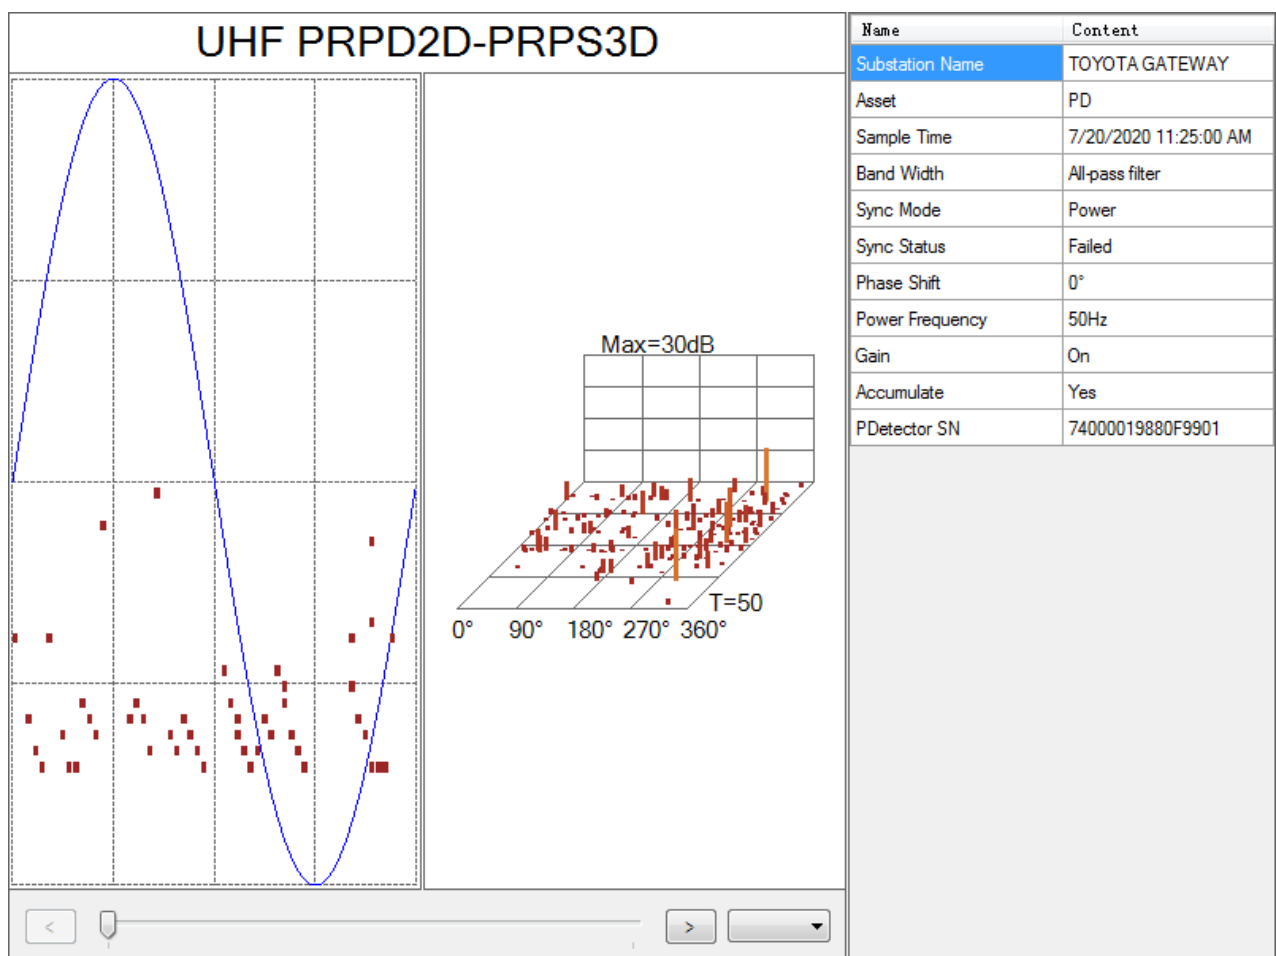
COSTOMER	TOYOTA GATEWAY (THAILAND) CO.,LTD.
SUBSTATION	SUBSTATION 115 KV
POSITION	CT PHASE Y
VOLTAGE LEVEL	115 KV

COMMENT	No Partial discharge (PD) was found.
EVALUATION	Normal
SUGGESTION	No action
TESTED AND REPORTED BY	Mr.Tukdanai Pothanak
APPROVED BY	Mr.Chanvit Crukaew

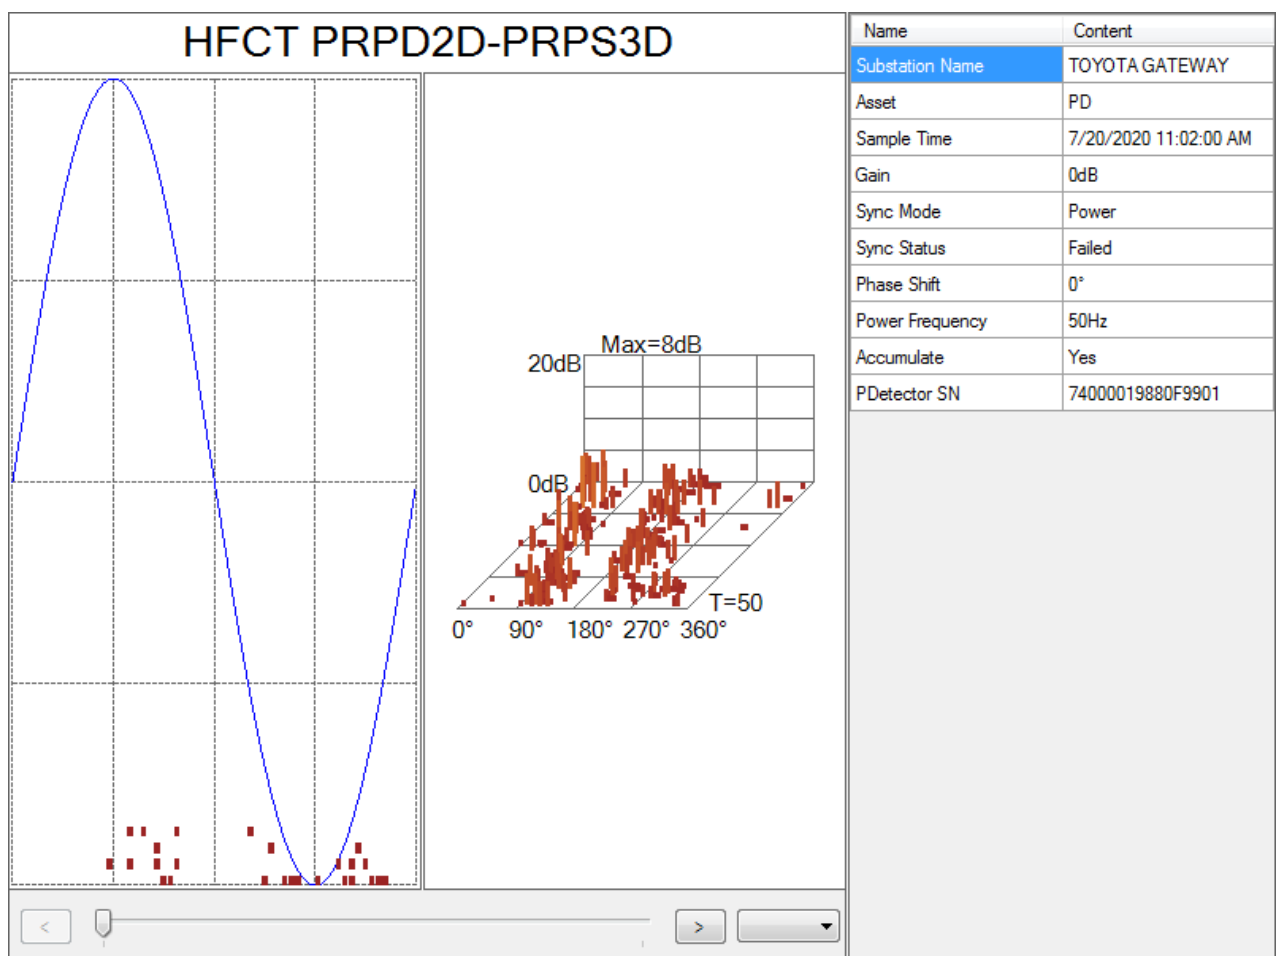
COSTOMER	TOYOTA GATEWAY (THAILAND) CO.,LTD.
SUBSTATION	SUBSTATION 115 KV
POSITION	CT PHASE Y
VOLTAGE LEVEL	115 KV

COMMENT	No Partial discharge (PD) was found.
EVALUATION	Normal
SUGGESTION	No action
TESTED AND REPORTED BY	Mr.Tukdanai Pothanak
APPROVED BY	Mr.Chanvit Crukaew

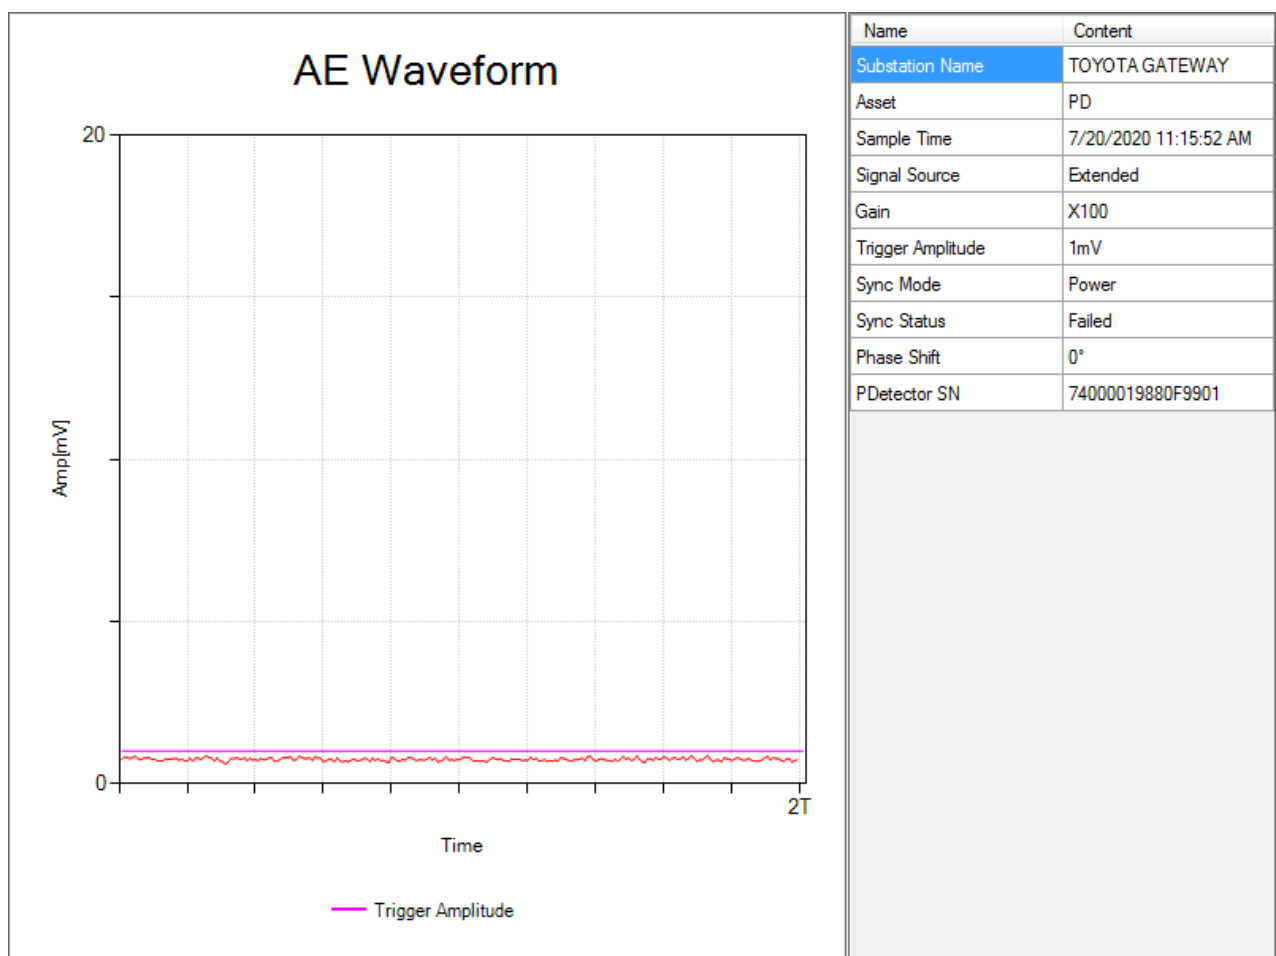
COSTOMER	TOYOTA GATEWAY (THAILAND) CO.,LTD.
SUBSTATION	SUBSTATION 115 KV
POSITION	CT PHASE B
VOLTAGE LEVEL	115 KV

COMMENT	No Partial discharge (PD) was found.
EVALUATION	Normal
SUGGESTION	No action
TESTED AND REPORTED BY	Mr.Tukdanai Pothanak
APPROVED BY	Mr.Chanvit Crukaew

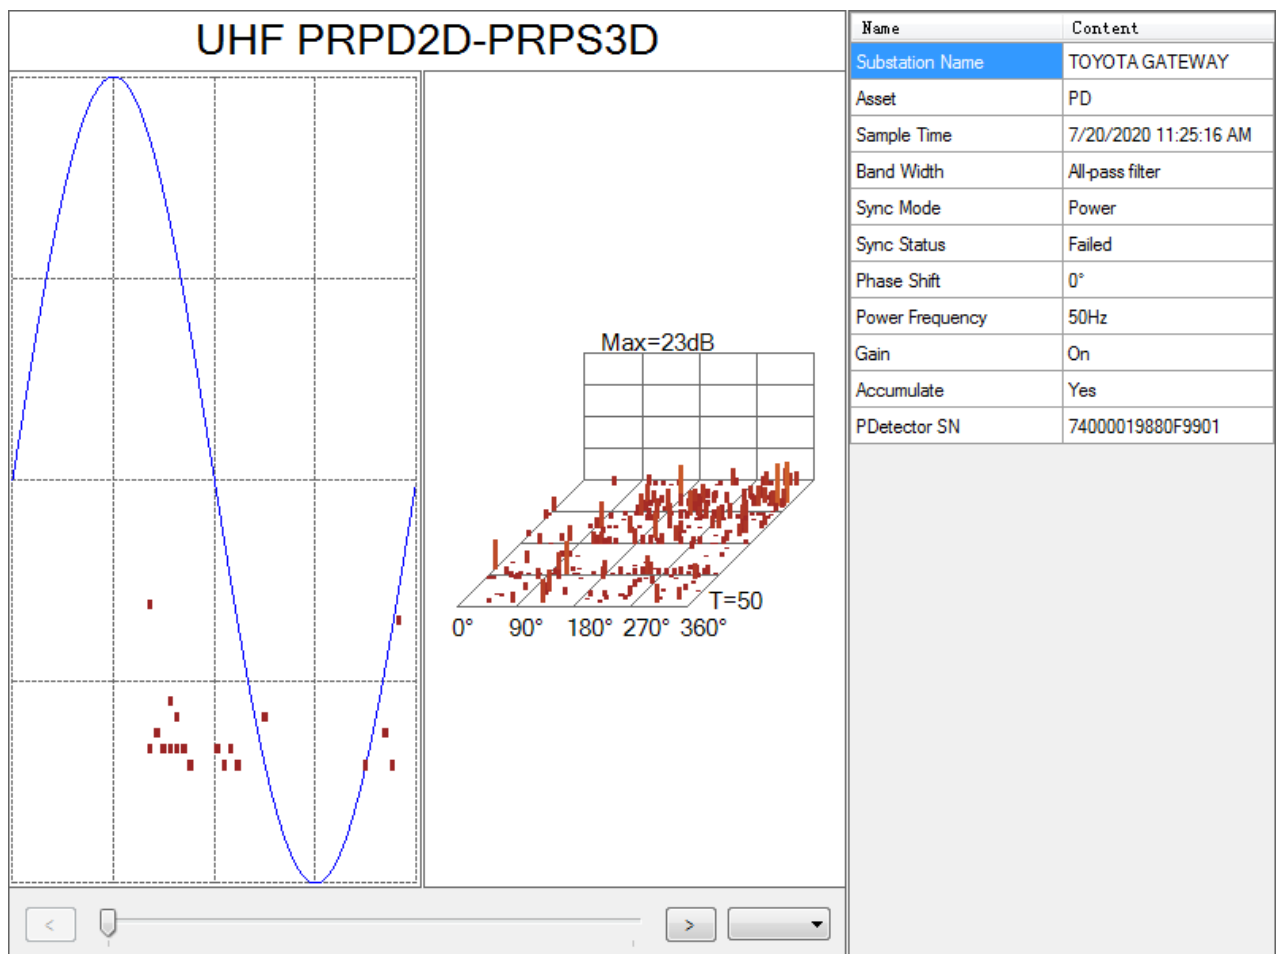
COSTOMER	TOYOTA GATEWAY (THAILAND) CO.,LTD.
SUBSTATION	SUBSTATION 115 KV
POSITION	CT PHASE B
VOLTAGE LEVEL	115 KV

COMMENT	No Partial discharge (PD) was found.
EVALUATION	Normal
SUGGESTION	No action
TESTED AND REPORTED BY	Mr.Tukdanai Pothanak
APPROVED BY	Mr.Chanvit Crukaew

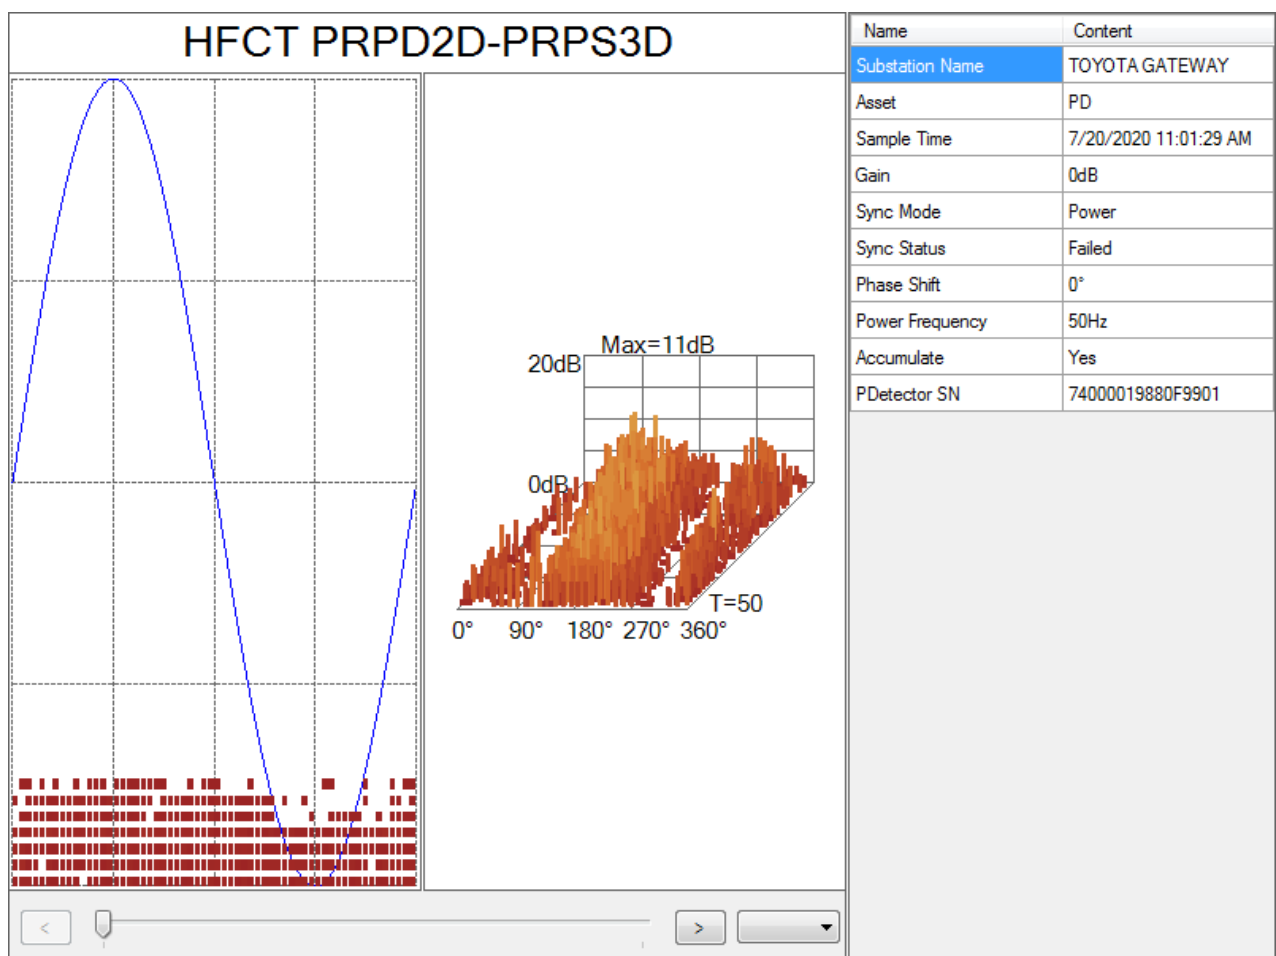
COSTOMER	TOYOTA GATEWAY (THAILAND) CO.,LTD.
SUBSTATION	SUBSTATION 115 KV
POSITION	CT PHASE B
VOLTAGE LEVEL	115 KV

COMMENT	No Partial discharge (PD) was found.
EVALUATION	Normal
SUGGESTION	No action
TESTED AND REPORTED BY	Mr.Tukdanai Pothanak
APPROVED BY	Mr.Chanvit Crukaew

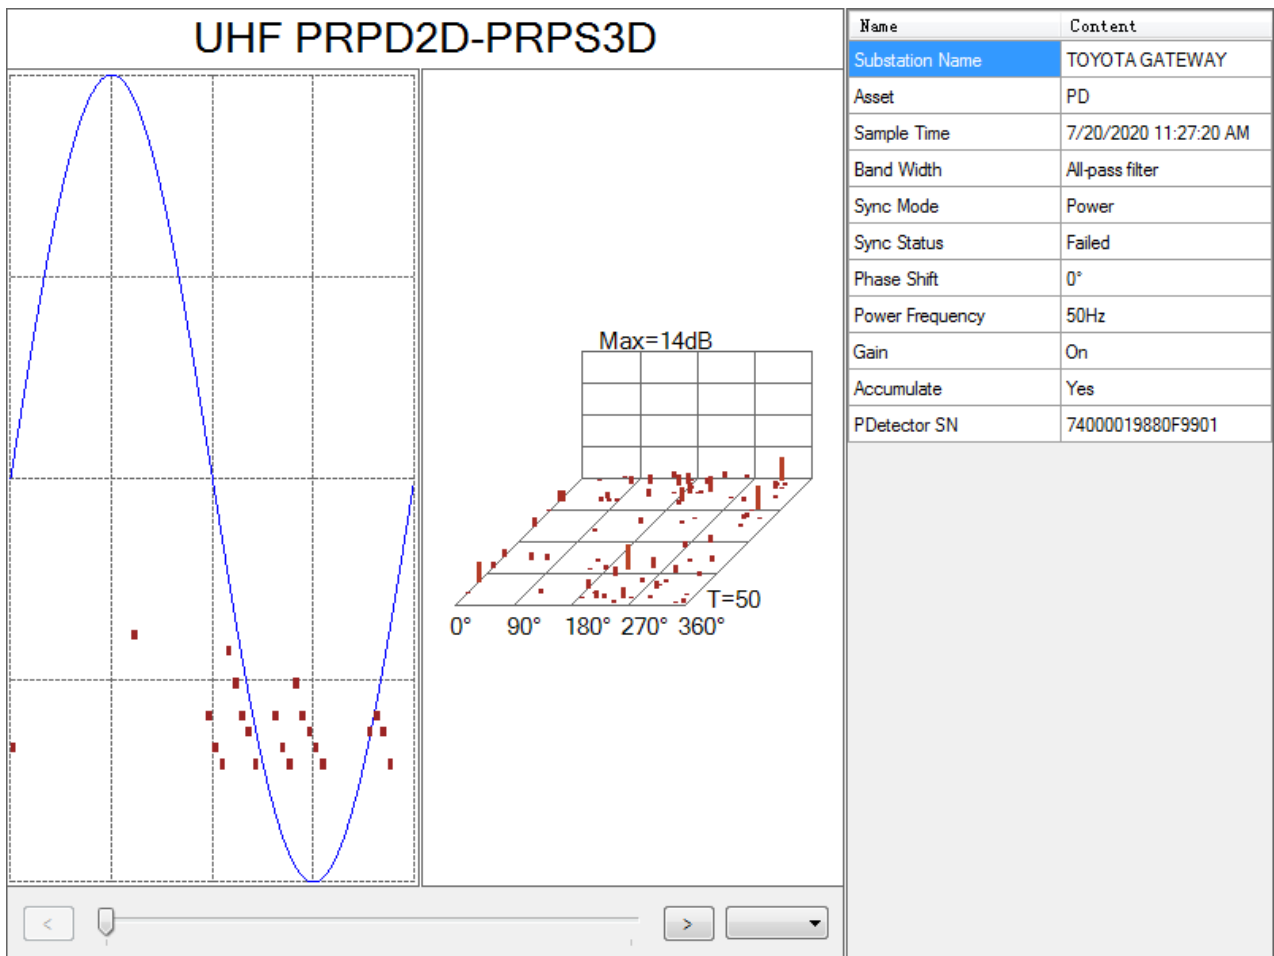
COSTOMER	TOYOTA GATEWAY (THAILAND) CO.,LTD.
SUBSTATION	SUBSTATION 115 KV
POSITION	PT (GAS)
VOLTAGE LEVEL	115 KV

COMMENT	No Partial discharge (PD) was found.
EVALUATION	Normal
SUGGESTION	No action
TESTED AND REPORTED BY	Mr.Tukdanai Pothanak
APPROVED BY	Mr.Chanvit Crukaew

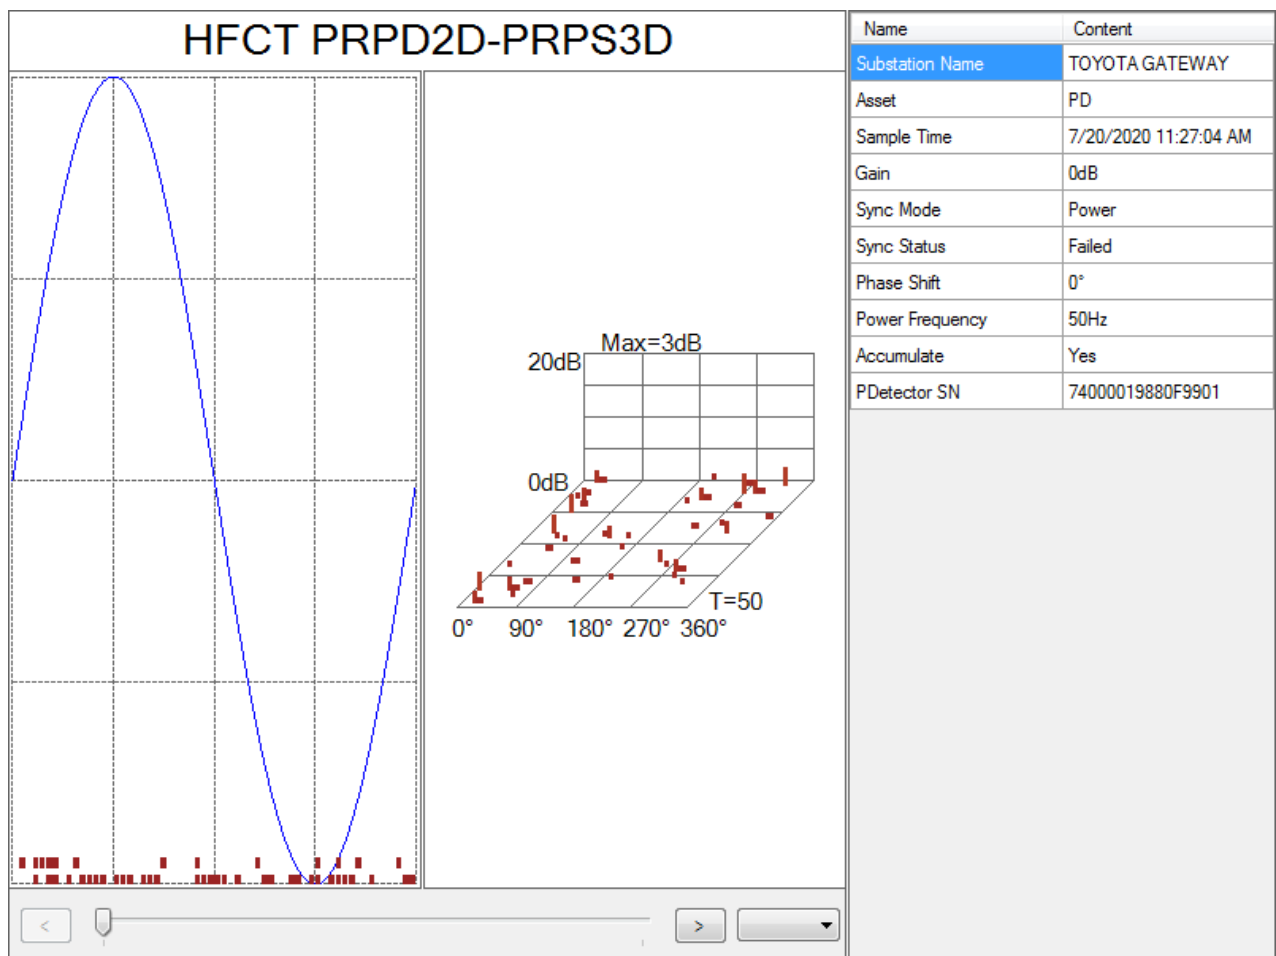
COSTOMER	TOYOTA GATEWAY (THAILAND) CO.,LTD.
SUBSTATION	SUBSTATION 115 KV
POSITION	PT (GAS)
VOLTAGE LEVEL	115 KV

COMMENT	No Partial discharge (PD) was found.
EVALUATION	Normal
SUGGESTION	No action
TESTED AND REPORTED BY	Mr.Tukdanai Pothanak
APPROVED BY	Mr.Chanvit Crukaew

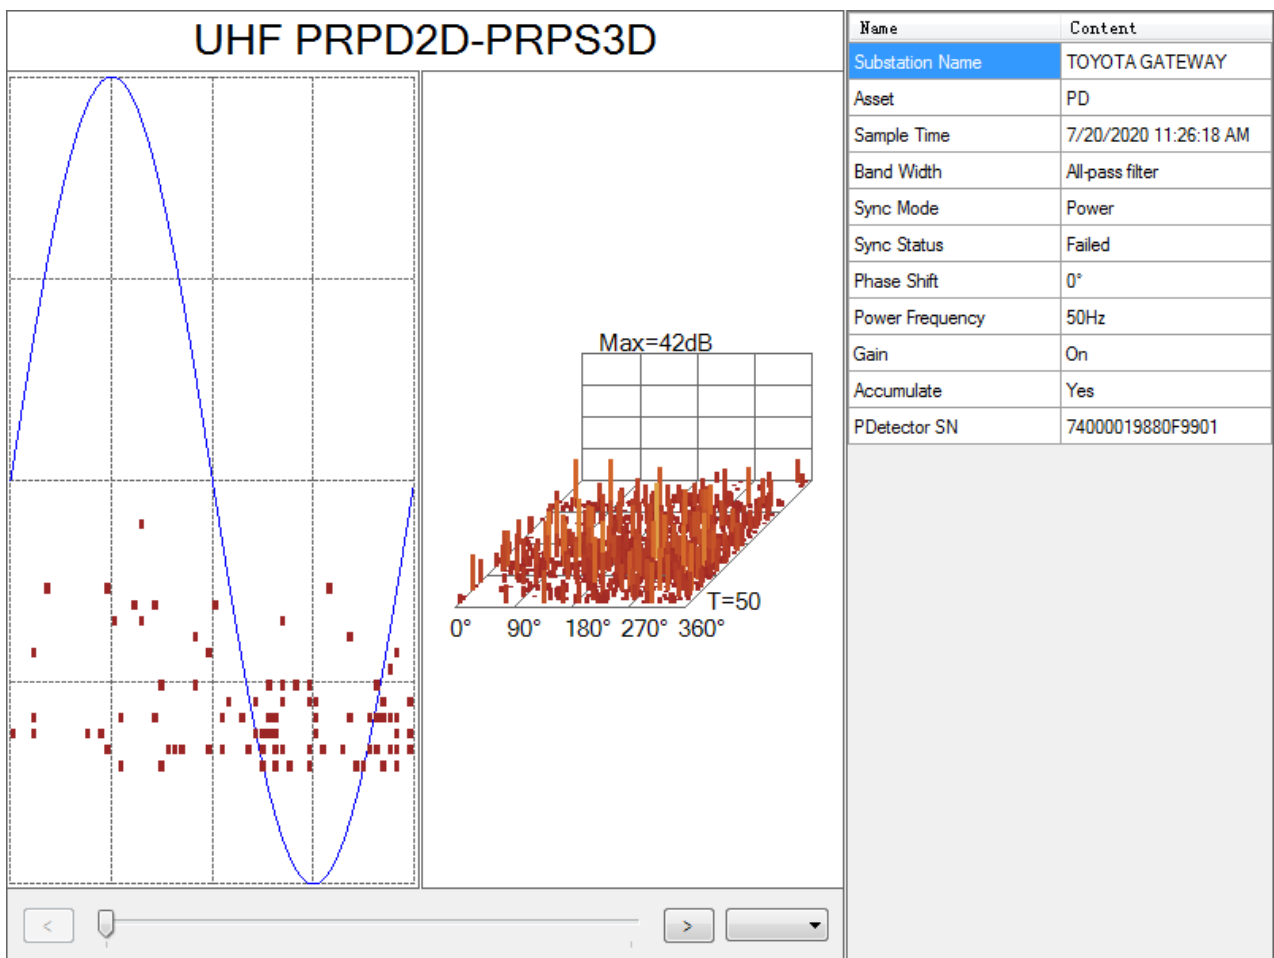
COSTOMER	TOYOTA GATEWAY (THAILAND) CO.,LTD.
SUBSTATION	SUBSTATION 115 KV
POSITION	CB 115 KV
VOLTAGE LEVEL	115 KV

COMMENT	No Partial discharge (PD) was found.
EVALUATION	Normal
SUGGESTION	No action
TESTED AND REPORTED BY	Mr.Tukdanai Pothanak
APPROVED BY	Mr.Chanvit Crukaew

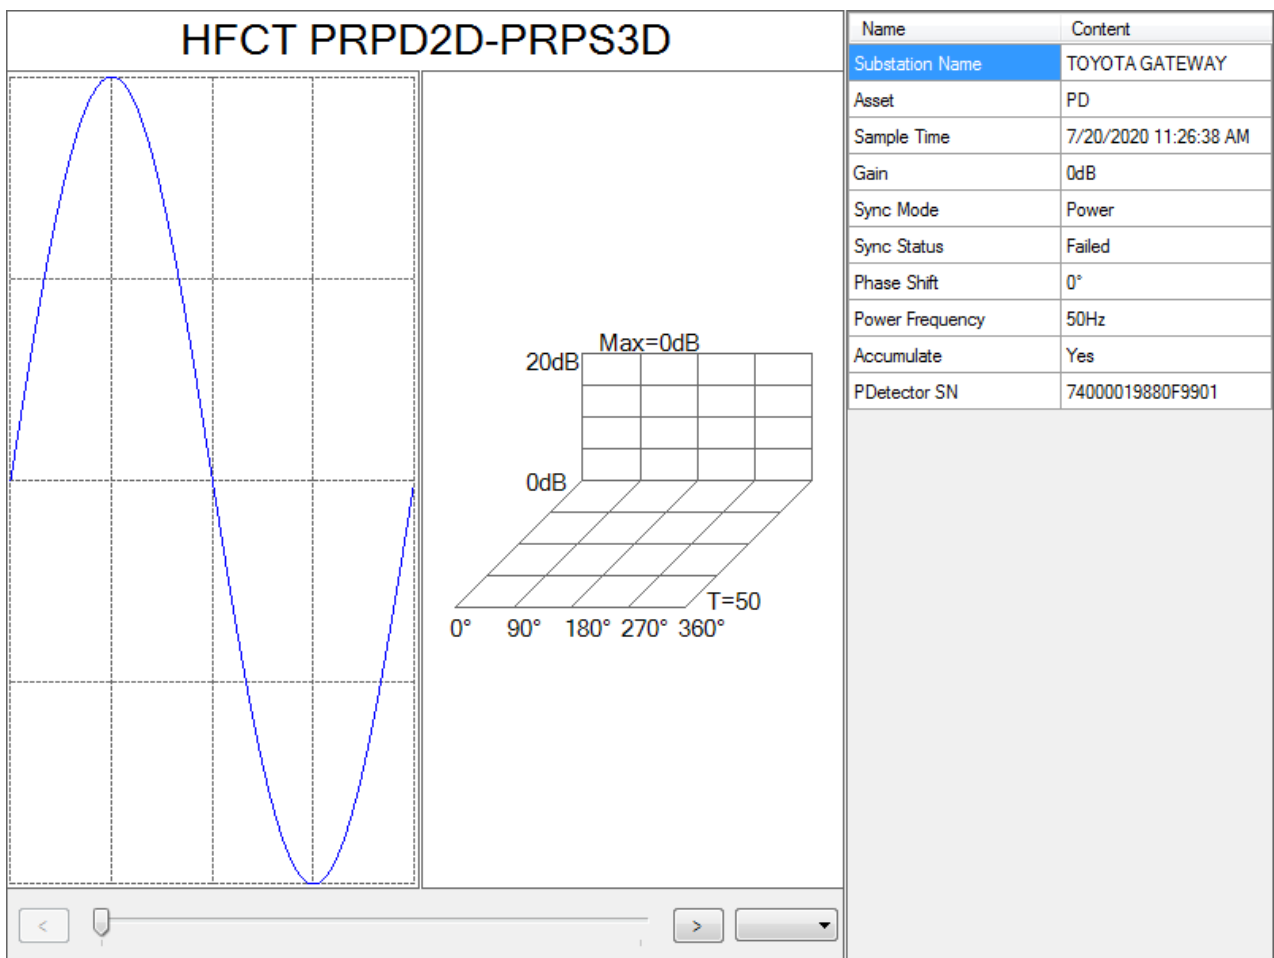
COSTOMER	TOYOTA GATEWAY (THAILAND) CO.,LTD.
SUBSTATION	SUBSTATION 115 KV
POSITION	CB 115 KV
VOLTAGE LEVEL	115 KV

COMMENT	No Partial discharge (PD) was found.
EVALUATION	Normal
SUGGESTION	No action
TESTED AND REPORTED BY	Mr.Tukdanai Pothanak
APPROVED BY	Mr.Chanvit Crukaew

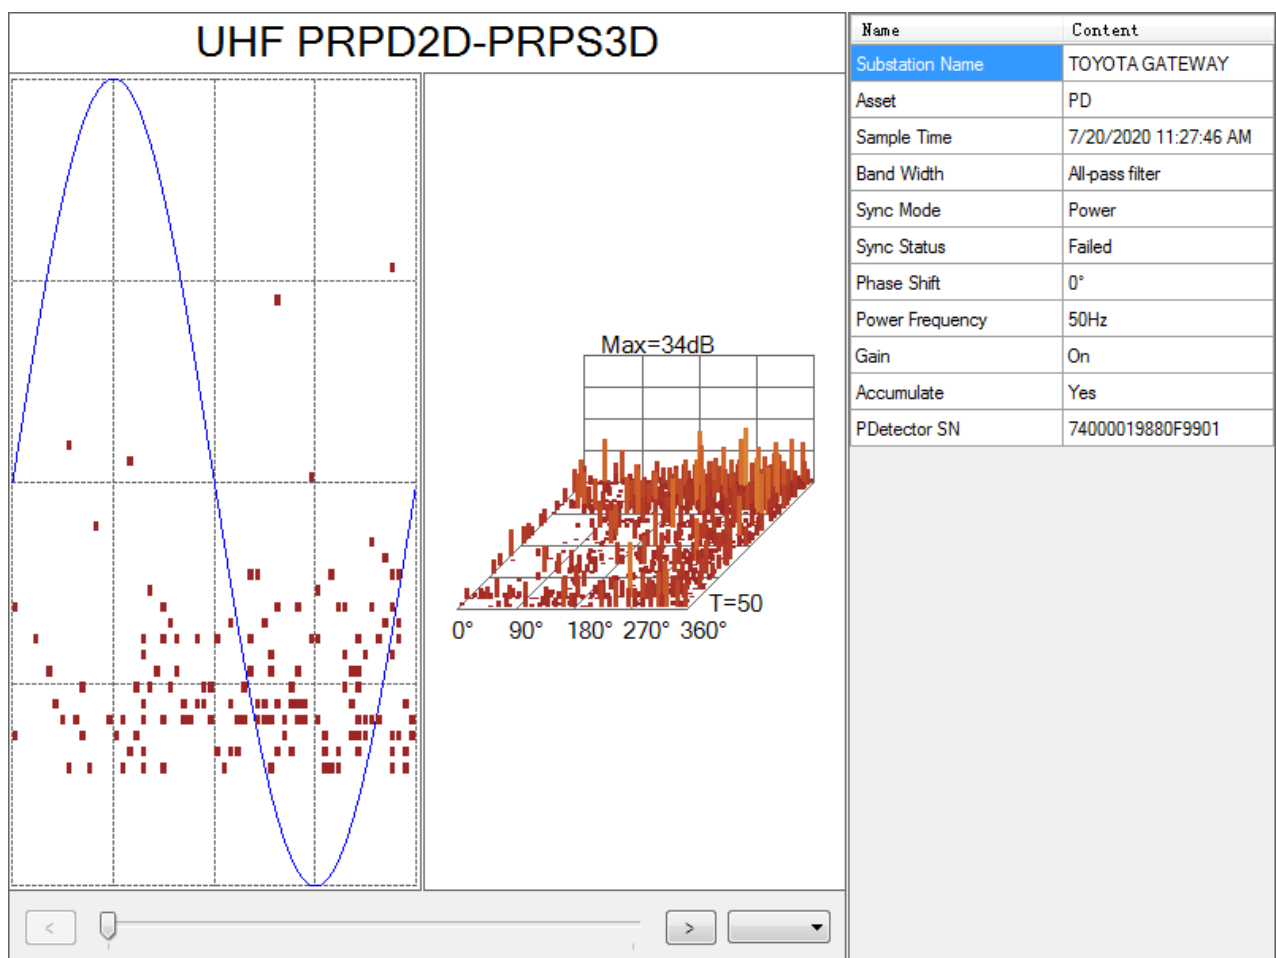
COSTOMER	TOYOTA GATEWAY (THAILAND) CO.,LTD.
SUBSTATION	SUBSTATION 115 KV
POSITION	RECEIVING TO TR.1
VOLTAGE LEVEL	115 KV

COMMENT	No Partial discharge (PD) was found.
EVALUATION	Normal
SUGGESTION	No action
TESTED AND REPORTED BY	Mr.Tukdanai Pothanak
APPROVED BY	Mr.Chanvit Crukaew

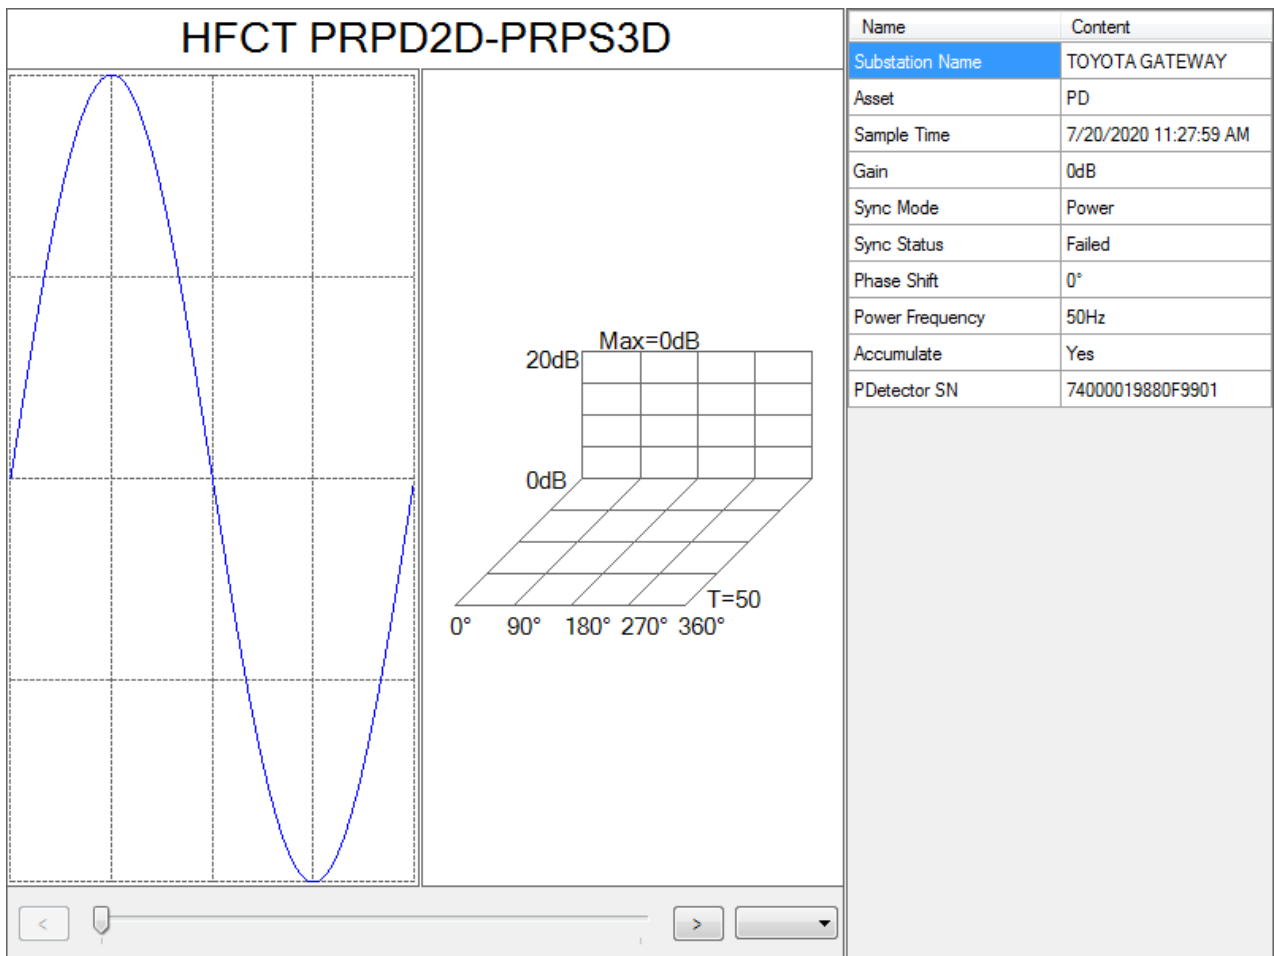
COSTOMER	TOYOTA GATEWAY (THAILAND) CO.,LTD.
SUBSTATION	SUBSTATION 115 KV
POSITION	RECEIVING TO TR.1
VOLTAGE LEVEL	115 KV

COMMENT	No Partial discharge (PD) was found.
EVALUATION	Normal
SUGGESTION	No action
TESTED AND REPORTED BY	Mr.Tukdanai Pothanak
APPROVED BY	Mr.Chanvit Crukaew

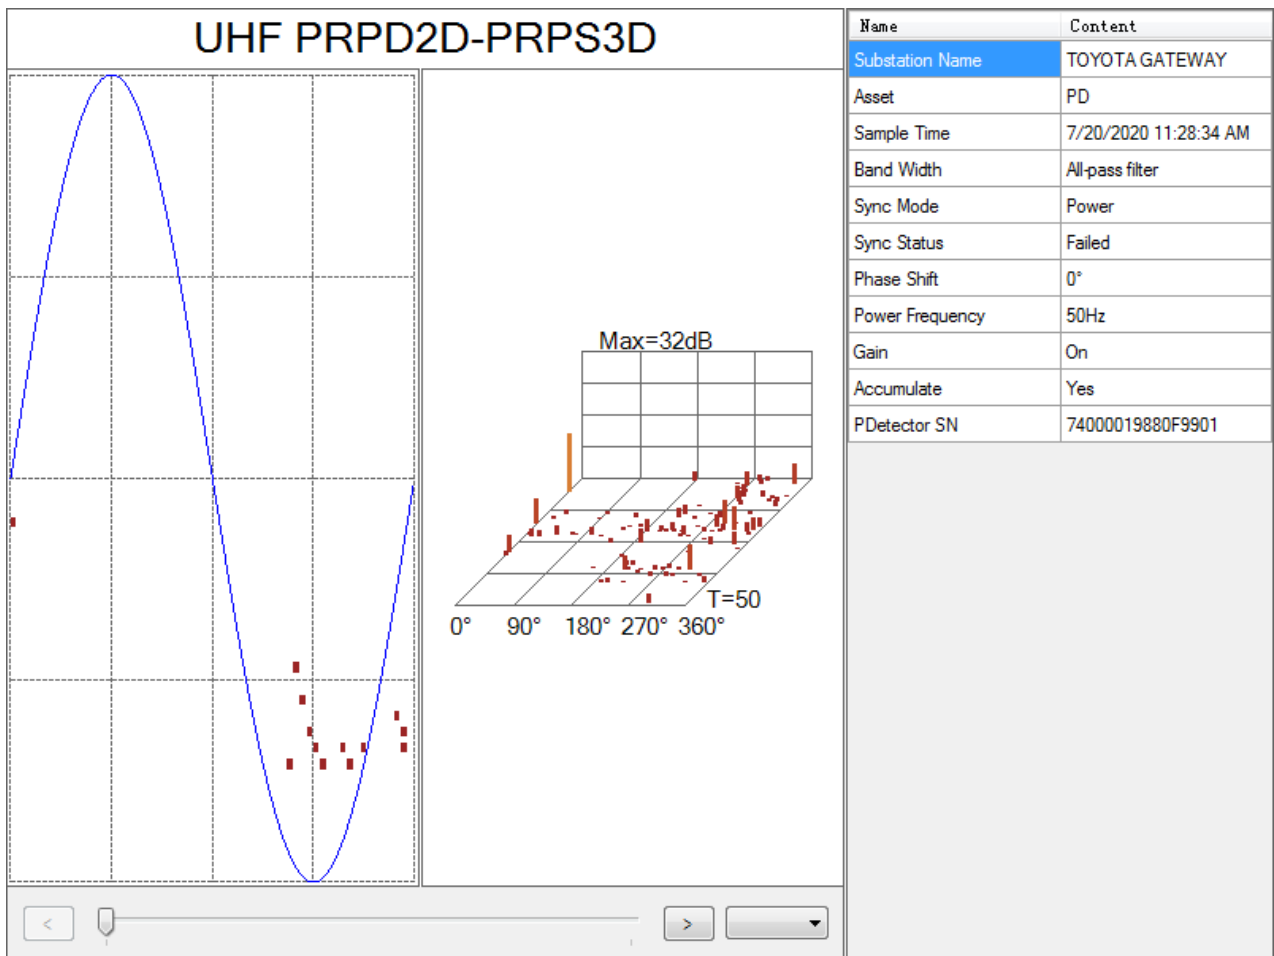
COSTOMER	TOYOTA GATEWAY (THAILAND) CO.,LTD.
SUBSTATION	SUBSTATION 115 KV
POSITION	CB TR1
VOLTAGE LEVEL	115 KV

COMMENT	No Partial discharge (PD) was found.
EVALUATION	Normal
SUGGESTION	No action
TESTED AND REPORTED BY	Mr.Tukdanai Pothanak
APPROVED BY	Mr.Chanvit Crukaew

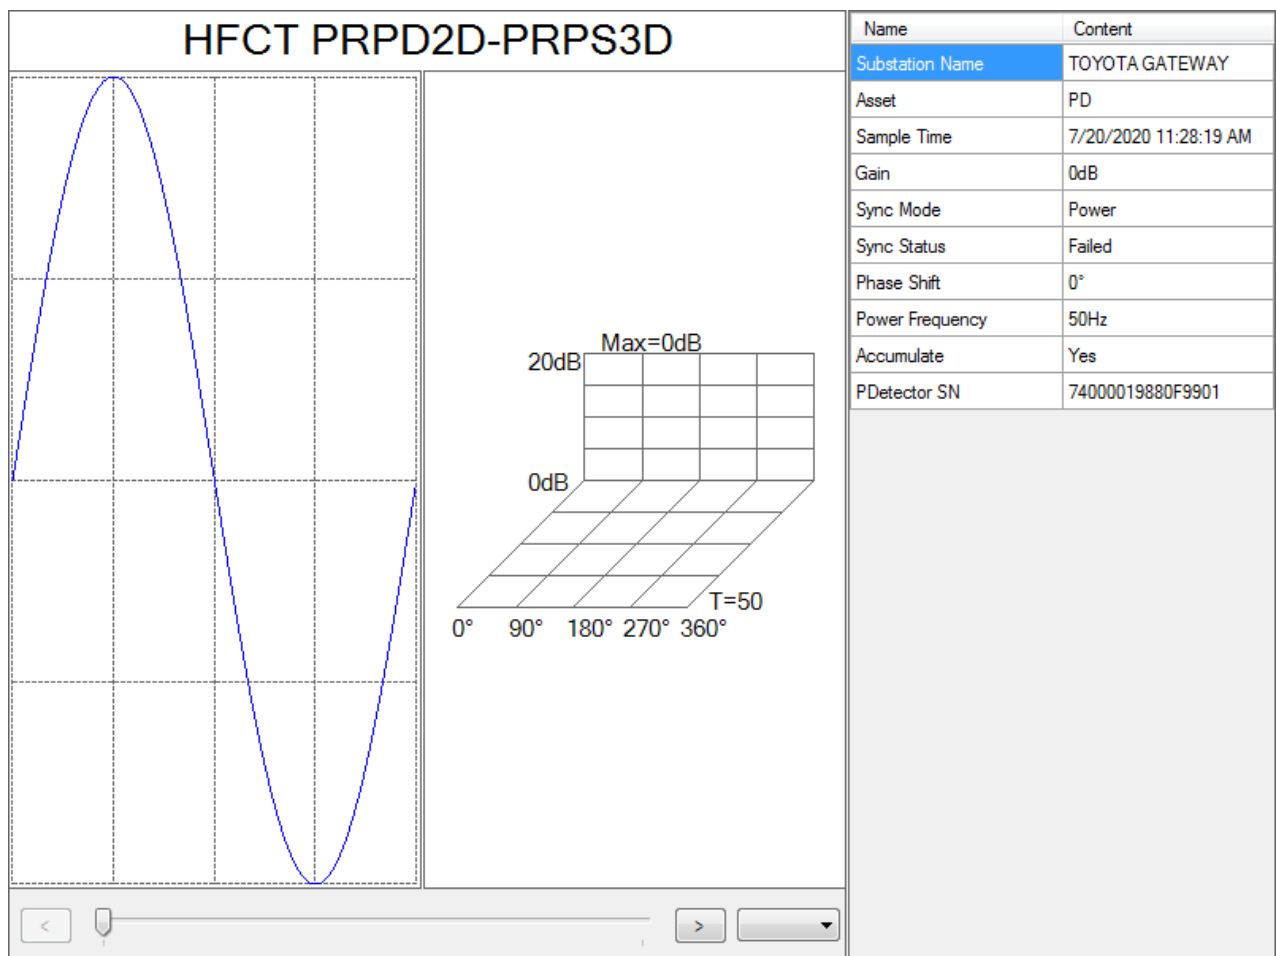
COSTOMER	TOYOTA GATEWAY (THAILAND) CO.,LTD.
SUBSTATION	SUBSTATION 115 KV
POSITION	CB TR1
VOLTAGE LEVEL	115 KV

COMMENT	No Partial discharge (PD) was found.
EVALUATION	Normal
SUGGESTION	No action
TESTED AND REPORTED BY	Mr.Tukdanai Pothanak
APPROVED BY	Mr.Chanvit Crukaew

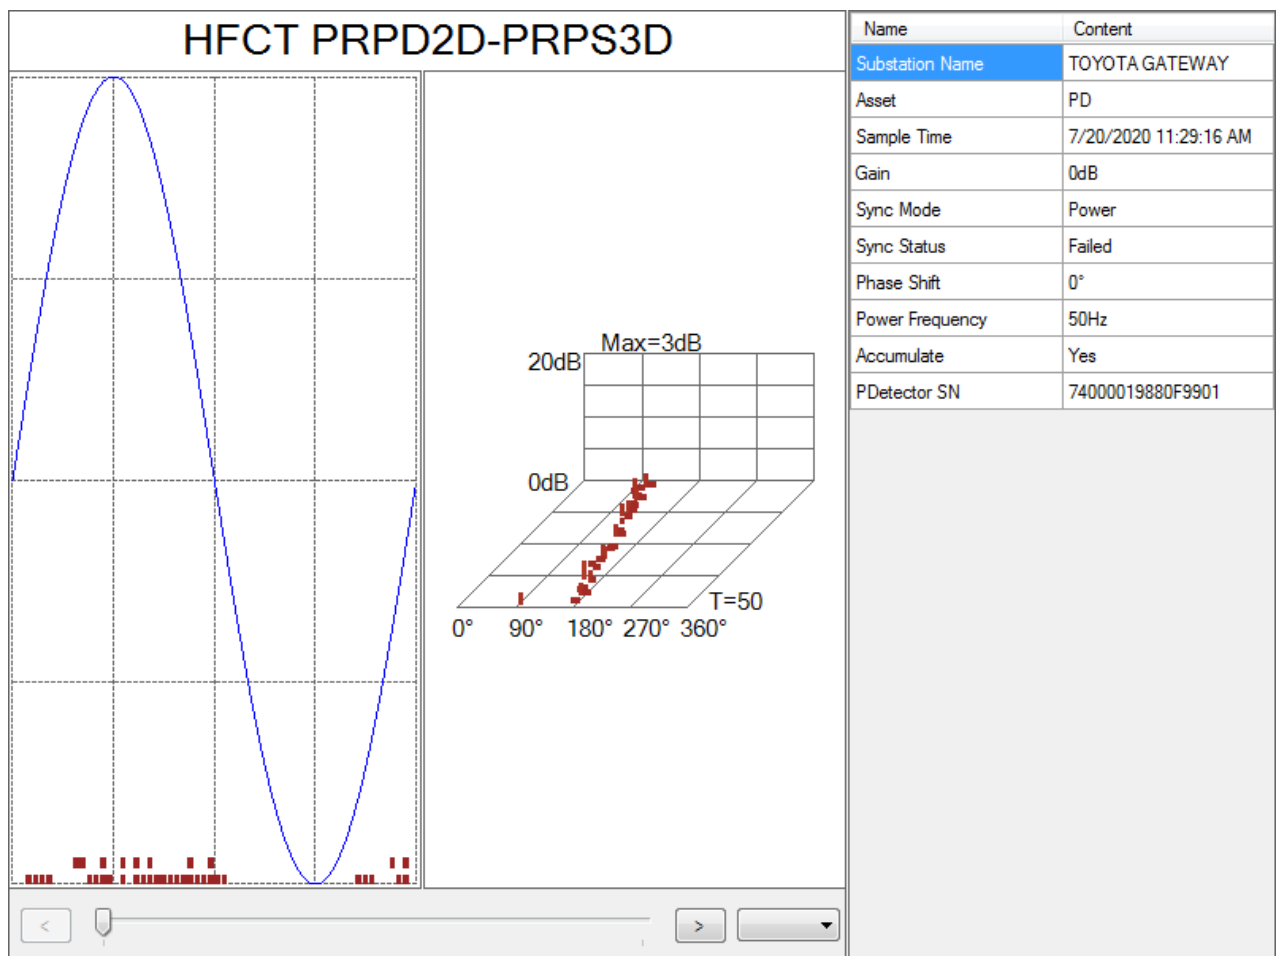
COSTOMER	TOYOTA GATEWAY (THAILAND) CO.,LTD.
SUBSTATION	SUBSTATION 115 KV
POSITION	TR1
VOLTAGE LEVEL	115 KV

COMMENT	No Partial discharge (PD) was found.
EVALUATION	Normal
SUGGESTION	No action
TESTED AND REPORTED BY	Mr.Tukdanai Pothanak
APPROVED BY	Mr.Chanvit Crukaew

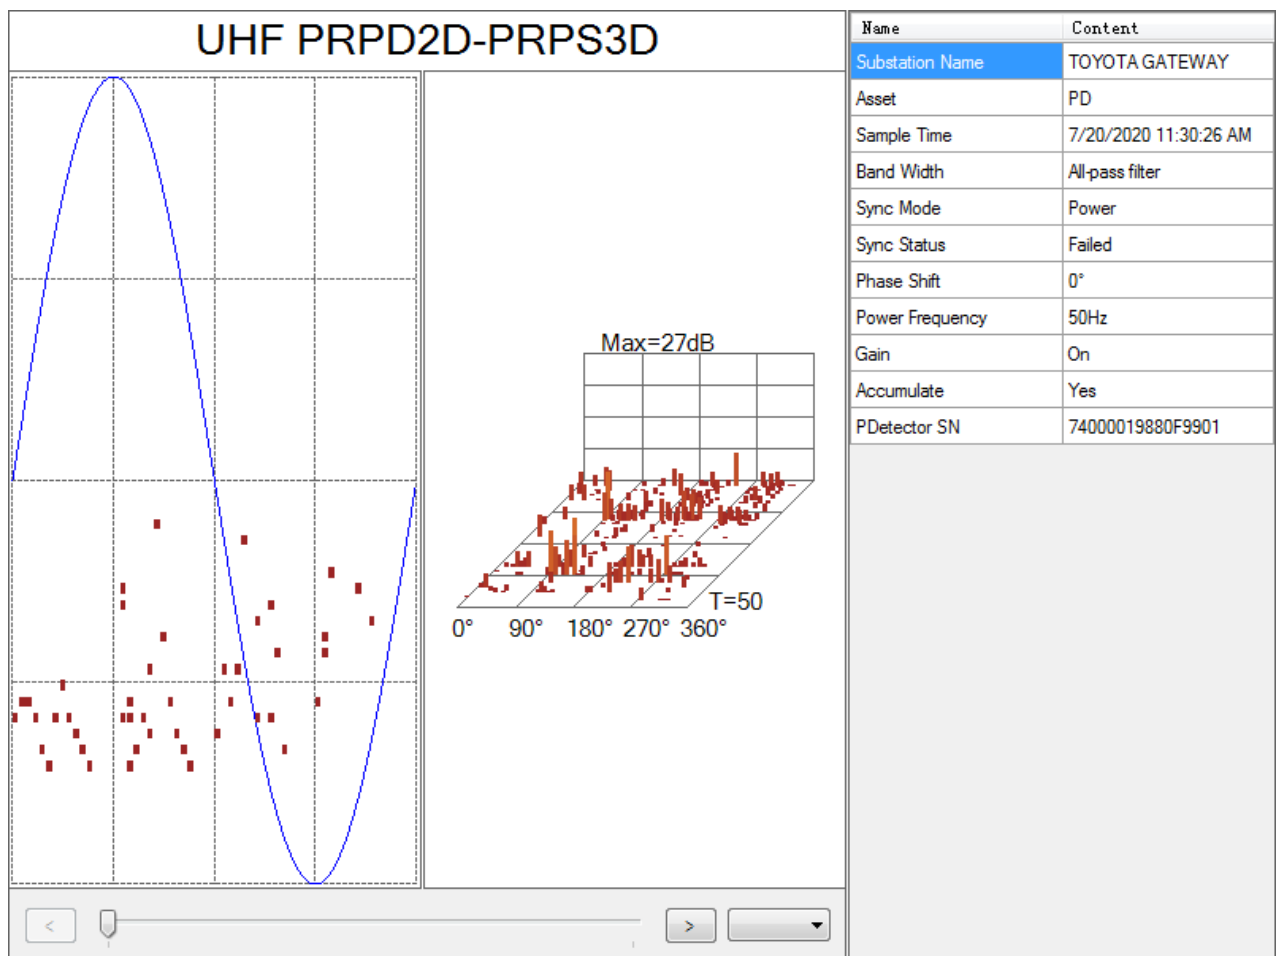
COSTOMER	TOYOTA GATEWAY (THAILAND) CO.,LTD.
SUBSTATION	SUBSTATION 115 KV
POSITION	RECEIVING TO TR2
VOLTAGE LEVEL	115 KV

COMMENT	No Partial discharge (PD) was found.
EVALUATION	Normal
SUGGESTION	No action
TESTED AND REPORTED BY	Mr.Tukdanai Pothanak
APPROVED BY	Mr.Chanvit Crukaew
