PARTIAL DISCHARGE REPORT

CUSTOMER :CO.,LTD.

DATE : July 8th, 2020

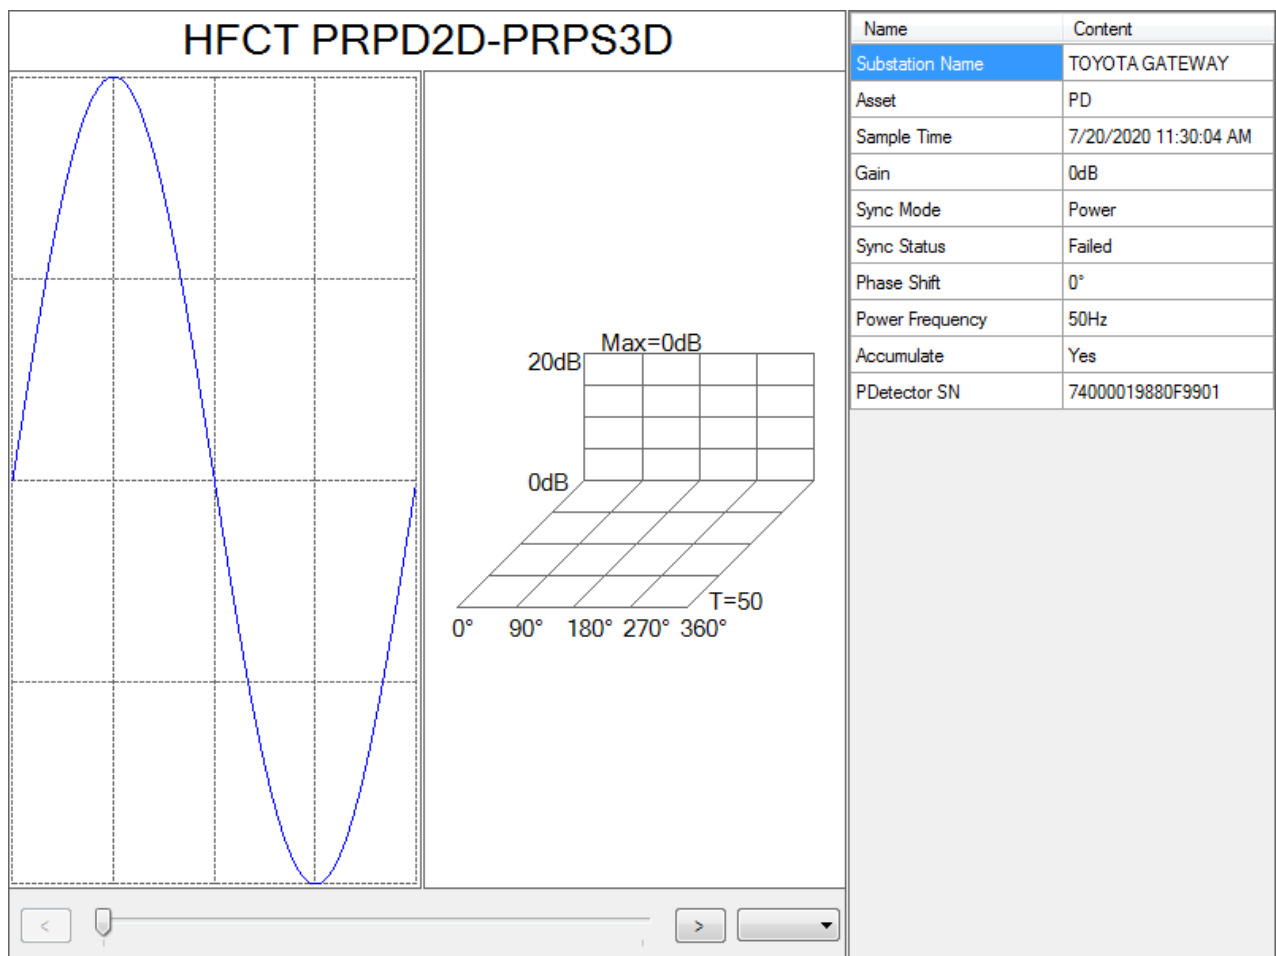
COSTOMER	TOYOTA GATEWAY (THAILAND) CO.,LTD.
SUBSTATION	SUBSTATION 115 KV
POSITION	RECEIVING TO TR2
VOLTAGE LEVEL	115 KV

COMMENT	No Partial discharge (PD) was found.
EVALUATION	Normal
SUGGESTION	No action
TESTED AND REPORTED BY	Mr.Tukdanai Pothanak
APPROVED BY	Mr.Chanvit Crukaew

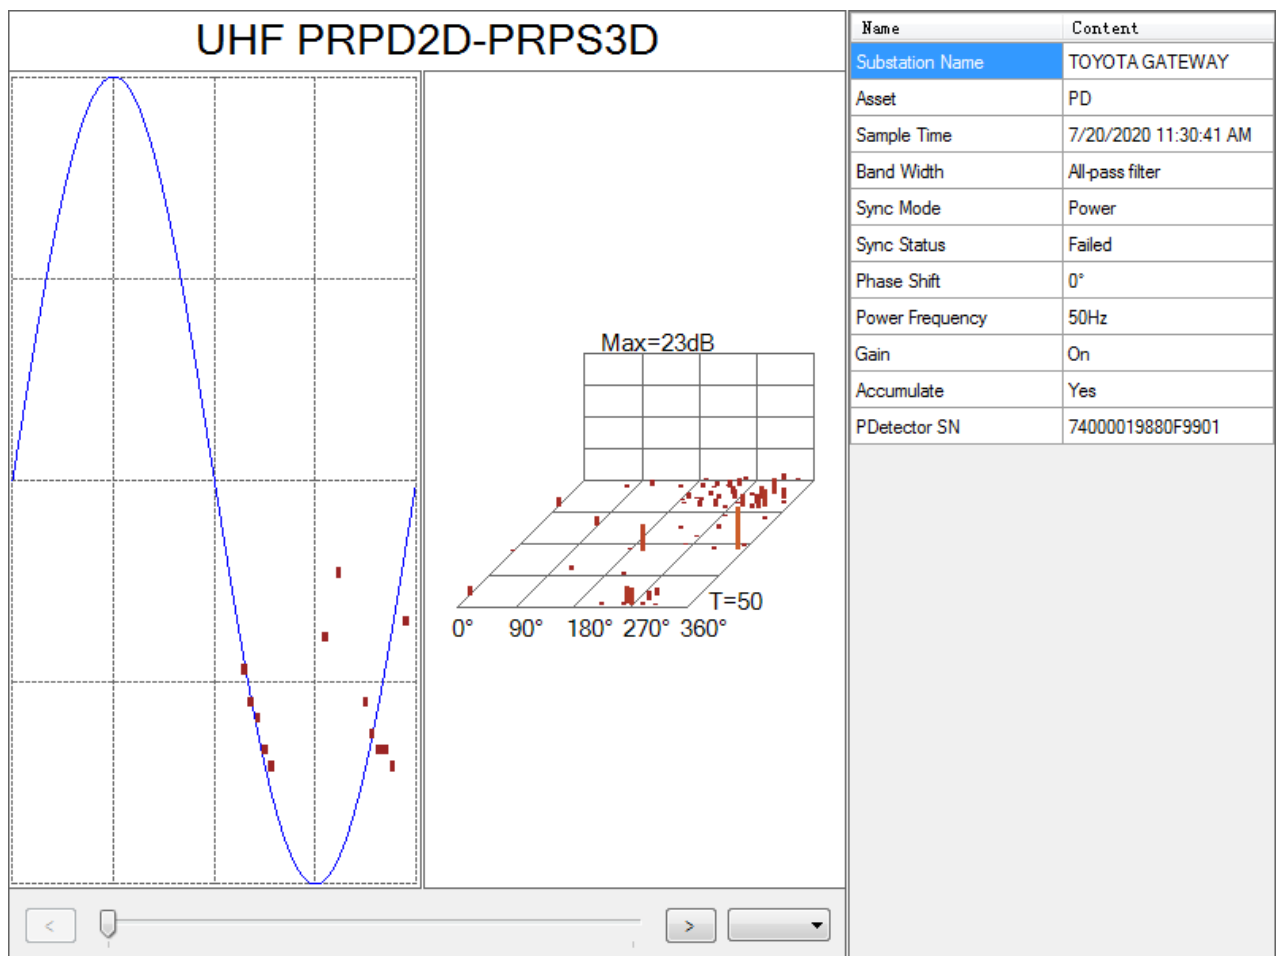
COSTOMER	TOYOTA GATEWAY (THAILAND) CO.,LTD.
SUBSTATION	SUBSTATION 115 KV
POSITION	CB TR.2
VOLTAGE LEVEL	115 KV

COMMENT	No Partial discharge (PD) was found.
EVALUATION	Normal
SUGGESTION	No action
TESTED AND REPORTED BY	Mr.Tukdanai Pothanak
APPROVED BY	Mr.Chanvit Crukaew

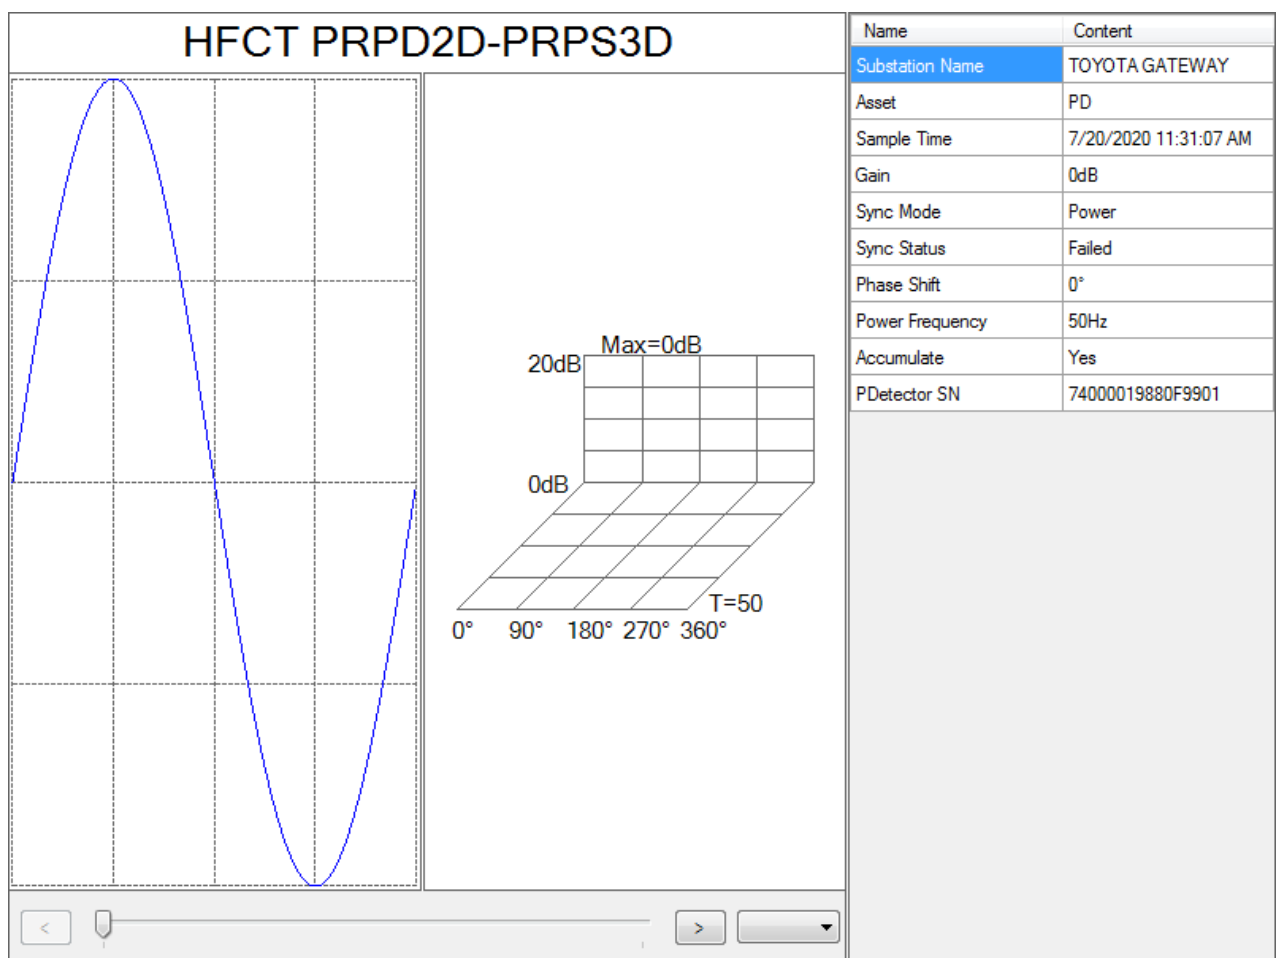
COSTOMER	TOYOTA GATEWAY (THAILAND) CO.,LTD.
SUBSTATION	SUBSTATION 115 KV
POSITION	RECEIVING TO TR2
VOLTAGE LEVEL	115 KV

COMMENT	No Partial discharge (PD) was found.
EVALUATION	Normal
SUGGESTION	No action
TESTED AND REPORTED BY	Mr.Tukdanai Pothanak
APPROVED BY	Mr.Chanvit Crukaew

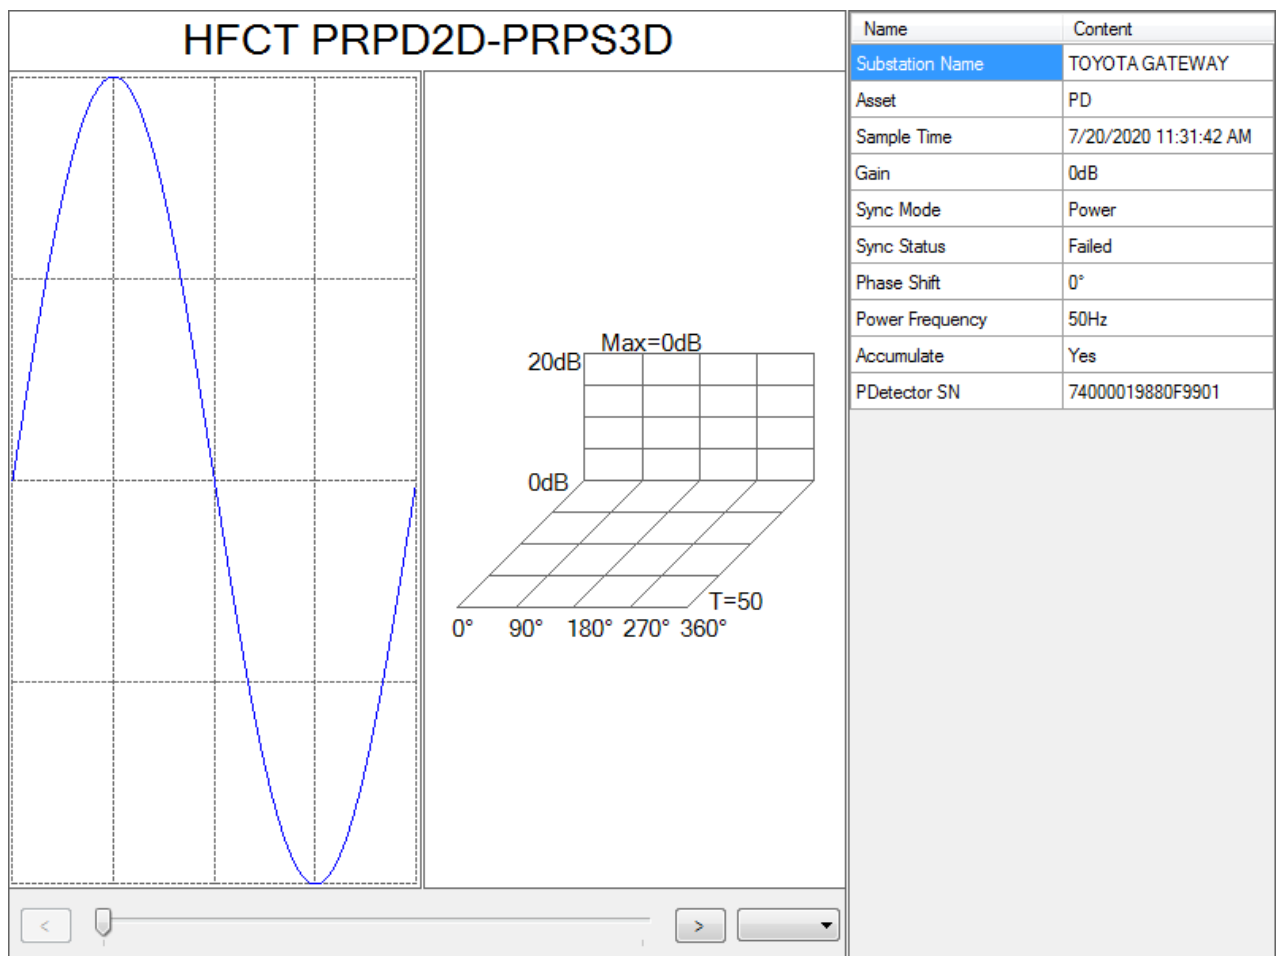
COSTOMER	TOYOTA GATEWAY (THAILAND) CO.,LTD.
SUBSTATION	SUBSTATION 115 KV
POSITION	TR2
VOLTAGE LEVEL	115 KV

COMMENT	No Partial discharge (PD) was found.
EVALUATION	Normal
SUGGESTION	No action
TESTED AND REPORTED BY	Mr.Tukdanai Pothanak
APPROVED BY	Mr.Chanvit Crukaew

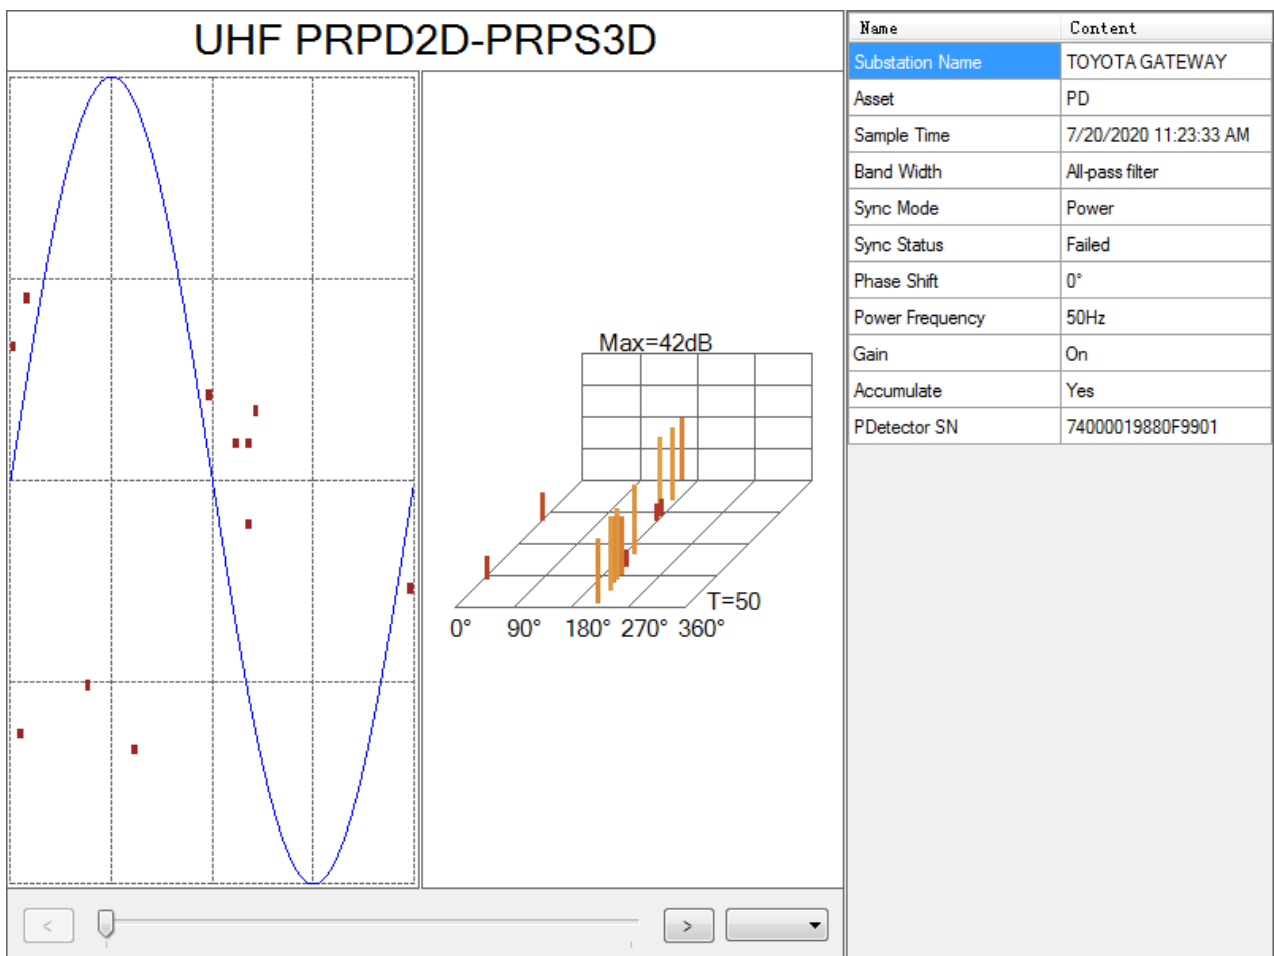
COSTOMER	TOYOTA GATEWAY (THAILAND) CO.,LTD.
SUBSTATION	SUBSTATION 115 KV
POSITION	DS PHASE R
VOLTAGE LEVEL	115 KV

COMMENT	No Partial discharge (PD) was found.
EVALUATION	Normal
SUGGESTION	No action
TESTED AND REPORTED BY	Mr.Tukdanai Pothanak
APPROVED BY	Mr.Chanvit Crukaew

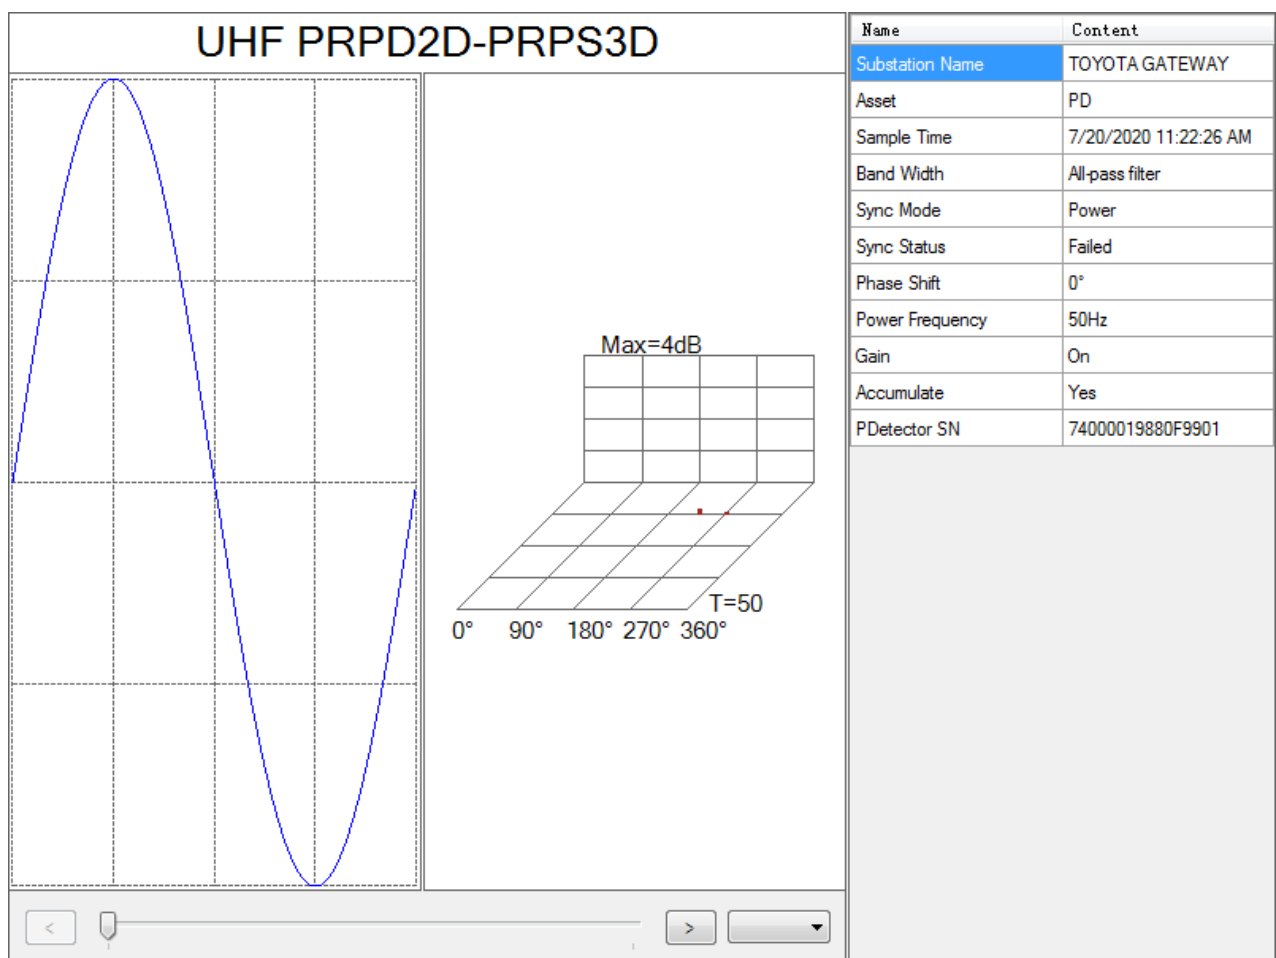
COSTOMER	TOYOTA GATEWAY (THAILAND) CO.,LTD.
SUBSTATION	SUBSTATION 115 KV
POSITION	DS PHASE Y
VOLTAGE LEVEL	115 KV

COMMENT	No Partial discharge (PD) was found.
EVALUATION	Normal
SUGGESTION	No action
TESTED AND REPORTED BY	Mr.Tukdanai Pothanak
APPROVED BY	Mr.Chanvit Crukaew

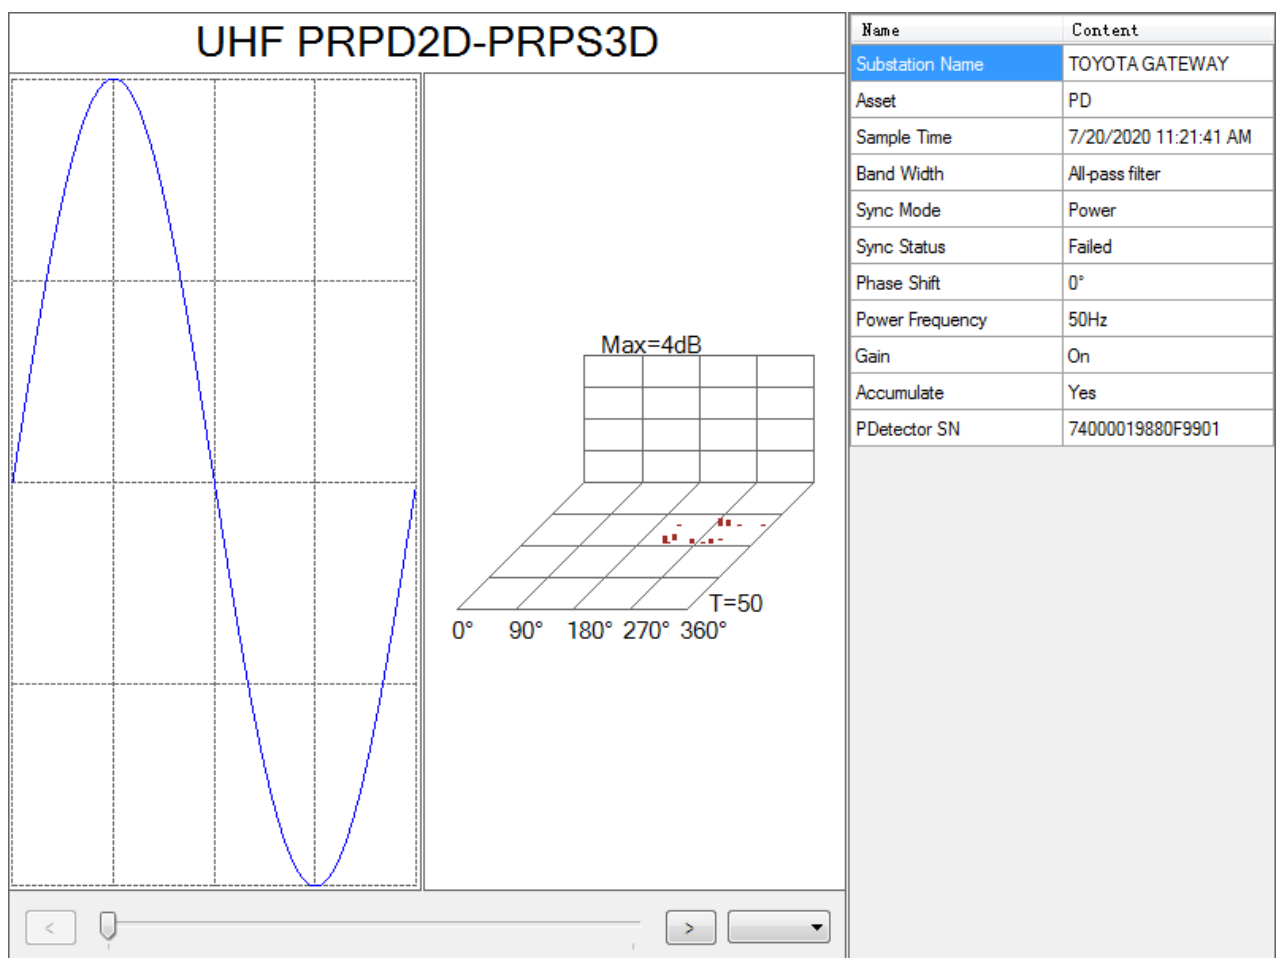
COSTOMER	TOYOTA GATEWAY (THAILAND) CO.,LTD.
SUBSTATION	SUBSTATION 115 KV
POSITION	DS PHASE B
VOLTAGE LEVEL	115 KV

COMMENT	No Partial discharge (PD) was found.
EVALUATION	Normal
SUGGESTION	No action
TESTED AND REPORTED BY	Mr.Tukdanai Pothanak
APPROVED BY	Mr.Chanvit Crukaew

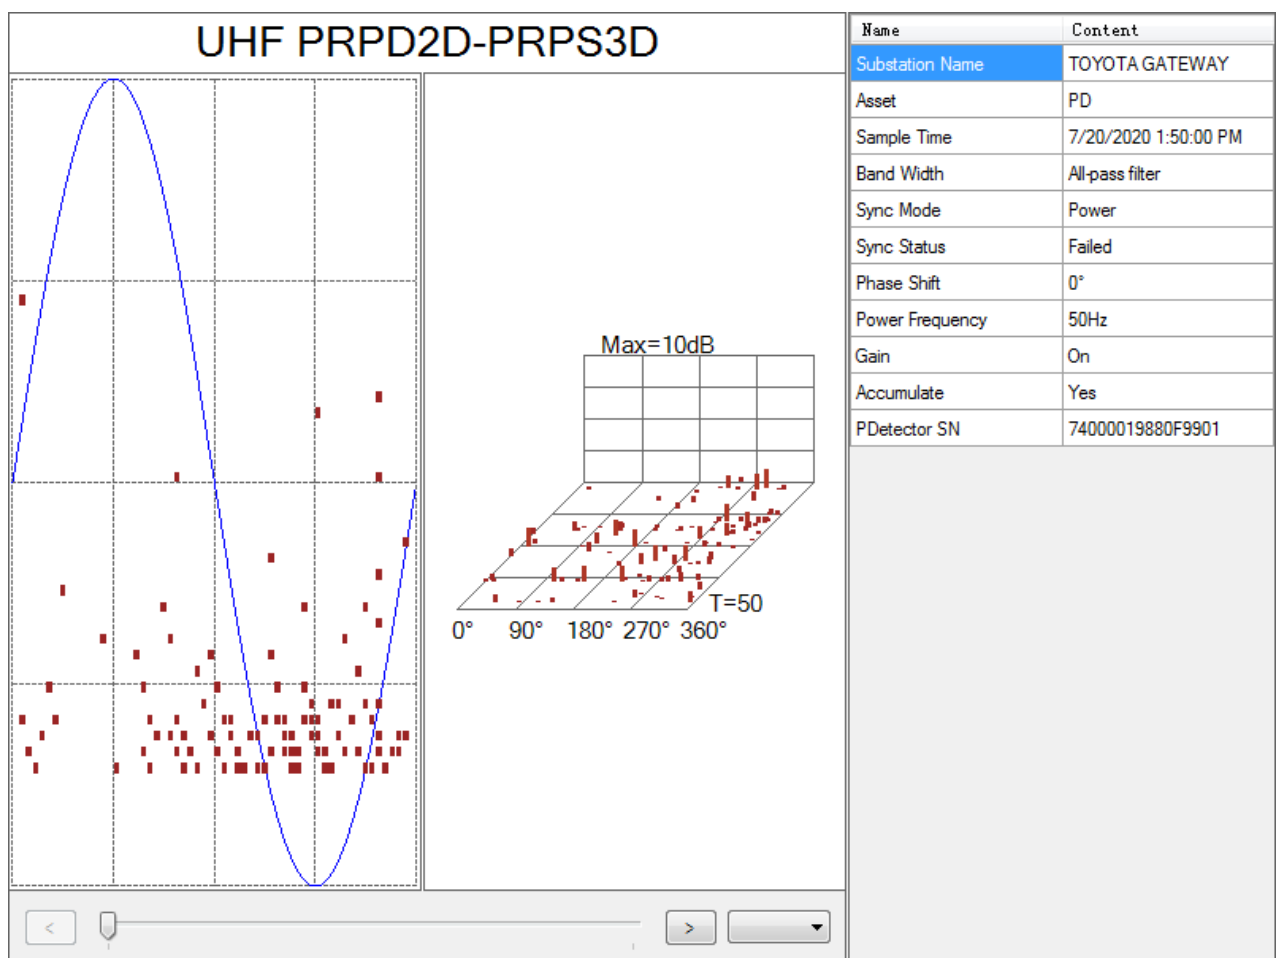
COSTOMER	TOYOTA GATEWAY (THAILAND) CO.,LTD.
SUBSTATION	GIS
POSITION	NO.2 BANK BUS-TIE
VOLTAGE LEVEL	22 KV

COMMENT	No Partial discharge (PD) was found.
EVALUATION	Normal
SUGGESTION	No action
TESTED AND REPORTED BY	Mr.Tukdanai Pothanak
APPROVED BY	Mr.Chanvit Crukaew

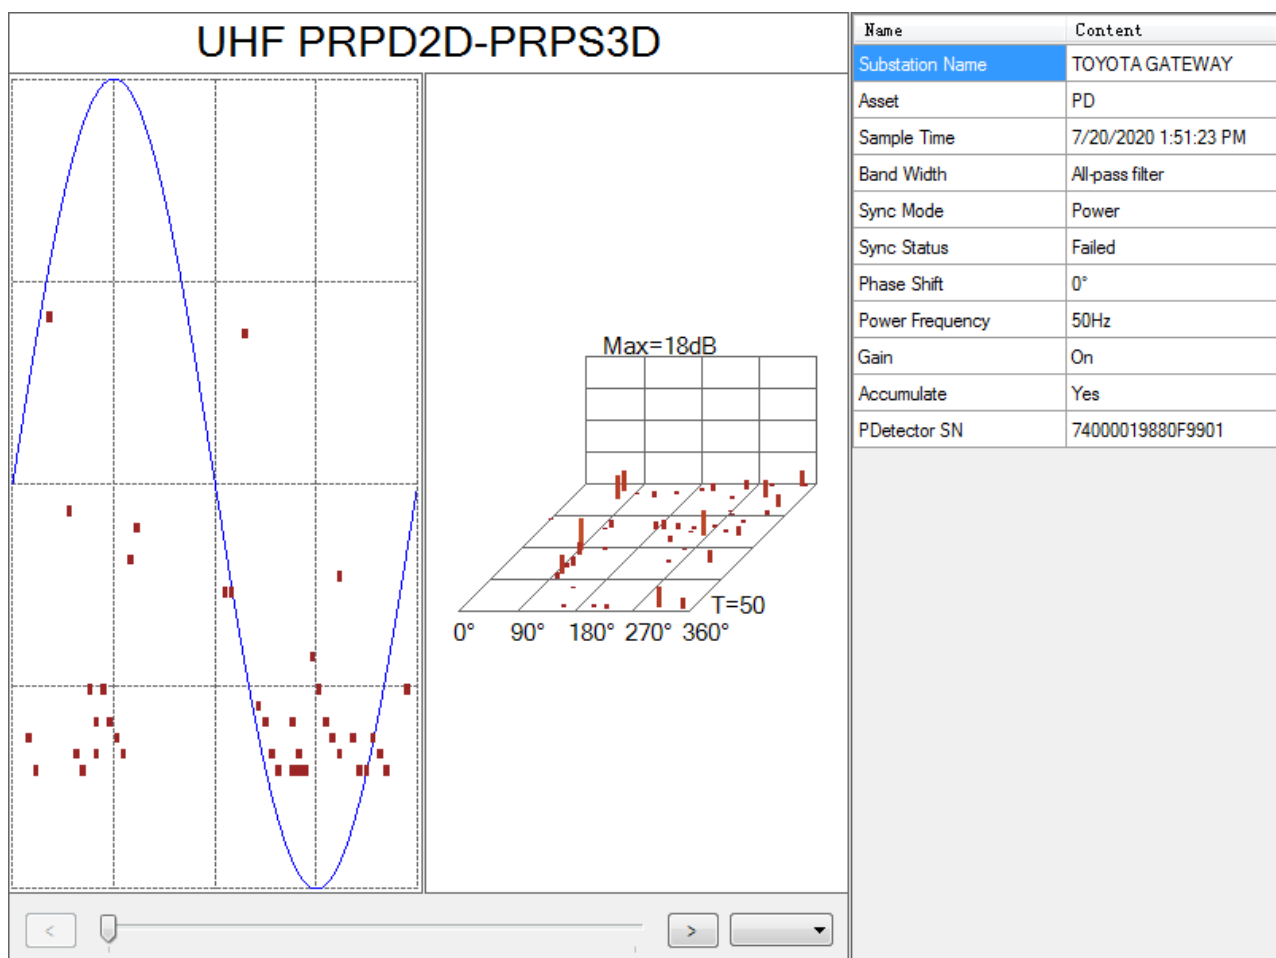
COSTOMER	TOYOTA GATEWAY (THAILAND) CO.,LTD.
SUBSTATION	GIS
POSITION	CAPACITOR
VOLTAGE LEVEL	22 KV

COMMENT	No Partial discharge (PD) was found.
EVALUATION	Normal
SUGGESTION	No action
TESTED AND REPORTED BY	Mr.Tukdanai Pothanak
APPROVED BY	Mr.Chanvit Crukaew

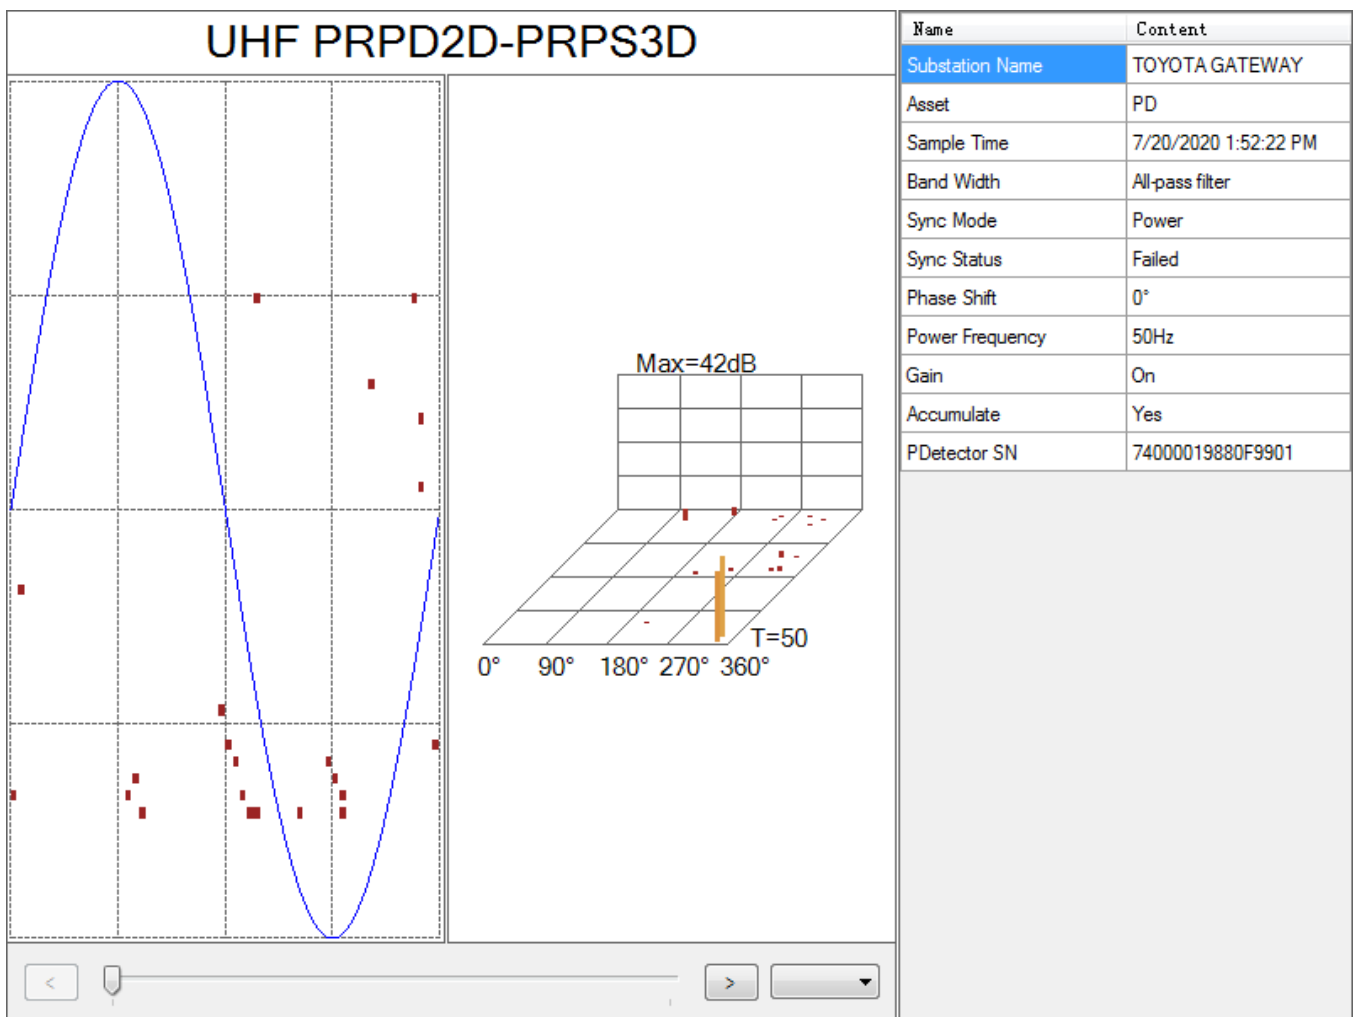
COSTOMER	TOYOTA GATEWAY (THAILAND) CO.,LTD.
SUBSTATION	GIS
POSITION	2-4 FEEDER
VOLTAGE LEVEL	22 KV

COMMENT	No Partial discharge (PD) was found.
EVALUATION	Normal
SUGGESTION	No action
TESTED AND REPORTED BY	Mr.Tukdanai Pothanak
APPROVED BY	Mr.Chanvit Crukaew

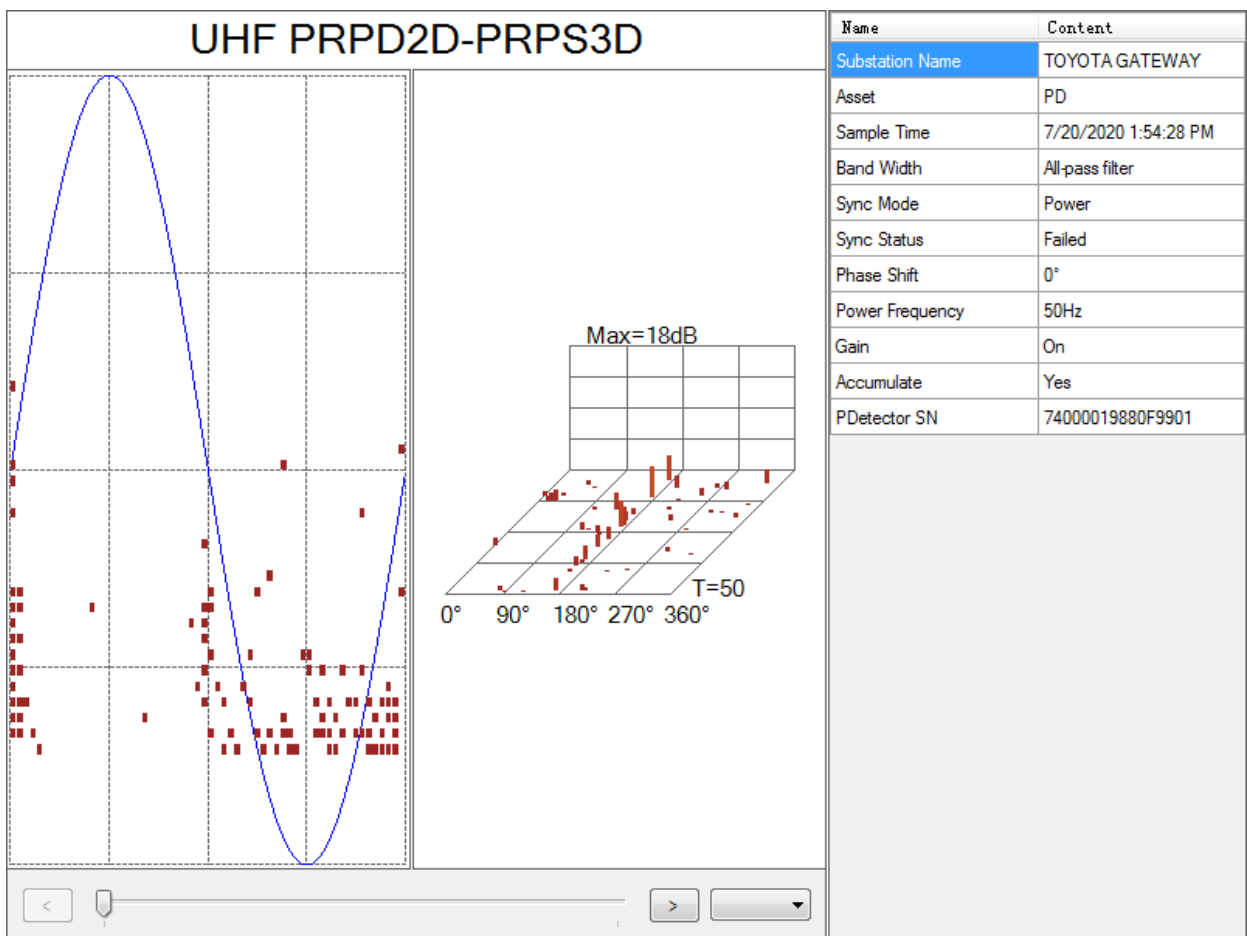
COSTOMER	TOYOTA GATEWAY (THAILAND) CO.,LTD.
SUBSTATION	GIS
POSITION	2-3 FEEDER
VOLTAGE LEVEL	22 KV

COMMENT	No Partial discharge (PD) was found.
EVALUATION	Normal
SUGGESTION	No action
TESTED AND REPORTED BY	Mr.Tukdanai Pothanak
APPROVED BY	Mr.Chanvit Crukaew

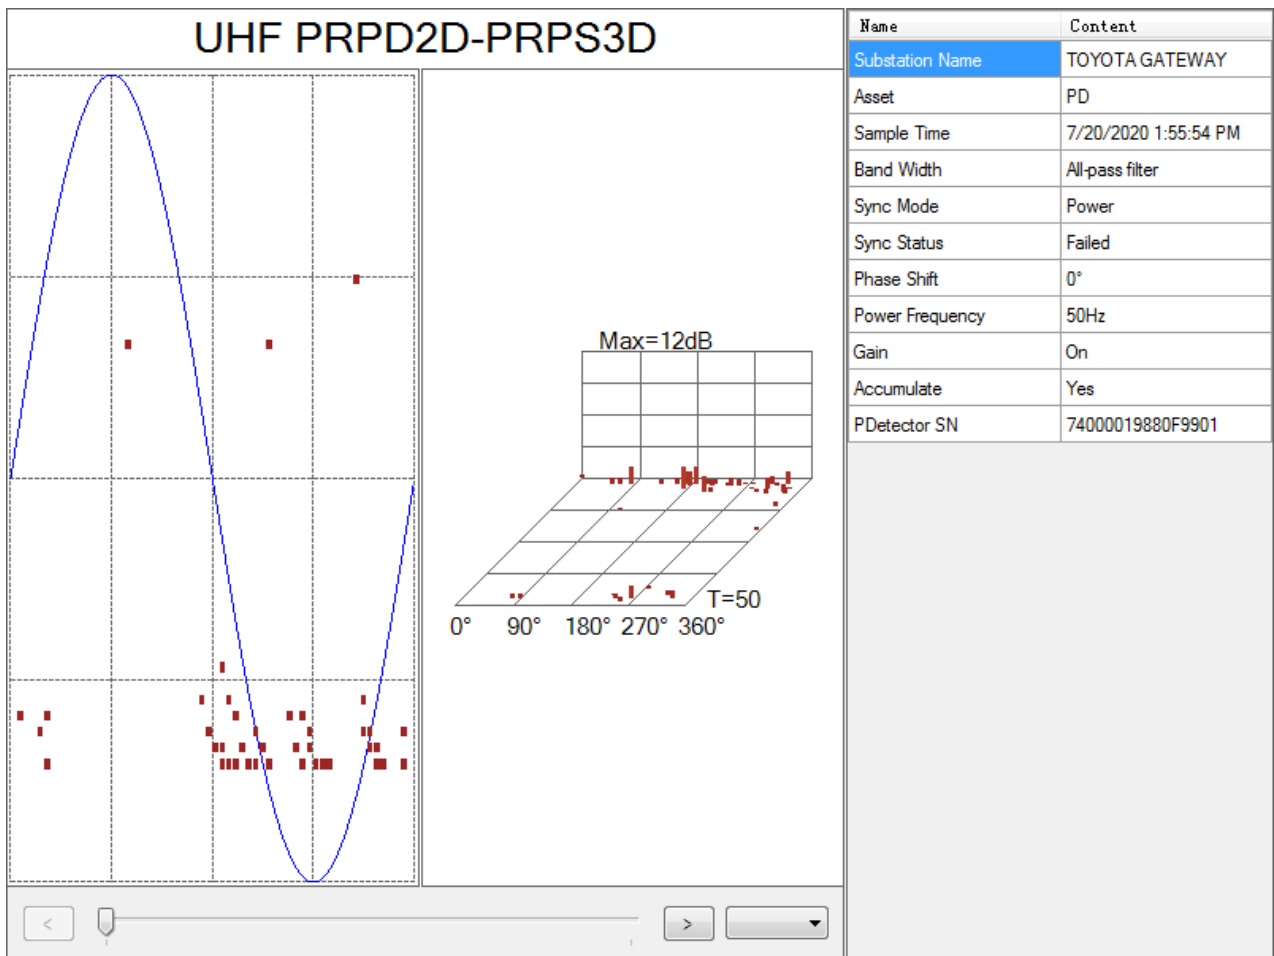
COSTOMER	TOYOTA GATEWAY (THAILAND) CO.,LTD.
SUBSTATION	GIS
POSITION	2-2 FEEDER
VOLTAGE LEVEL	22 KV

COMMENT	No Partial discharge (PD) was found.
EVALUATION	Normal
SUGGESTION	No action
TESTED AND REPORTED BY	Mr.Tukdanai Pothanak
APPROVED BY	Mr.Chanvit Crukaew

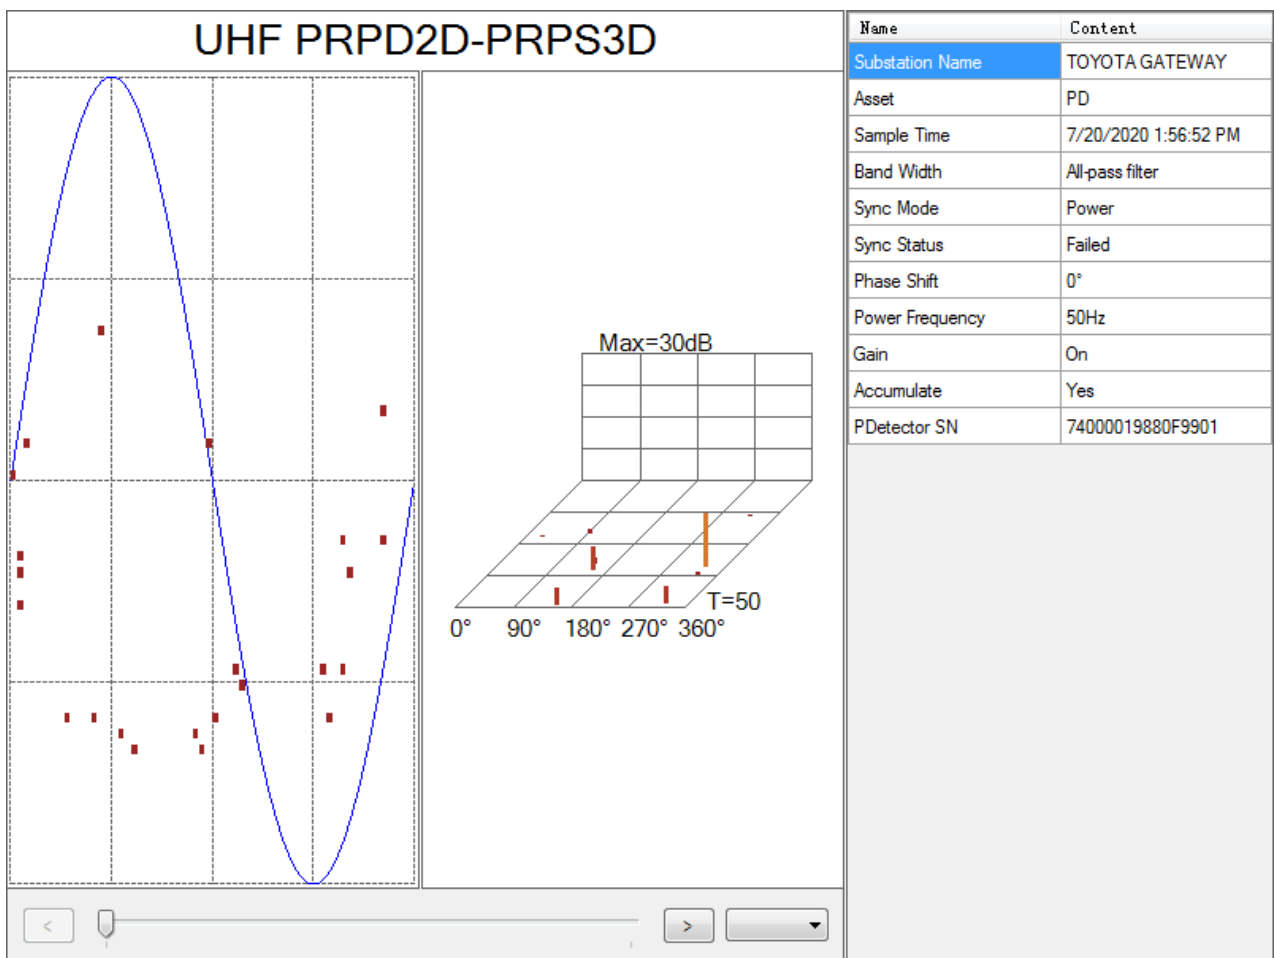
COSTOMER	TOYOTA GATEWAY (THAILAND) CO.,LTD.
SUBSTATION	GIS
POSITION	2-1 FEEDER
VOLTAGE LEVEL	22 KV

COMMENT	No Partial discharge (PD) was found.
EVALUATION	Normal
SUGGESTION	No action
TESTED AND REPORTED BY	Mr.Tukdanai Pothanak
APPROVED BY	Mr.Chanvit Crukaew

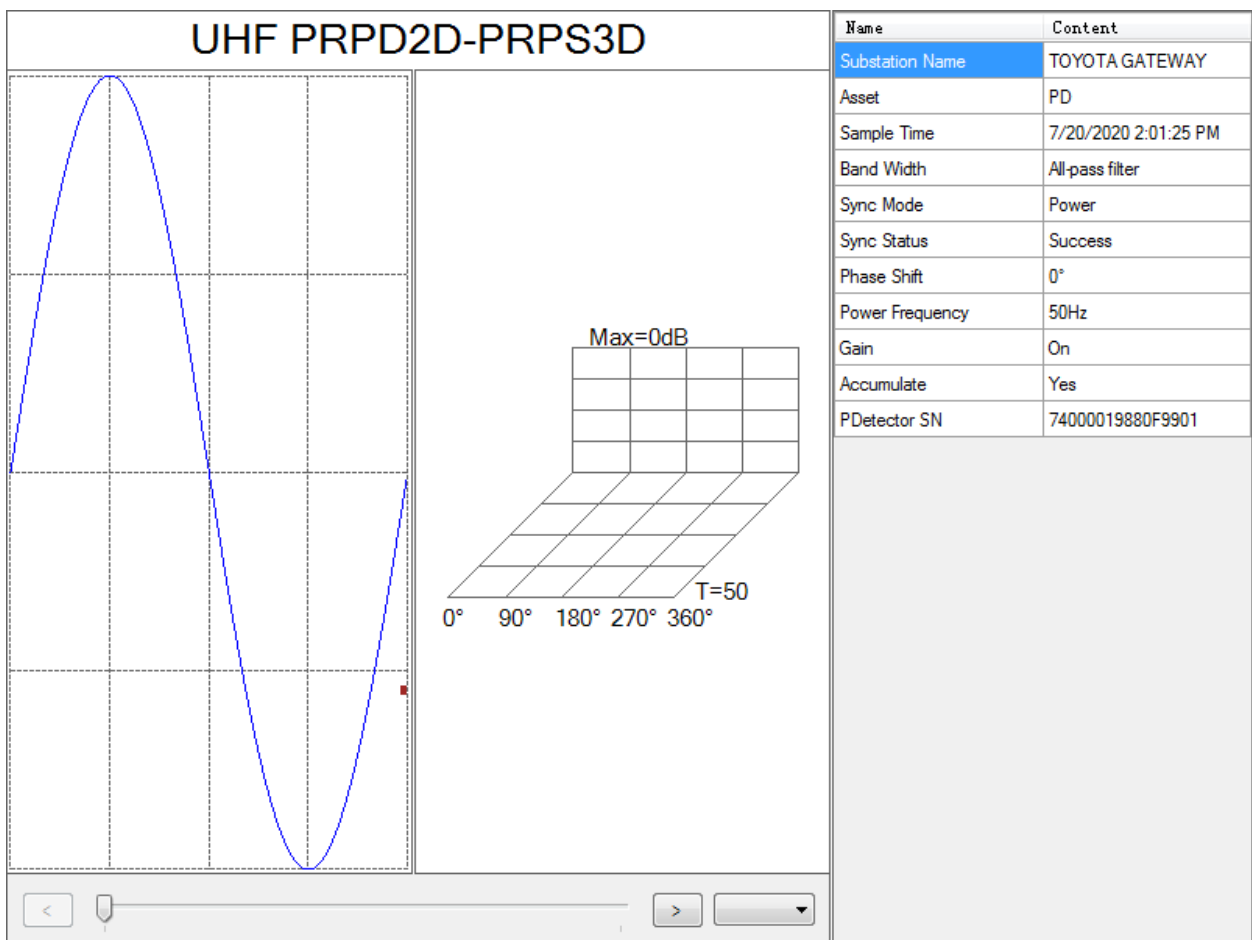
COSTOMER	TOYOTA GATEWAY (THAILAND) CO.,LTD.
SUBSTATION	GIS
POSITION	NO.1 BANK BUS-TIE
VOLTAGE LEVEL	22 KV

COMMENT	No Partial discharge (PD) was found.
EVALUATION	Normal
SUGGESTION	No action
TESTED AND REPORTED BY	Mr.Tukdanai Pothanak
APPROVED BY	Mr.Chanvit Crukaew

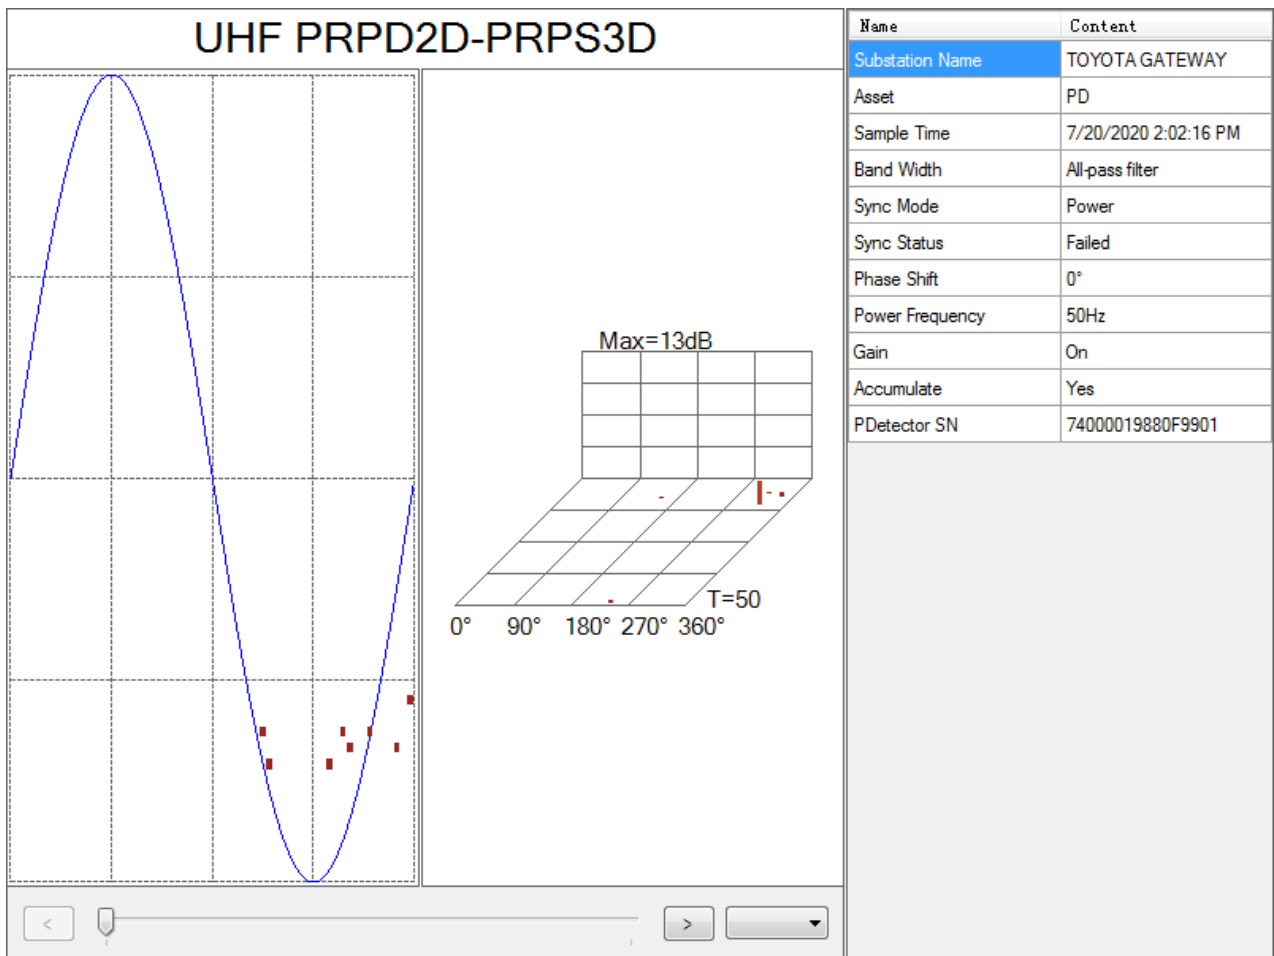
COSTOMER	TOYOTA GATEWAY (THAILAND) CO.,LTD.
SUBSTATION	GIS
POSITION	STATION TR
VOLTAGE LEVEL	22 KV

COMMENT	No Partial discharge (PD) was found.
EVALUATION	Normal
SUGGESTION	No action
TESTED AND REPORTED BY	Mr.Tukdanai Pothanak
APPROVED BY	Mr.Chanvit Crukaew

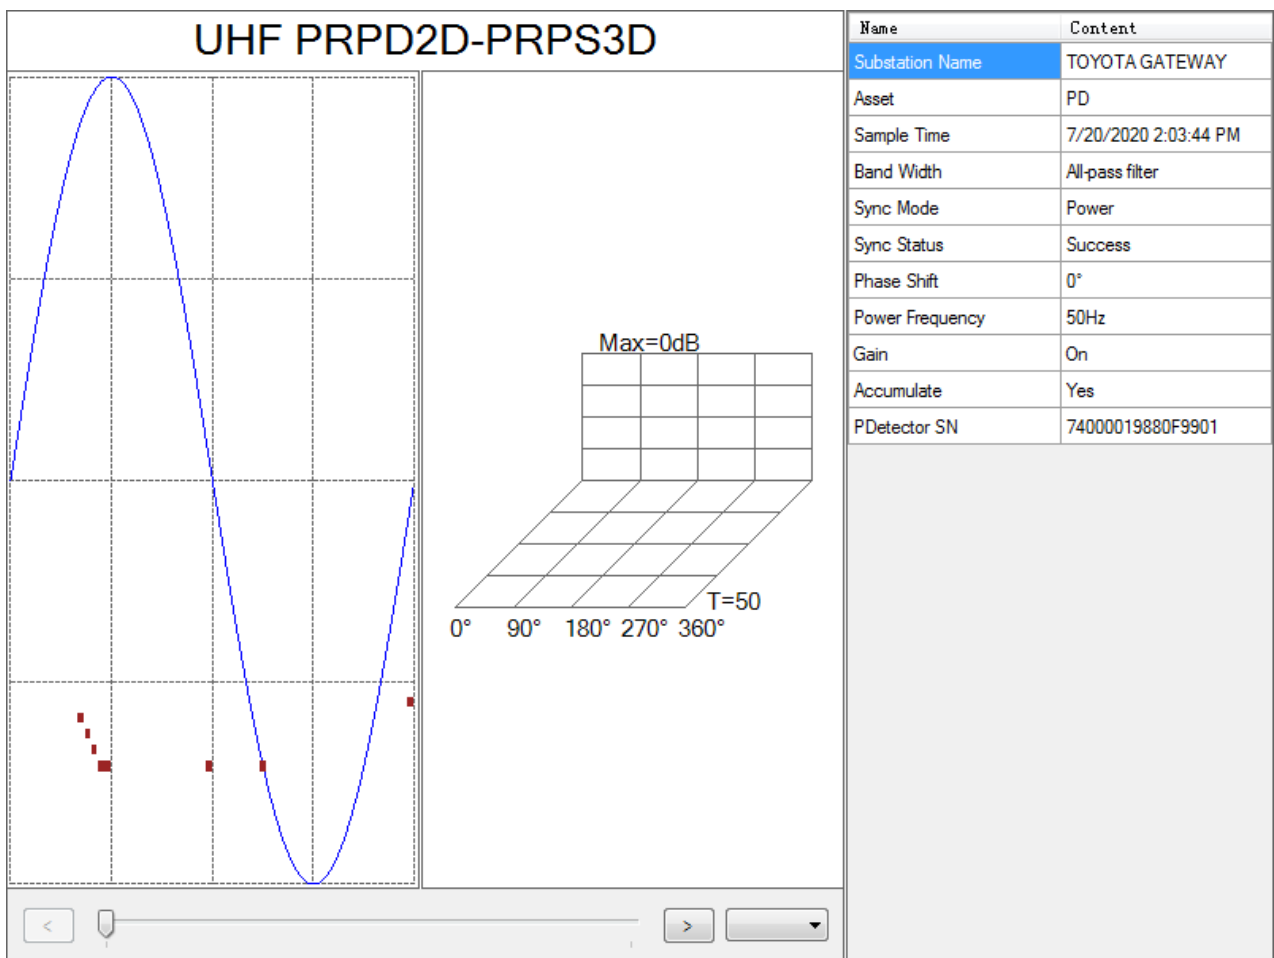
COSTOMER	TOYOTA GATEWAY (THAILAND) CO.,LTD.
SUBSTATION	GIS
POSITION	1-4 FEEDER
VOLTAGE LEVEL	22 KV

COMMENT	No Partial discharge (PD) was found.
EVALUATION	Normal
SUGGESTION	No action
TESTED AND REPORTED BY	Mr.Tukdanai Pothanak
APPROVED BY	Mr.Chanvit Crukaew

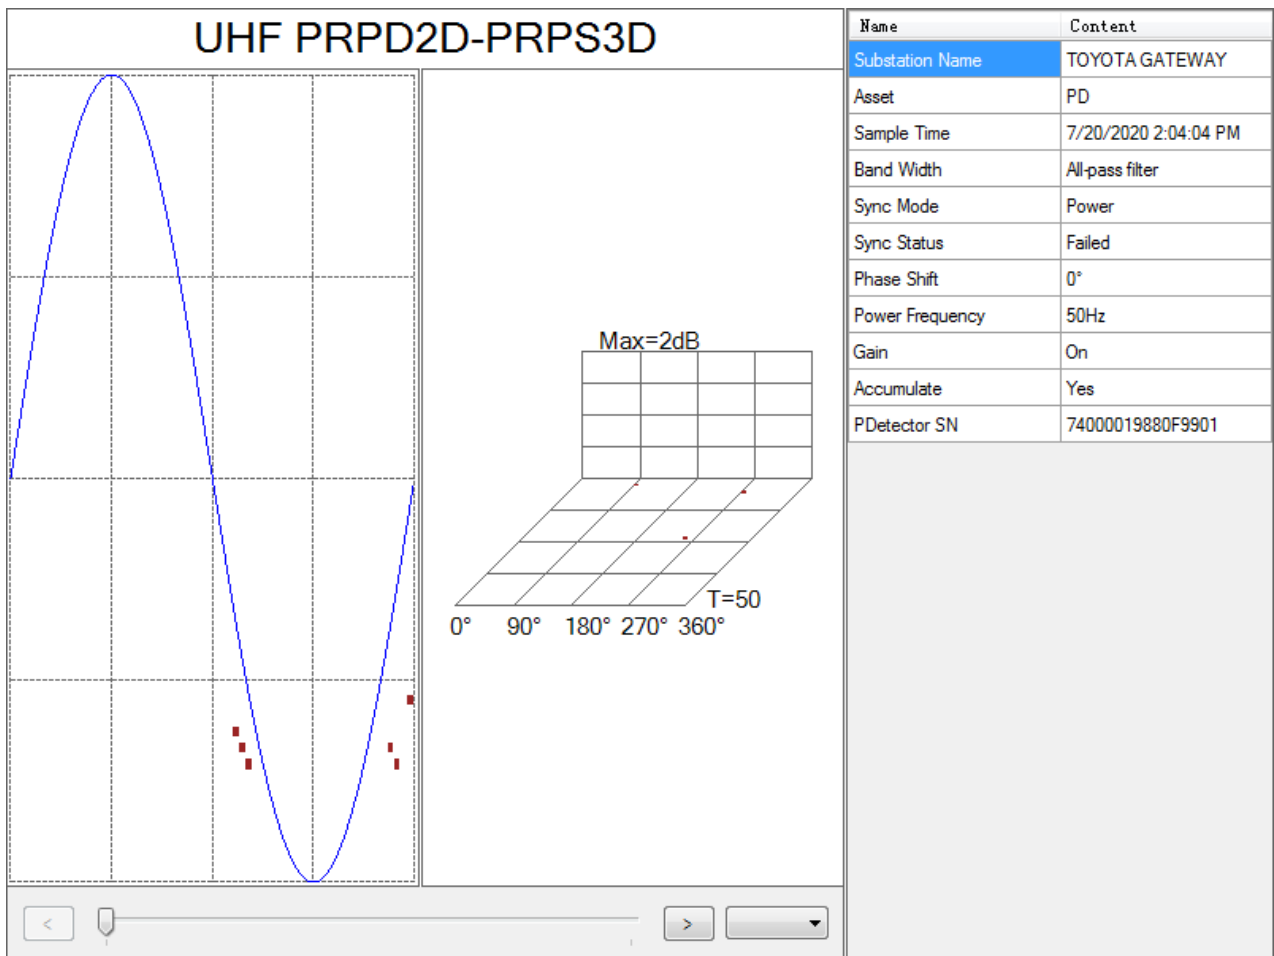
COSTOMER	TOYOTA GATEWAY (THAILAND) CO.,LTD.
SUBSTATION	GIS
POSITION	1-3 FEEDER
VOLTAGE LEVEL	22 KV

COMMENT	No Partial discharge (PD) was found.
EVALUATION	Normal
SUGGESTION	No action
TESTED AND REPORTED BY	Mr.Tukdanai Pothanak
APPROVED BY	Mr.Chanvit Crukaew

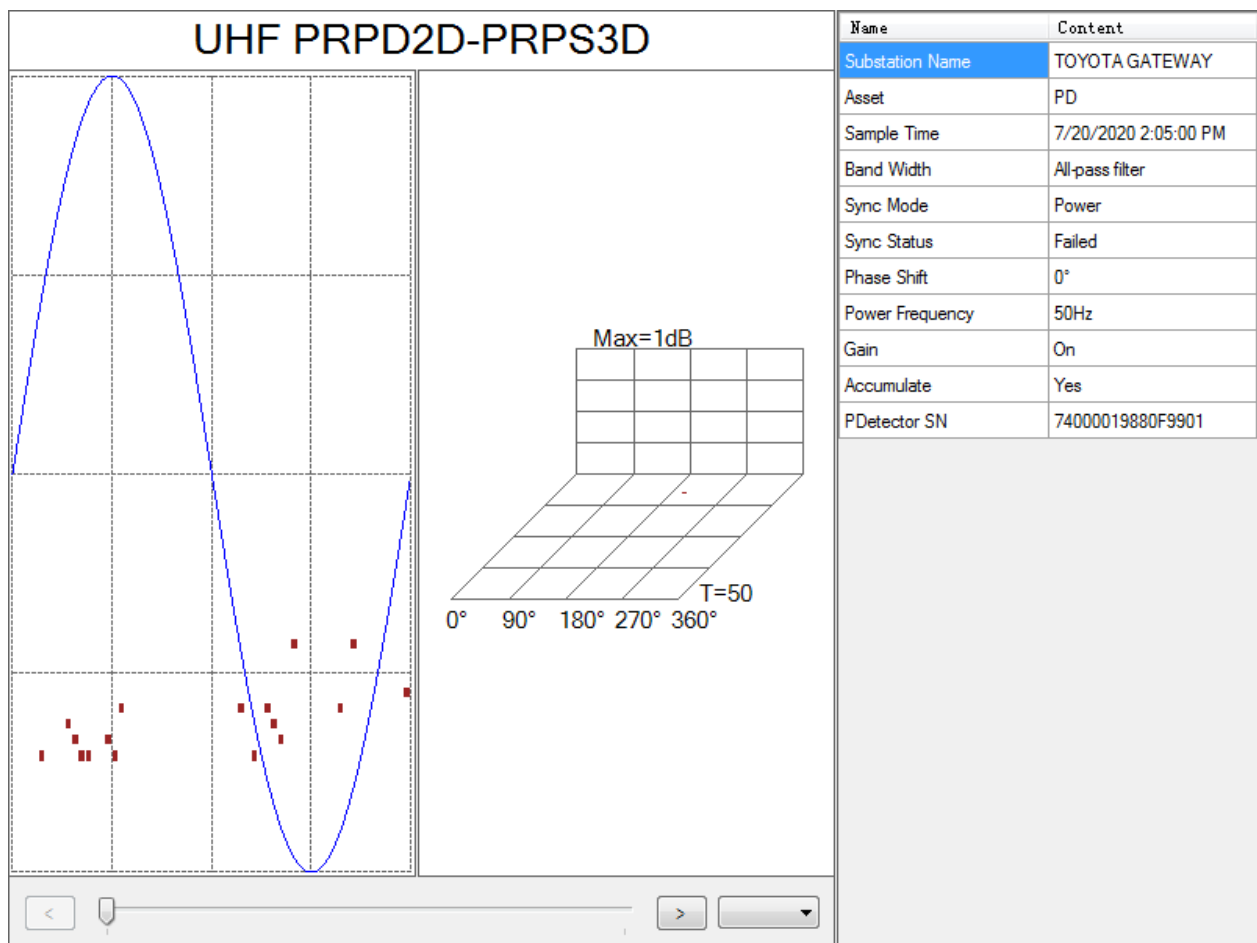
COSTOMER	TOYOTA GATEWAY (THAILAND) CO.,LTD.
SUBSTATION	GIS
POSITION	1-2 FEEDER
VOLTAGE LEVEL	22 KV

COMMENT	No Partial discharge (PD) was found.
EVALUATION	Normal
SUGGESTION	No action
TESTED AND REPORTED BY	Mr.Tukdanai Pothanak
APPROVED BY	Mr.Chanvit Crukaew
