PARTIAL DISCHARGE REPORT

CUSTOMER :CO.,LTD.

DATE : July 8th, 2020

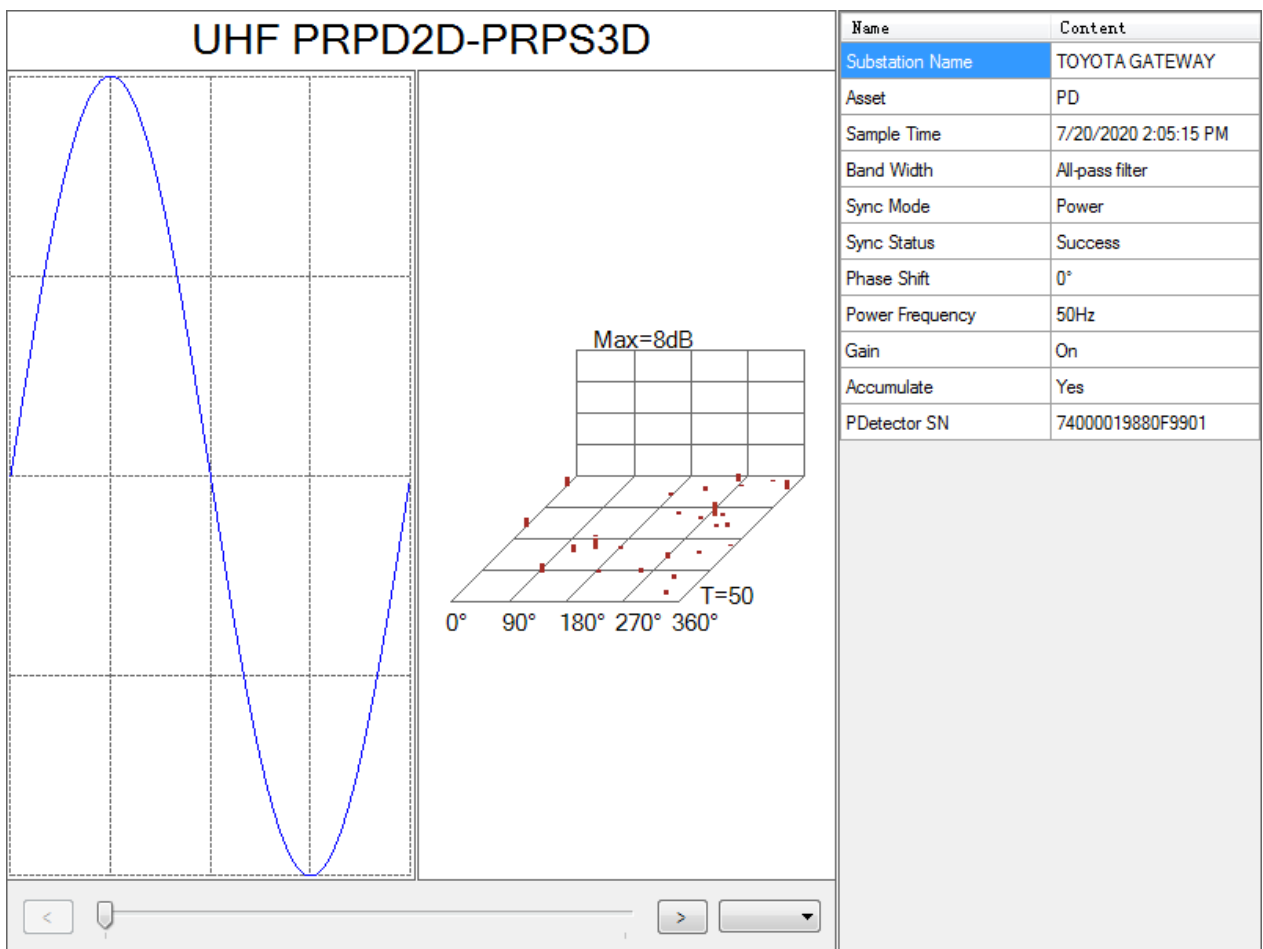
COSTOMER	TOYOTA GATEWAY (THAILAND) CO.,LTD.
SUBSTATION	GIS
POSITION	1-1 FEEDER
VOLTAGE LEVEL	22 KV

COMMENT	No Partial discharge (PD) was found.
EVALUATION	Normal
SUGGESTION	No action
TESTED AND REPORTED BY	Mr.Tukdanai Pothanak
APPROVED BY	Mr.Chanvit Crukaew

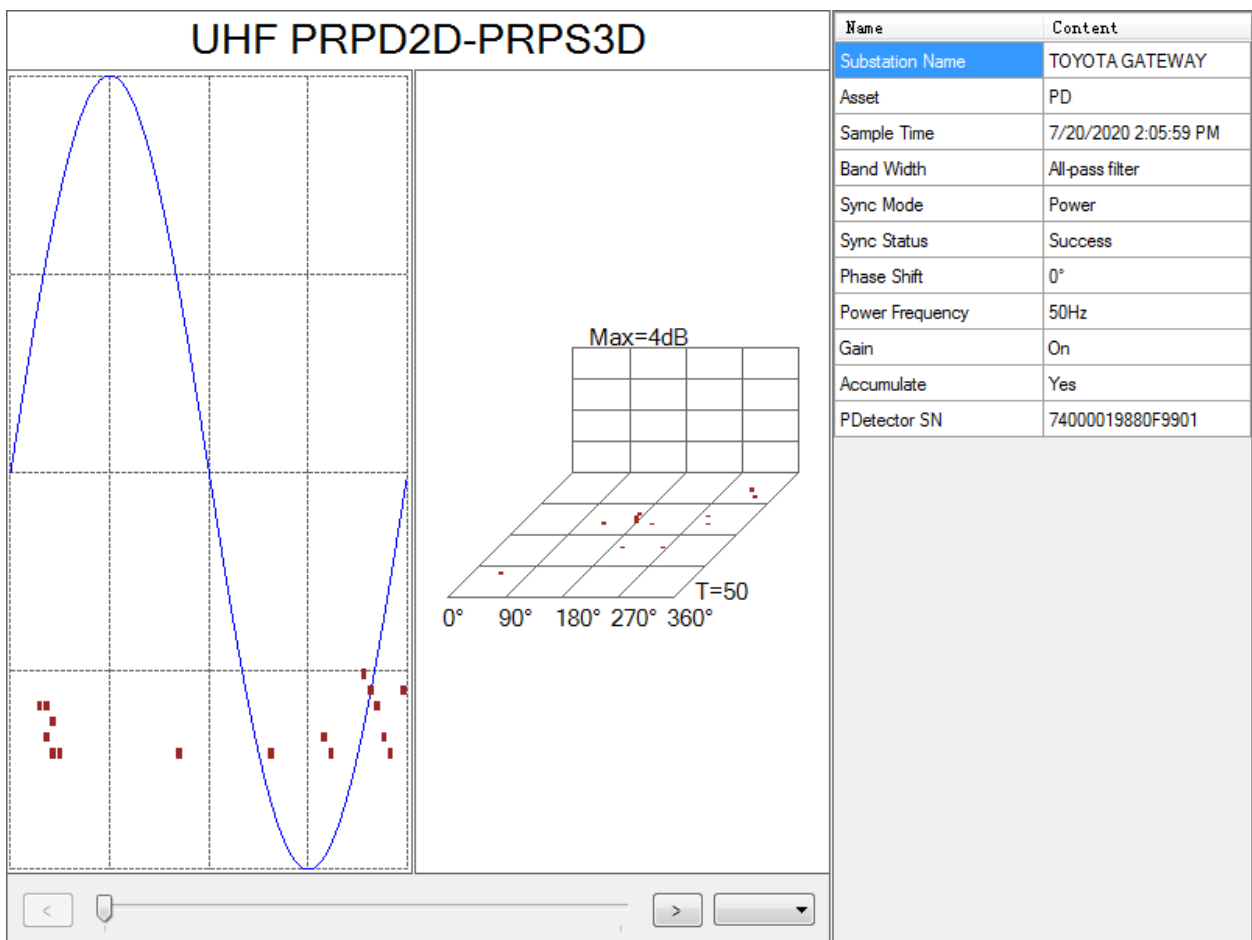
COSTOMER	TOYOTA GATEWAY (THAILAND) CO.,LTD.
SUBSTATION	GIS
POSITION	NO.1 TR SEC
VOLTAGE LEVEL	22 KV

COMMENT	No Partial discharge (PD) was found.
EVALUATION	Normal
SUGGESTION	No action
TESTED AND REPORTED BY	Mr.Tukdanai Pothanak
APPROVED BY	Mr.Chanvit Crukaew

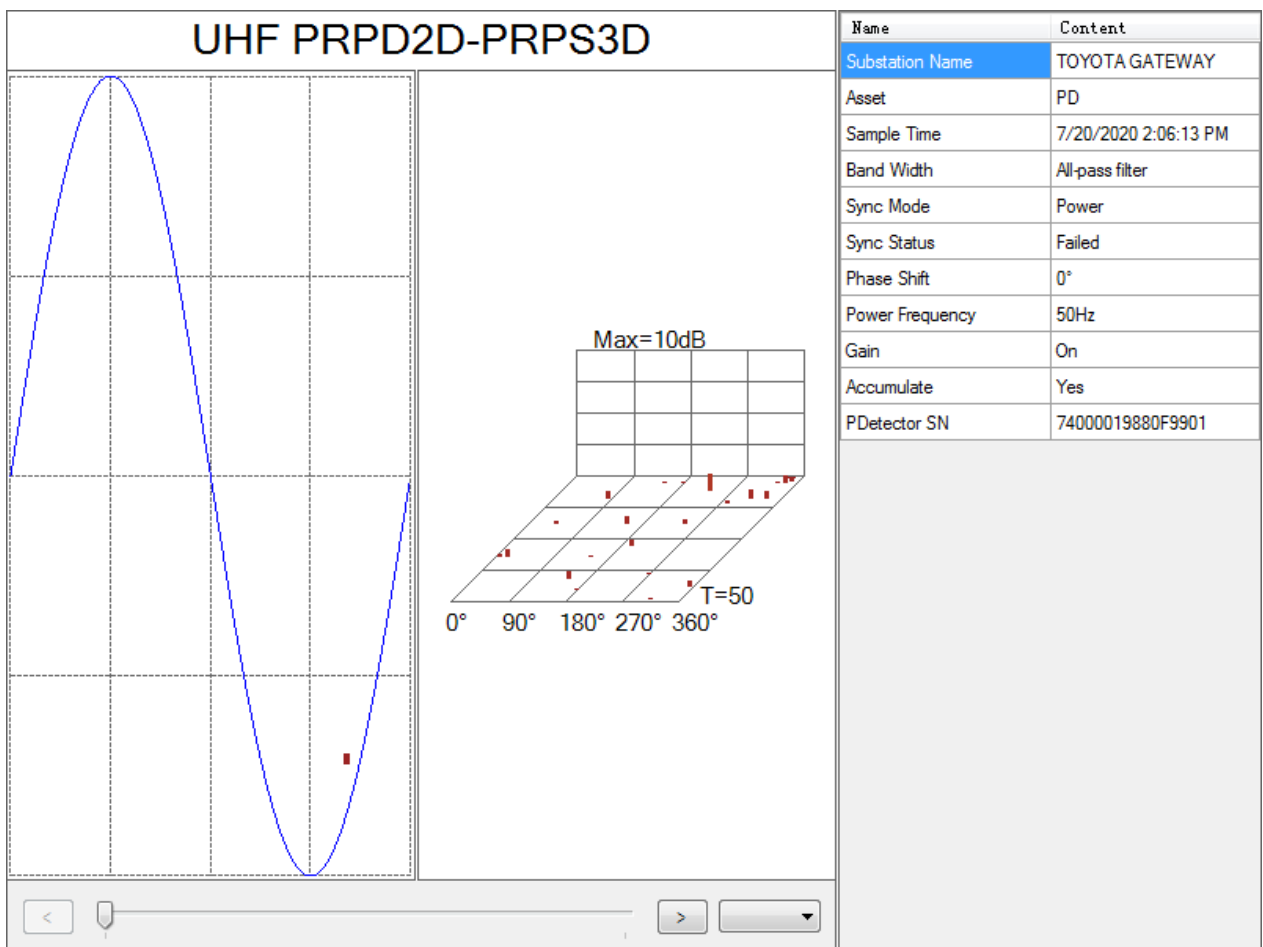
COSTOMER	TOYOTA GATEWAY (THAILAND) CO.,LTD.
SUBSTATION	GIS
POSITION	NO.1 BANK BUS VT
VOLTAGE LEVEL	22 KV

COMMENT	No Partial discharge (PD) was found.
EVALUATION	Normal
SUGGESTION	No action
TESTED AND REPORTED BY	Mr.Tukdanai Pothanak
APPROVED BY	Mr.Chanvit Crukaew

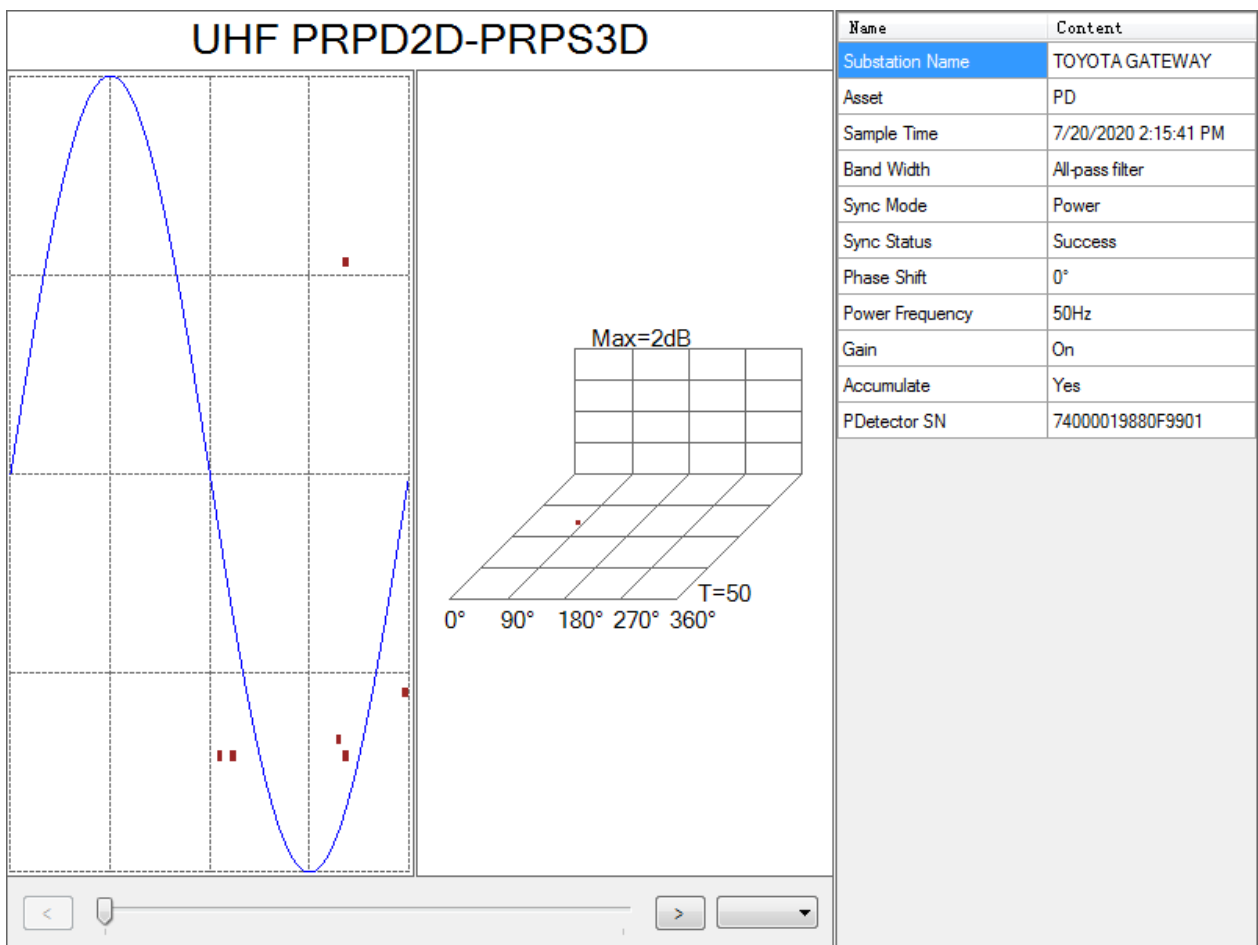
COSTOMER	TOYOTA GATEWAY (THAILAND) CO.,LTD.
SUBSTATION	GIS
POSITION	FOR STR ANCLVAC DISTR BUTION BOX
VOLTAGE LEVEL	22 KV

COMMENT	No Partial discharge (PD) was found.
EVALUATION	Normal
SUGGESTION	No action
TESTED AND REPORTED BY	Mr.Tukdanai Pothanak
APPROVED BY	Mr.Chanvit Crukaew

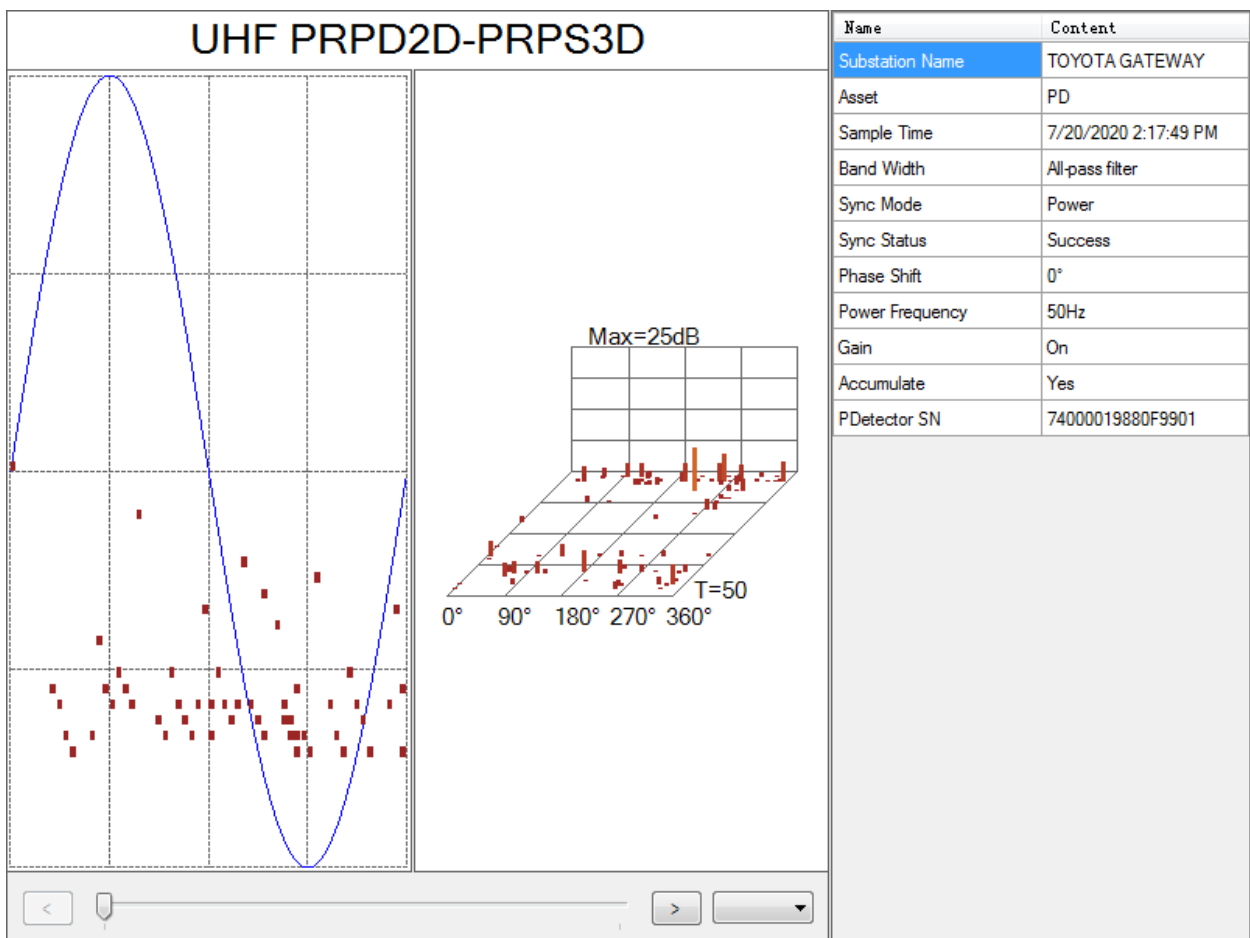
COSTOMER	TOYOTA GATEWAY (THAILAND) CO.,LTD.
SUBSTATION	GIS
POSITION	TO SS-ADMIN
VOLTAGE LEVEL	22 KV

COMMENT	No Partial discharge (PD) was found.
EVALUATION	Normal
SUGGESTION	No action
TESTED AND REPORTED BY	Mr.Tukdanai Pothanak
APPROVED BY	Mr.Chanvit Crukaew

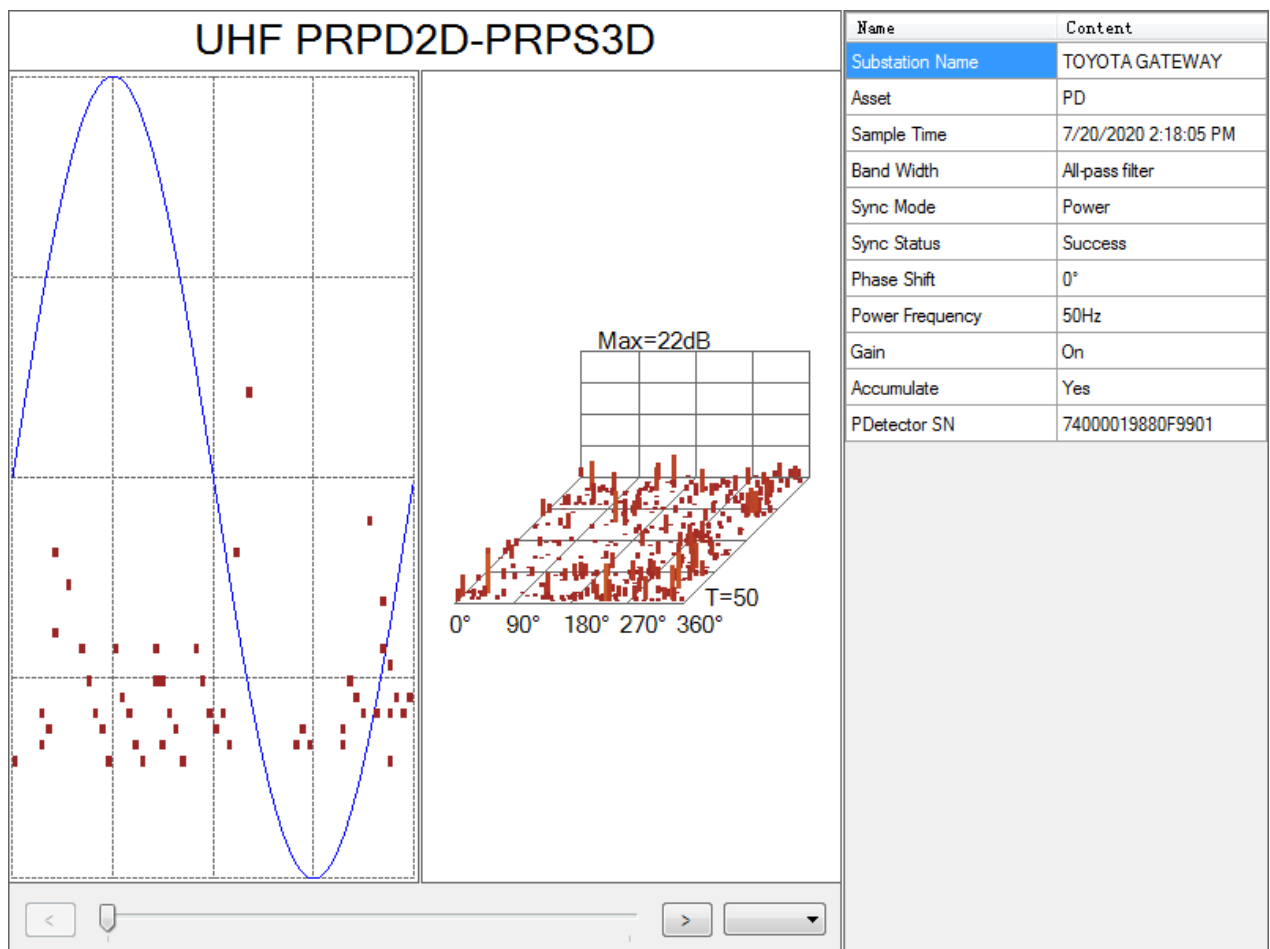
COSTOMER	TOYOTA GATEWAY (THAILAND) CO.,LTD.
SUBSTATION	GIS
POSITION	FROM TR 115/22 KV
VOLTAGE LEVEL	22 KV

COMMENT	No Partial discharge (PD) was found.
EVALUATION	Normal
SUGGESTION	No action
TESTED AND REPORTED BY	Mr.Tukdanai Pothanak
APPROVED BY	Mr.Chanvit Crukaew

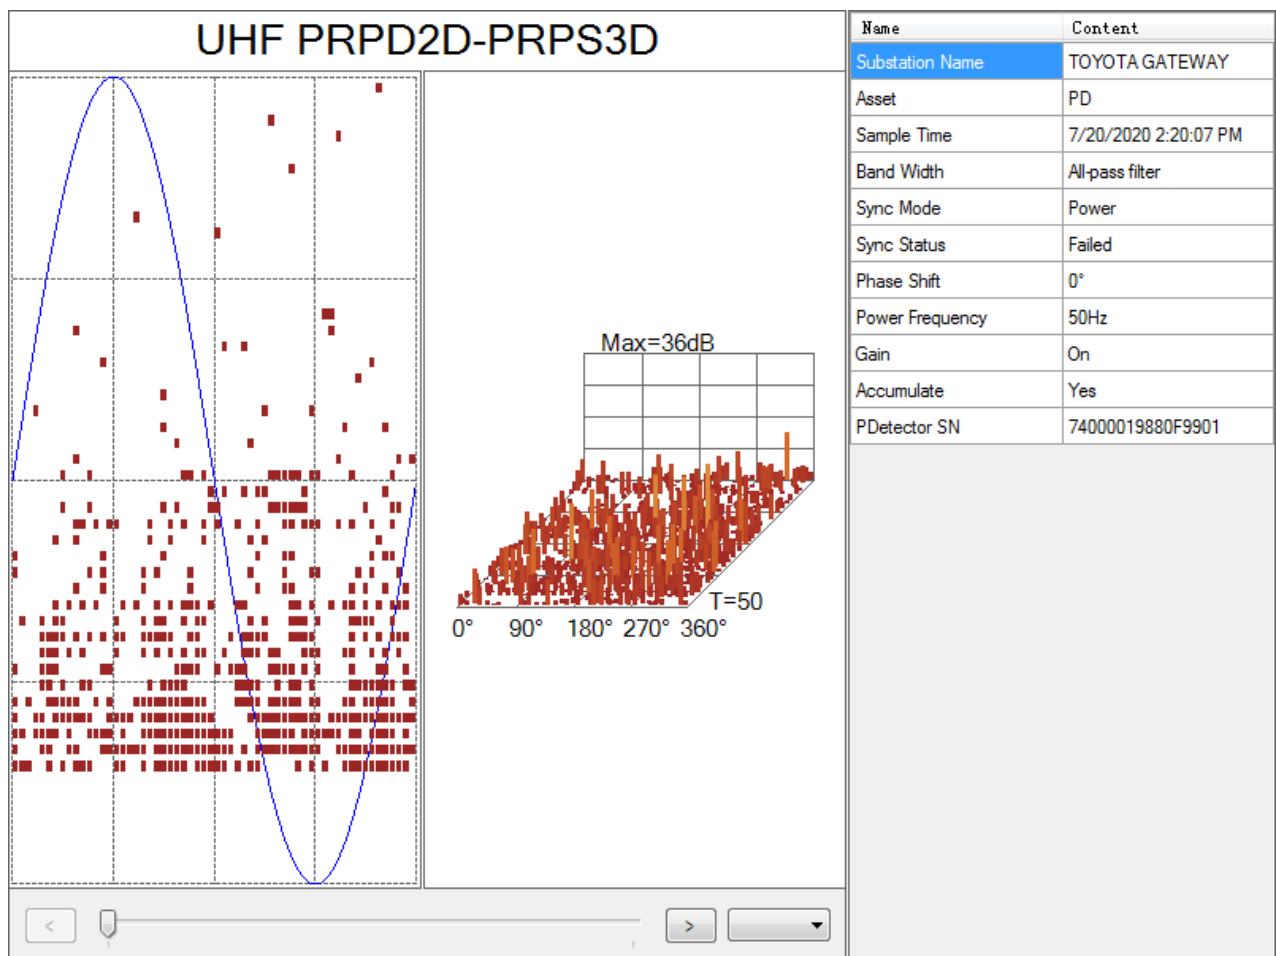
COSTOMER	TOYOTA GATEWAY (THAILAND) CO.,LTD.
SUBSTATION	GIS
POSITION	DT GAS TR.1
VOLTAGE LEVEL	22 KV

COMMENT	No Partial discharge (PD) was found.
EVALUATION	Normal
SUGGESTION	No action
TESTED AND REPORTED BY	Mr.Tukdanai Pothanak
APPROVED BY	Mr.Chanvit Crukaew

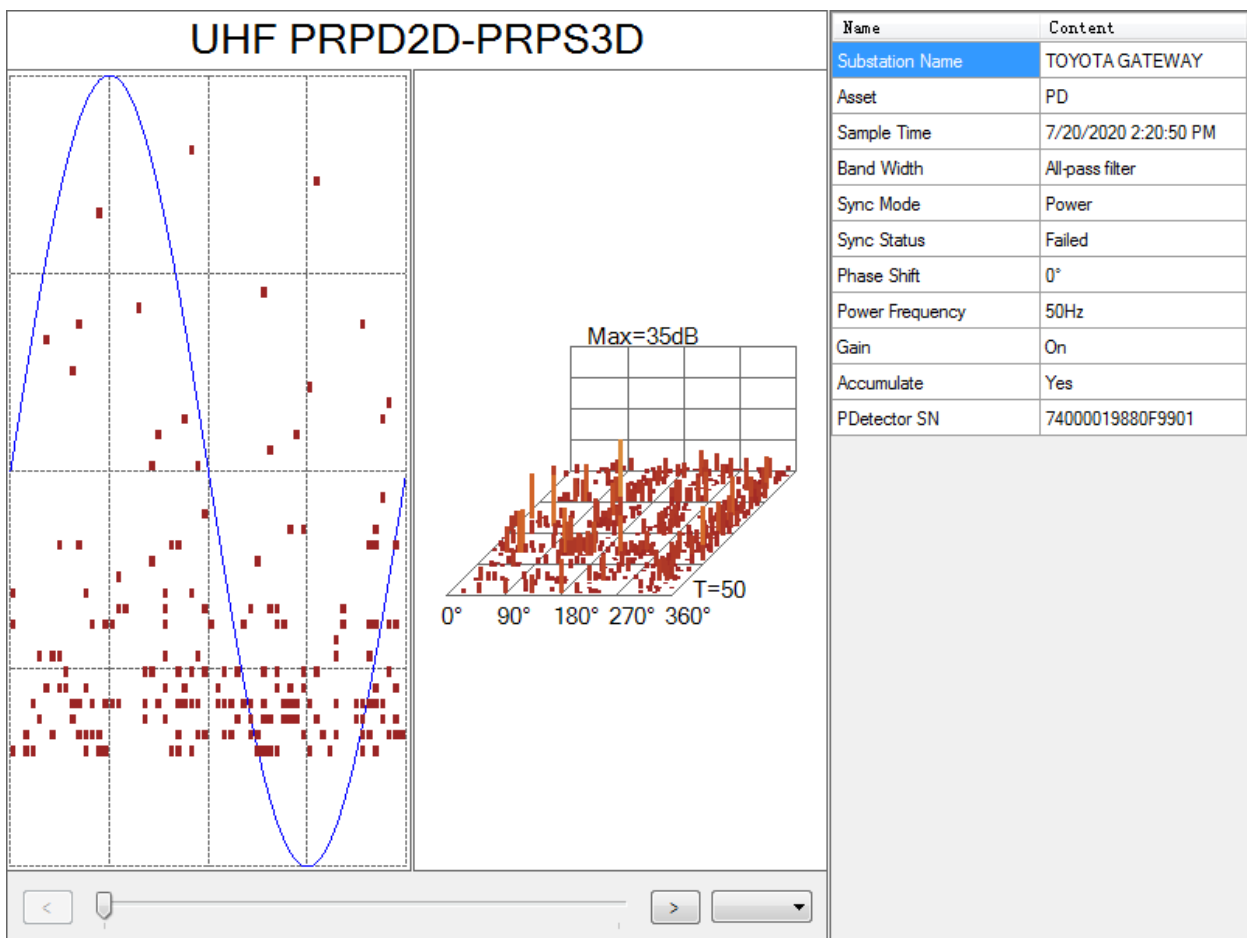
COSTOMER	TOYOTA GATEWAY (THAILAND) CO.,LTD.
SUBSTATION	GIS
POSITION	DT GAS TR.1
VOLTAGE LEVEL	22 KV

COMMENT	No Partial discharge (PD) was found.
EVALUATION	Normal
SUGGESTION	No action
TESTED AND REPORTED BY	Mr.Tukdanai Pothanak
APPROVED BY	Mr.Chanvit Crukaew

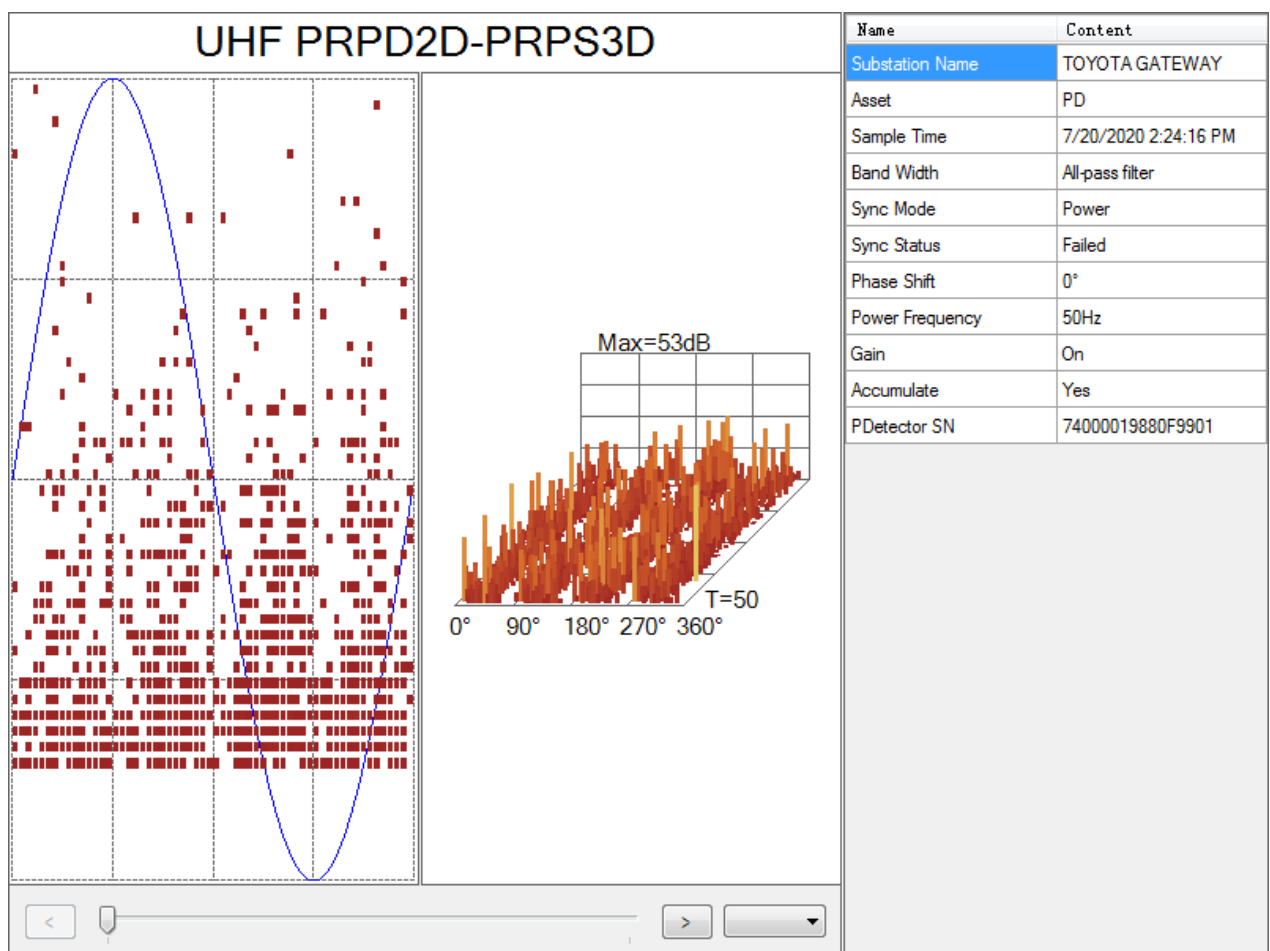
COSTOMER	TOYOTA GATEWAY (THAILAND) CO.,LTD.
SUBSTATION	GIS
POSITION	INCOMING CABLE BOX
VOLTAGE LEVEL	22 KV

COMMENT	No Partial discharge (PD) was found.
EVALUATION	Normal
SUGGESTION	No action
TESTED AND REPORTED BY	Mr.Tukdanai Pothanak
APPROVED BY	Mr.Chanvit Crukaew

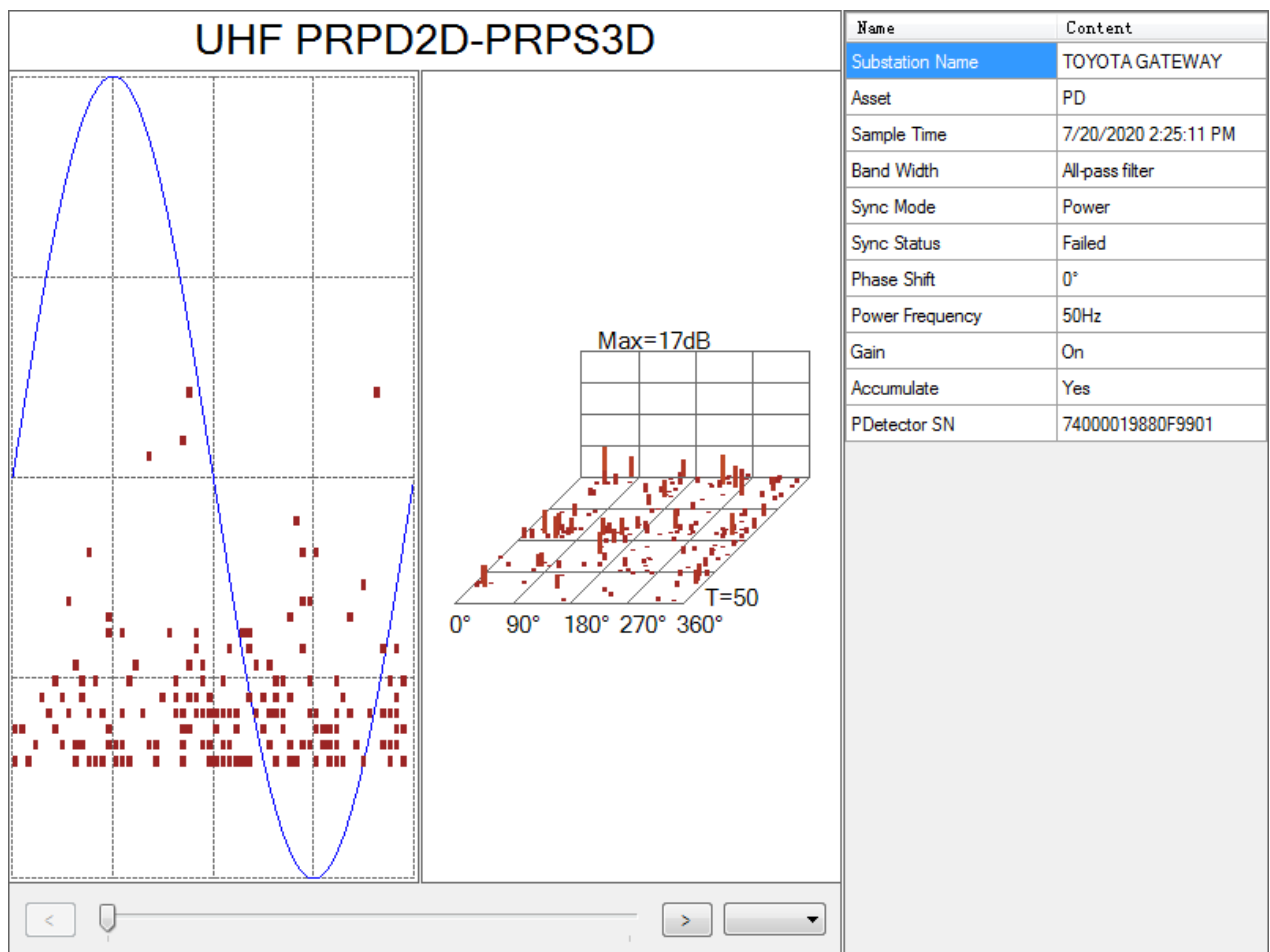
COSTOMER	TOYOTA GATEWAY (THAILAND) CO.,LTD.
SUBSTATION	GIS
POSITION	CAPACITOR BOX NO.4
VOLTAGE LEVEL	22 KV

COMMENT	No Partial discharge (PD) was found.
EVALUATION	Normal
SUGGESTION	No action
TESTED AND REPORTED BY	Mr.Tukdanai Pothanak
APPROVED BY	Mr.Chanvit Crukaew

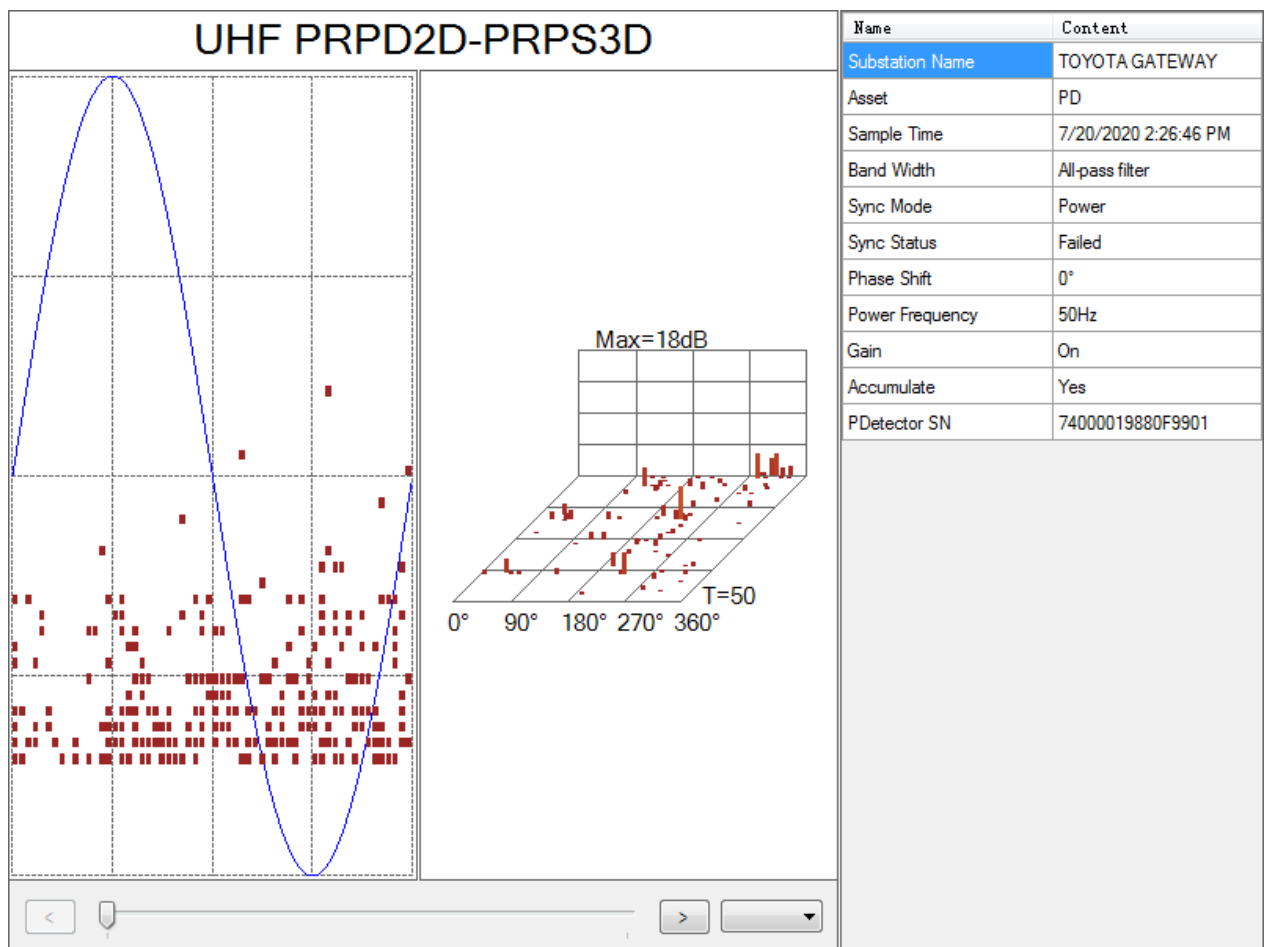
COSTOMER	TOYOTA GATEWAY (THAILAND) CO.,LTD.
SUBSTATION	GIS
POSITION	CAPACITOR BOX NO.3
VOLTAGE LEVEL	22 KV

COMMENT	No Partial discharge (PD) was found.
EVALUATION	Normal
SUGGESTION	No action
TESTED AND REPORTED BY	Mr.Tukdanai Pothanak
APPROVED BY	Mr.Chanvit Crukaew

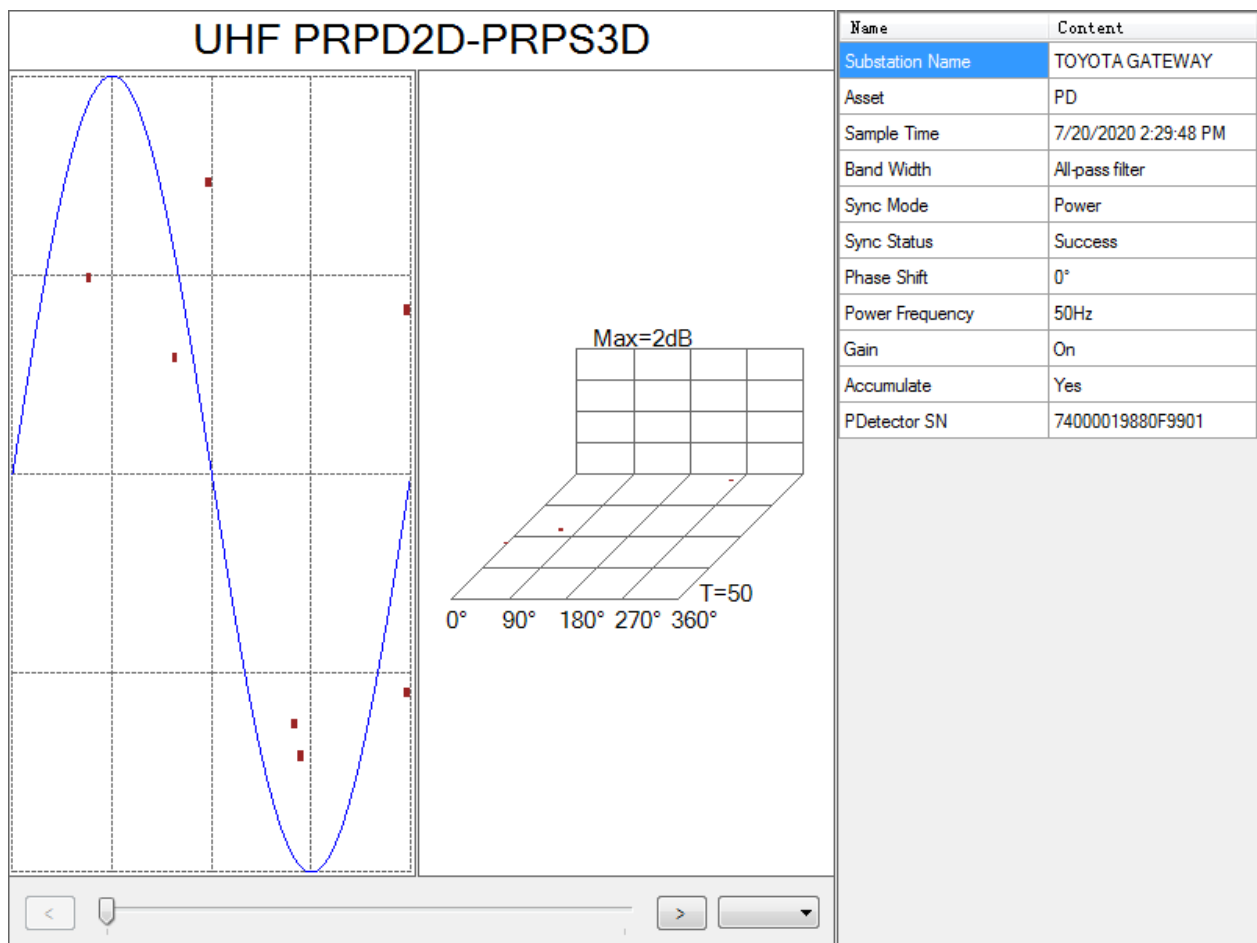
COSTOMER	TOYOTA GATEWAY (THAILAND) CO.,LTD.
SUBSTATION	GIS
POSITION	INCOMING CABLE BOX
VOLTAGE LEVEL	22 KV

COMMENT	No Partial discharge (PD) was found.
EVALUATION	Normal
SUGGESTION	No action
TESTED AND REPORTED BY	Mr.Tukdanai Pothanak
APPROVED BY	Mr.Chanvit Crukaew

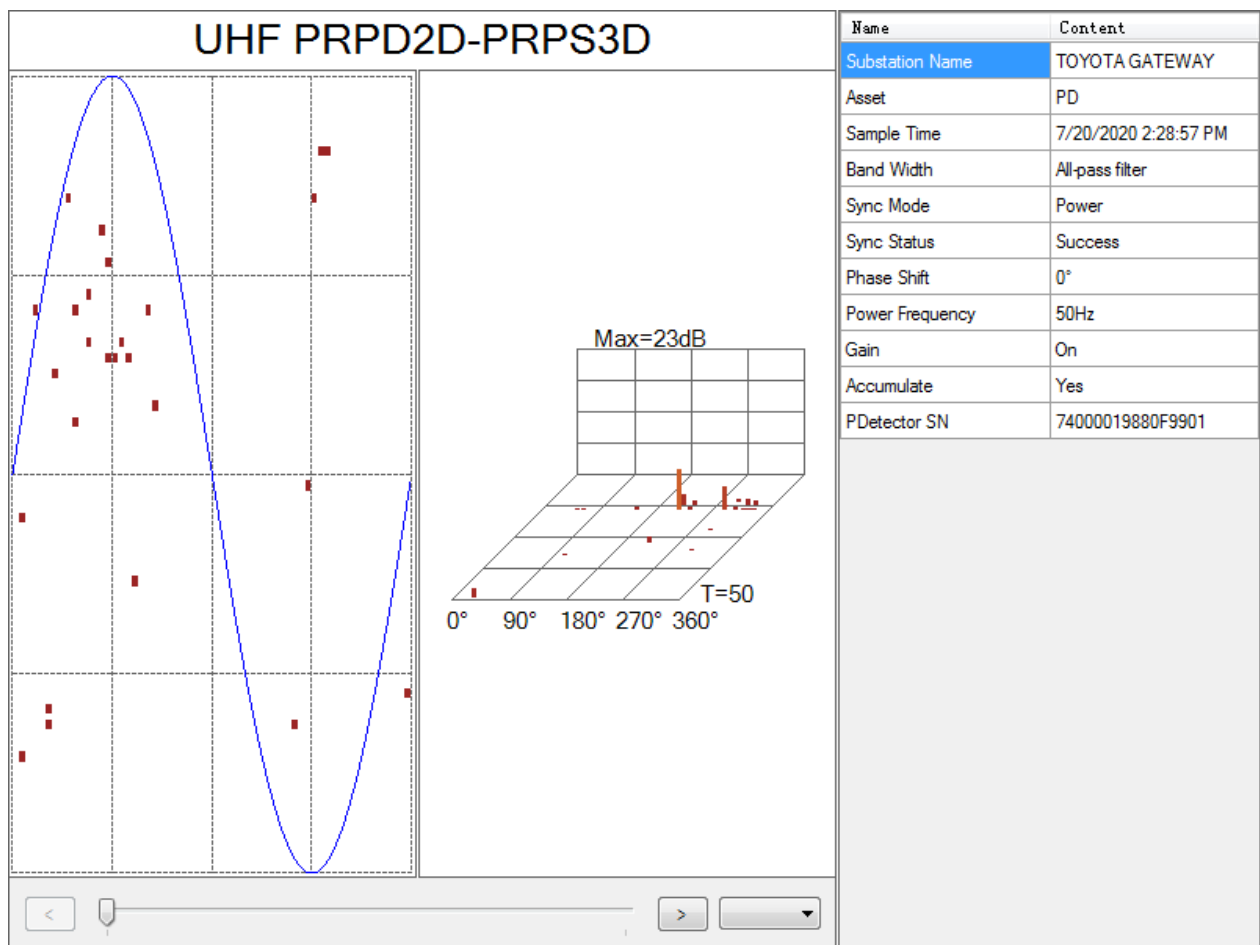
COSTOMER	TOYOTA GATEWAY (THAILAND) CO.,LTD.
SUBSTATION	GIS
POSITION	CAPACITOR BOX NO.2
VOLTAGE LEVEL	22 KV

COMMENT	No Partial discharge (PD) was found.
EVALUATION	Normal
SUGGESTION	No action
TESTED AND REPORTED BY	Mr.Tukdanai Pothanak
APPROVED BY	Mr.Chanvit Crukaew

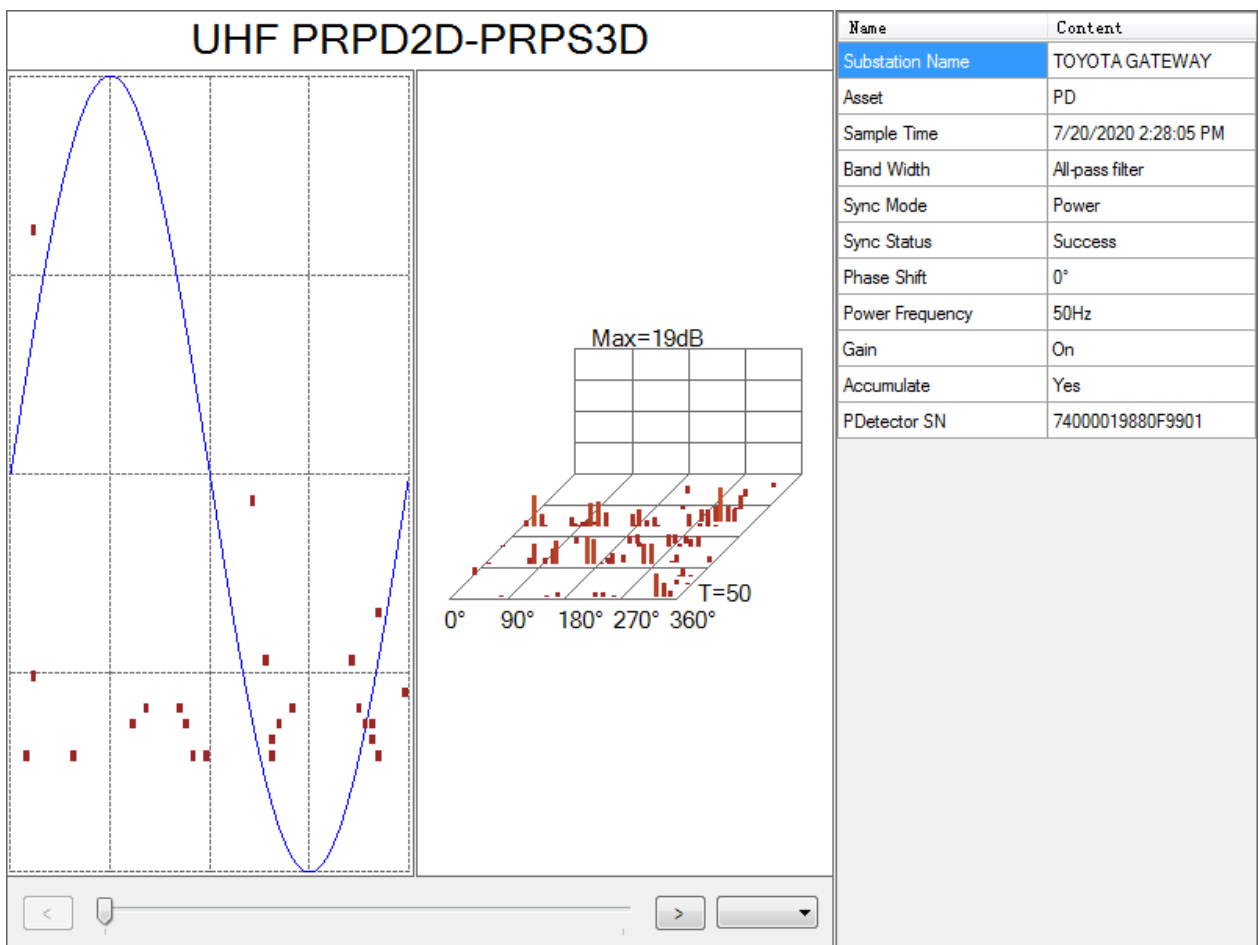
COSTOMER	TOYOTA GATEWAY (THAILAND) CO.,LTD.
SUBSTATION	GIS
POSITION	CAPACITOR BOX NO.1
VOLTAGE LEVEL	22 KV

COMMENT	No Partial discharge (PD) was found.
EVALUATION	Normal
SUGGESTION	No action
TESTED AND REPORTED BY	Mr.Tukdanai Pothanak
APPROVED BY	Mr.Chanvit Crukaew

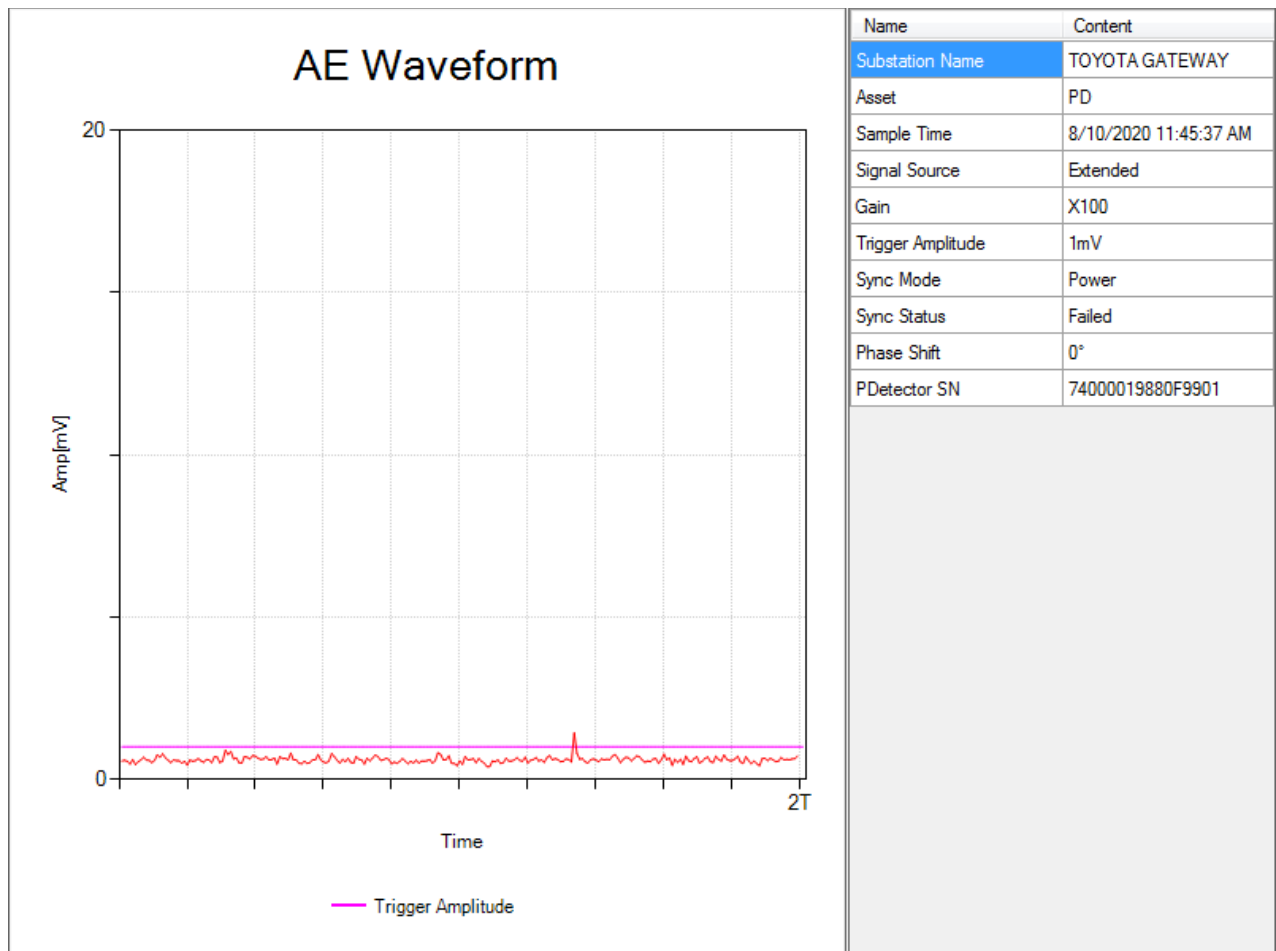
COSTOMER	TOYOTA GATEWAY (THAILAND) CO.,LTD.
SUBSTATION	GIS
POSITION	NO.BANK BUS VT (BACK PANEL)
VOLTAGE LEVEL	22KV

COMMENT	No Partial discharge (PD) was found.
EVALUATION	Normal
SUGGESTION	No action
TESTED AND REPORTED BY	Mr.Tukdanai Pothanak
APPROVED BY	Mr.Chanvit Crukaew

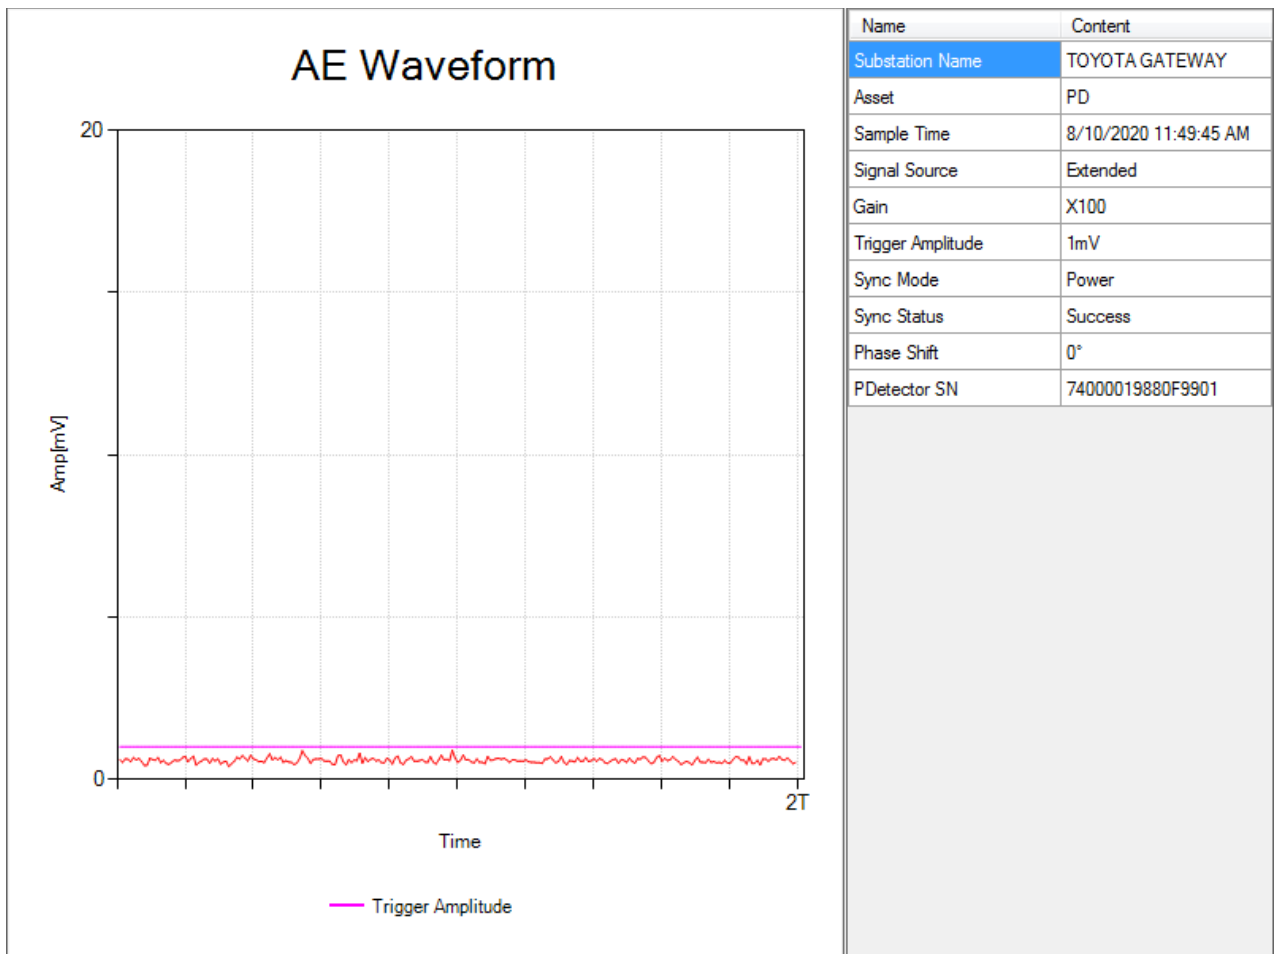
COSTOMER	TOYOTA GATEWAY (THAILAND) CO.,LTD.
SUBSTATION	GIS
POSITION	NO.BANK BUS VT (FRONT PANEL)
VOLTAGE LEVEL	22 KV

COMMENT	No Partial discharge (PD) was found.
EVALUATION	Normal
SUGGESTION	No action
TESTED AND REPORTED BY	Mr.Tukdanai Pothanak
APPROVED BY	Mr.Chanvit Crukaew

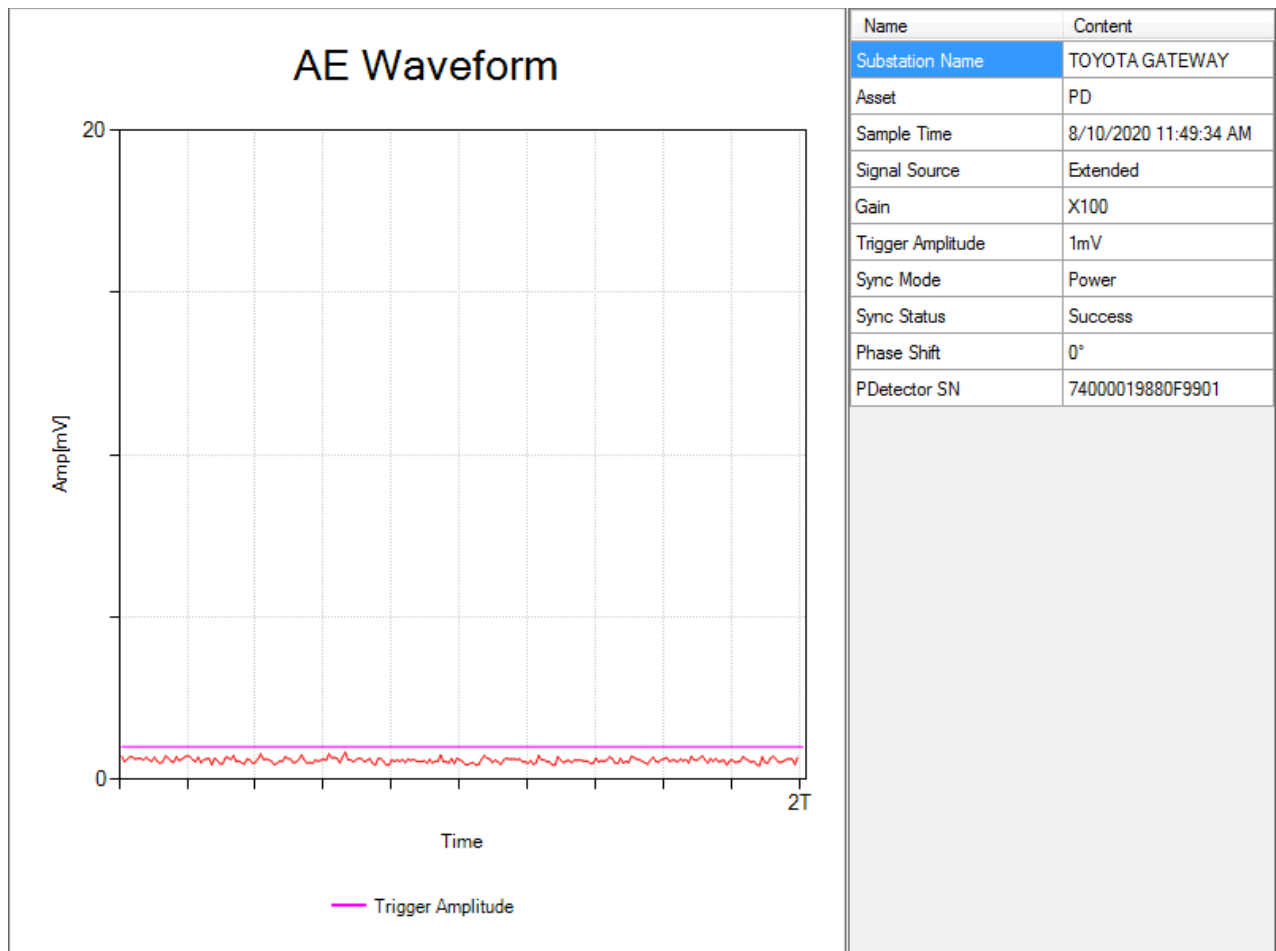
COSTOMER	TOYOTA GATEWAY (THAILAND) CO.,LTD.
SUBSTATION	GIS
POSITION	NO.1 TR.SEC FRONT PANEL
VOLTAGE LEVEL	22 KV

COMMENT	No Partial discharge (PD) was found.
EVALUATION	Normal
SUGGESTION	No action
TESTED AND REPORTED BY	Mr.Tukdanai Pothanak
APPROVED BY	Mr.Chanvit Crukaew

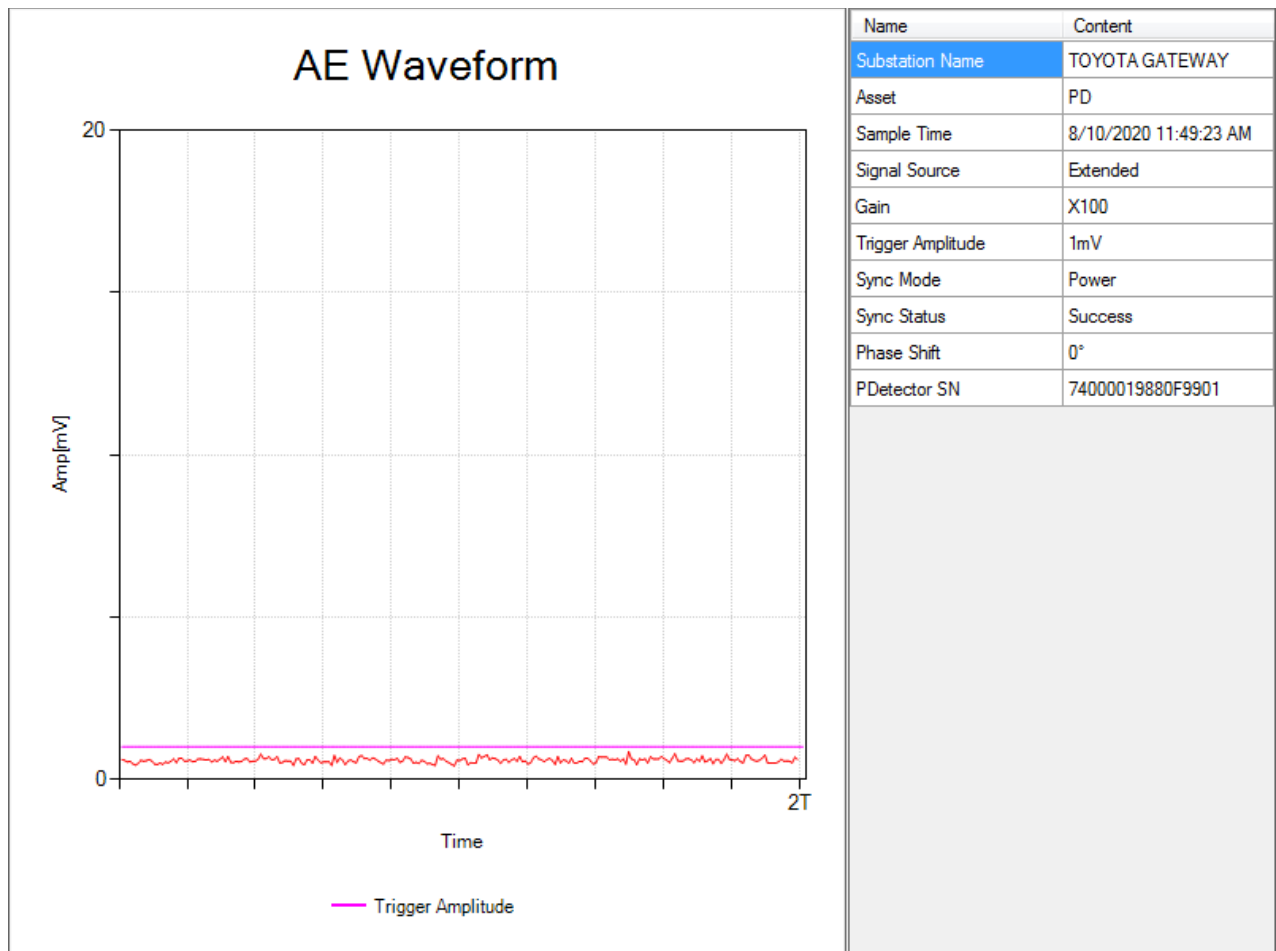
COSTOMER	TOYOTA GATEWAY (THAILAND) CO.,LTD.
SUBSTATION	GIS
POSITION	1-1 FEEDER FRONT PANEL
VOLTAGE LEVEL	22 KV

COMMENT	No Partial discharge (PD) was found.
EVALUATION	Normal
SUGGESTION	No action
TESTED AND REPORTED BY	Mr.Tukdanai Pothanak
APPROVED BY	Mr.Chanvit Crukaew
