PARTIAL DISCHARGE REPORT

CUSTOMER :CO.,LTD.

DATE : July 8th, 2020

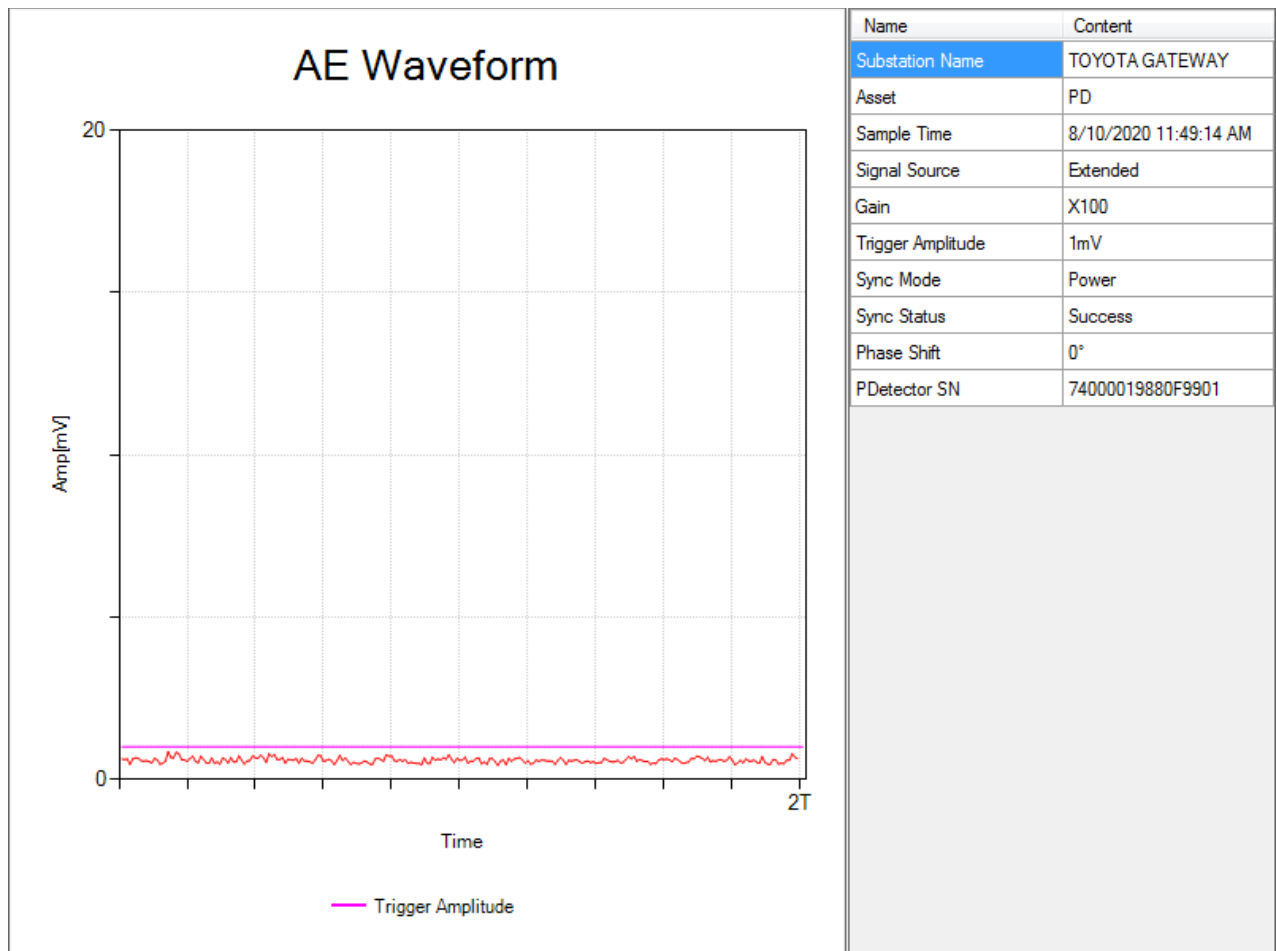
COSTOMER	TOYOTA GATEWAY (THAILAND) CO.,LTD.
SUBSTATION	GIS
POSITION	1-2 FEEDER (FRONT PANEL)
VOLTAGE LEVEL	22 KV

COMMENT	No Partial discharge (PD) was found.
EVALUATION	Normal
SUGGESTION	No action
TESTED AND REPORTED BY	Mr.Tukdanai Pothanak
APPROVED BY	Mr.Chanvit Crukaew

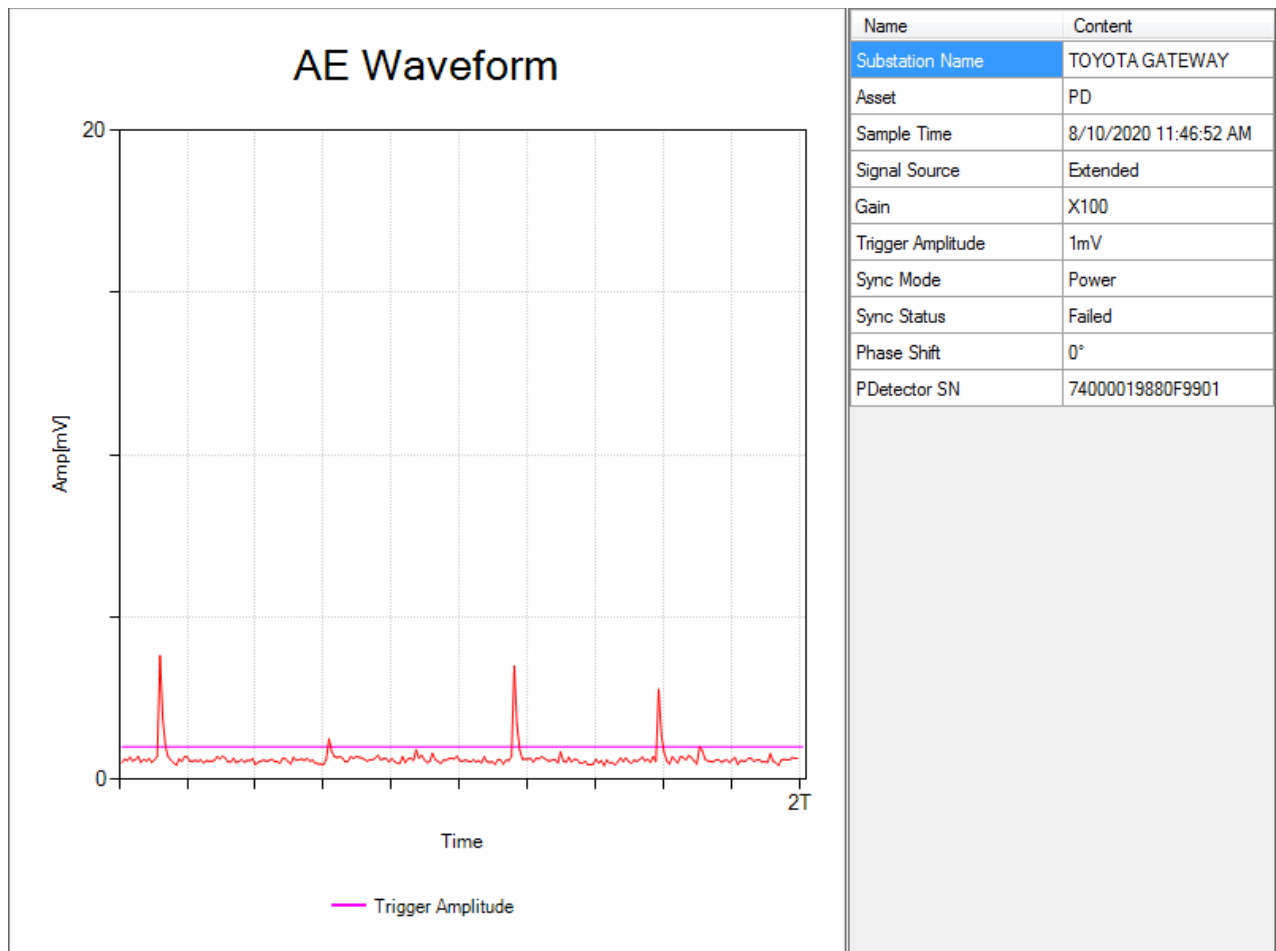
COSTOMER	TOYOTA GATEWAY (THAILAND) CO.,LTD.
SUBSTATION	GIS
POSITION	1-3 FEEDER (BACK PANEL)
VOLTAGE LEVEL	22 KV

COMMENT	Partial discharge (PD) was found.
EVALUATION	Warning
SUGGESTION	No action
TESTED AND REPORTED BY	Mr.Tukdanai Pothanak
APPROVED BY	Mr.Chanvit Crukaew

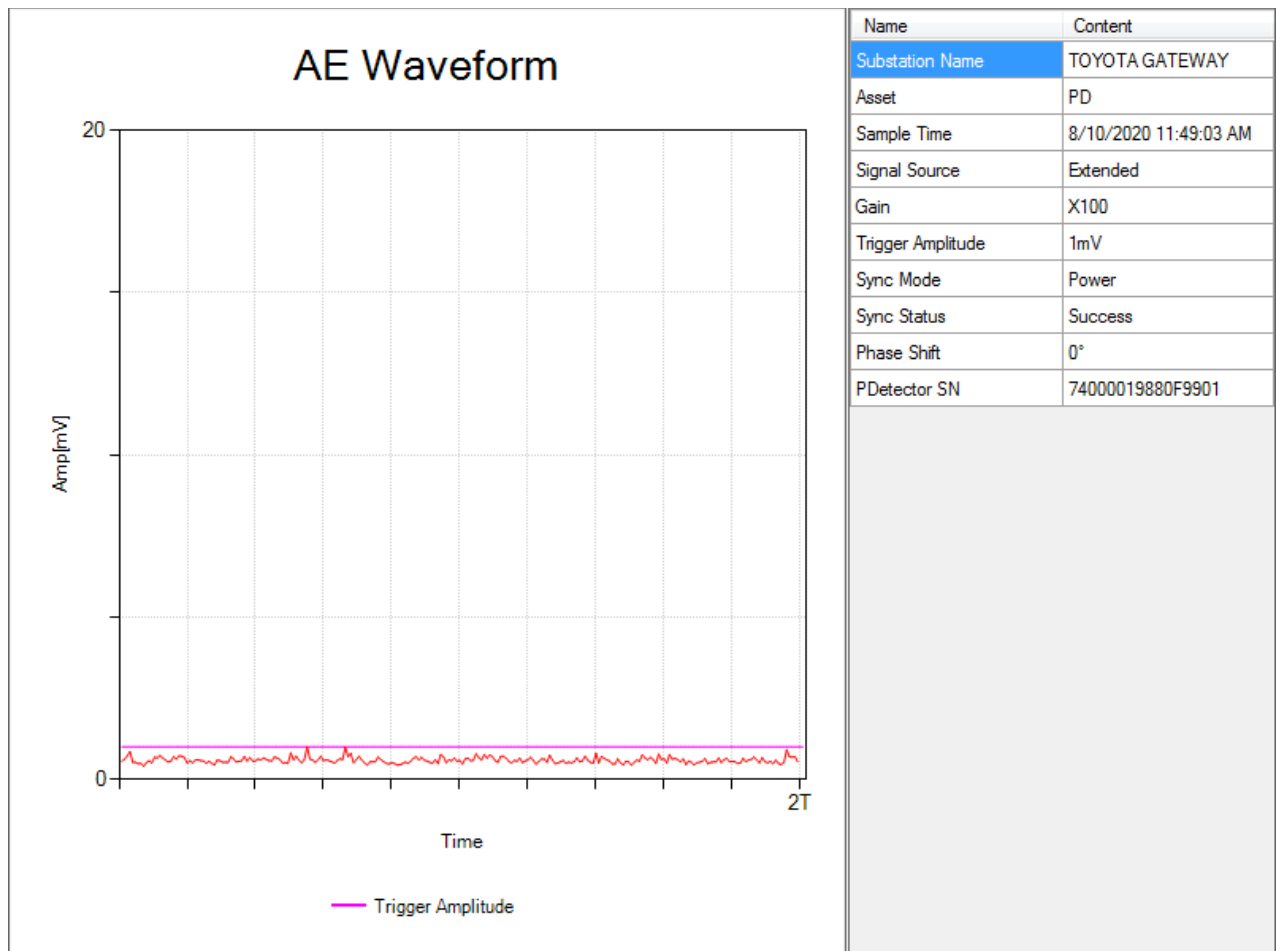
COSTOMER	TOYOTA GATEWAY (THAILAND) CO.,LTD.
SUBSTATION	GIS
POSITION	1-3 FEEDER (FRONT PANEL)
VOLTAGE LEVEL	22 KV

COMMENT	No Partial discharge (PD) was found.
EVALUATION	Normal
SUGGESTION	No action
TESTED AND REPORTED BY	Mr.Tukdanai Pothanak
APPROVED BY	Mr.Chanvit Crukaew

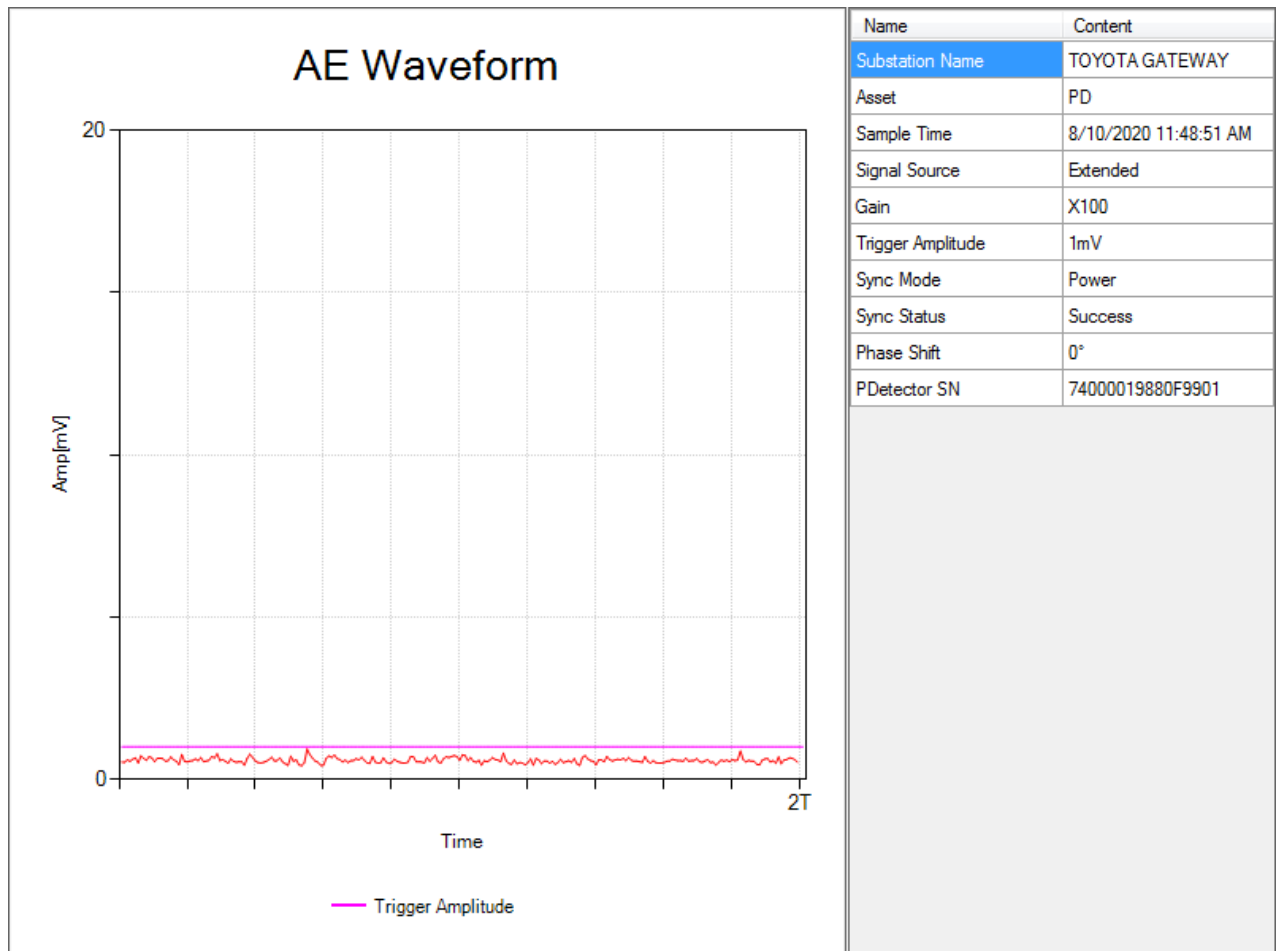
COSTOMER	TOYOTA GATEWAY (THAILAND) CO.,LTD.
SUBSTATION	GIS
POSITION	1-4 FEEDER (FRONT PANEL)
VOLTAGE LEVEL	22 KV

COMMENT	No Partial discharge (PD) was found.
EVALUATION	Normal
SUGGESTION	No action
TESTED AND REPORTED BY	Mr.Tukdanai Pothanak
APPROVED BY	Mr.Chanvit Crukaew

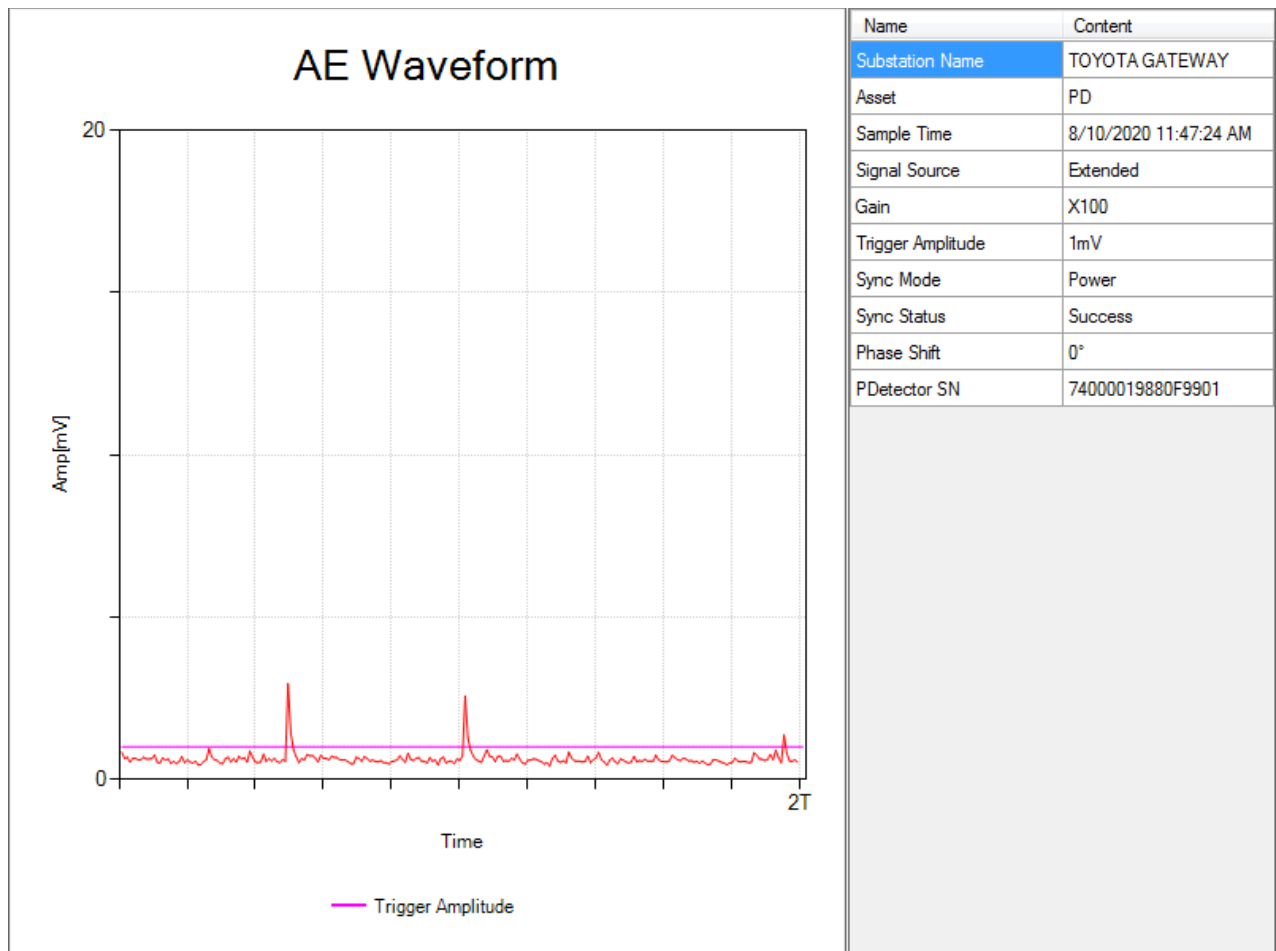
COSTOMER	TOYOTA GATEWAY (THAILAND) CO.,LTD.
SUBSTATION	GIS
POSITION	CAPACITOR (BACK PANEL)
VOLTAGE LEVEL	22 KV

COMMENT	Partial discharge (PD) was found.
EVALUATION	Warning
SUGGESTION	No action
TESTED AND REPORTED BY	Mr.Tukdanai Pothanak
APPROVED BY	Mr.Chanvit Crukaew

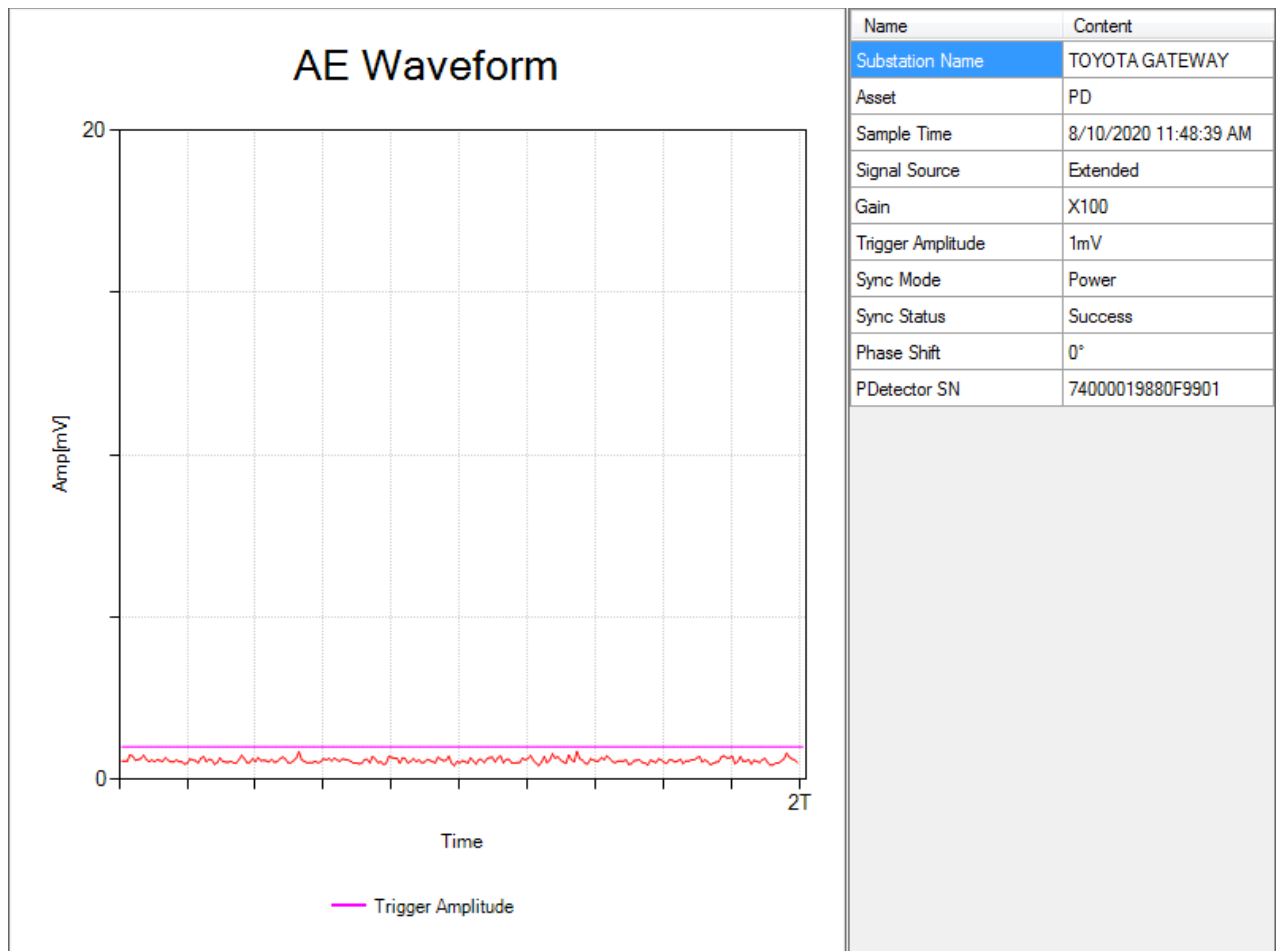
COSTOMER	TOYOTA GATEWAY (THAILAND) CO.,LTD.
SUBSTATION	GIS
POSITION	CAPACITOR (FRONT PANEL)
VOLTAGE LEVEL	22 KV

COMMENT	No Partial discharge (PD) was found.
EVALUATION	Normal
SUGGESTION	No action
TESTED AND REPORTED BY	Mr.Tukdanai Pothanak
APPROVED BY	Mr.Chanvit Crukaew

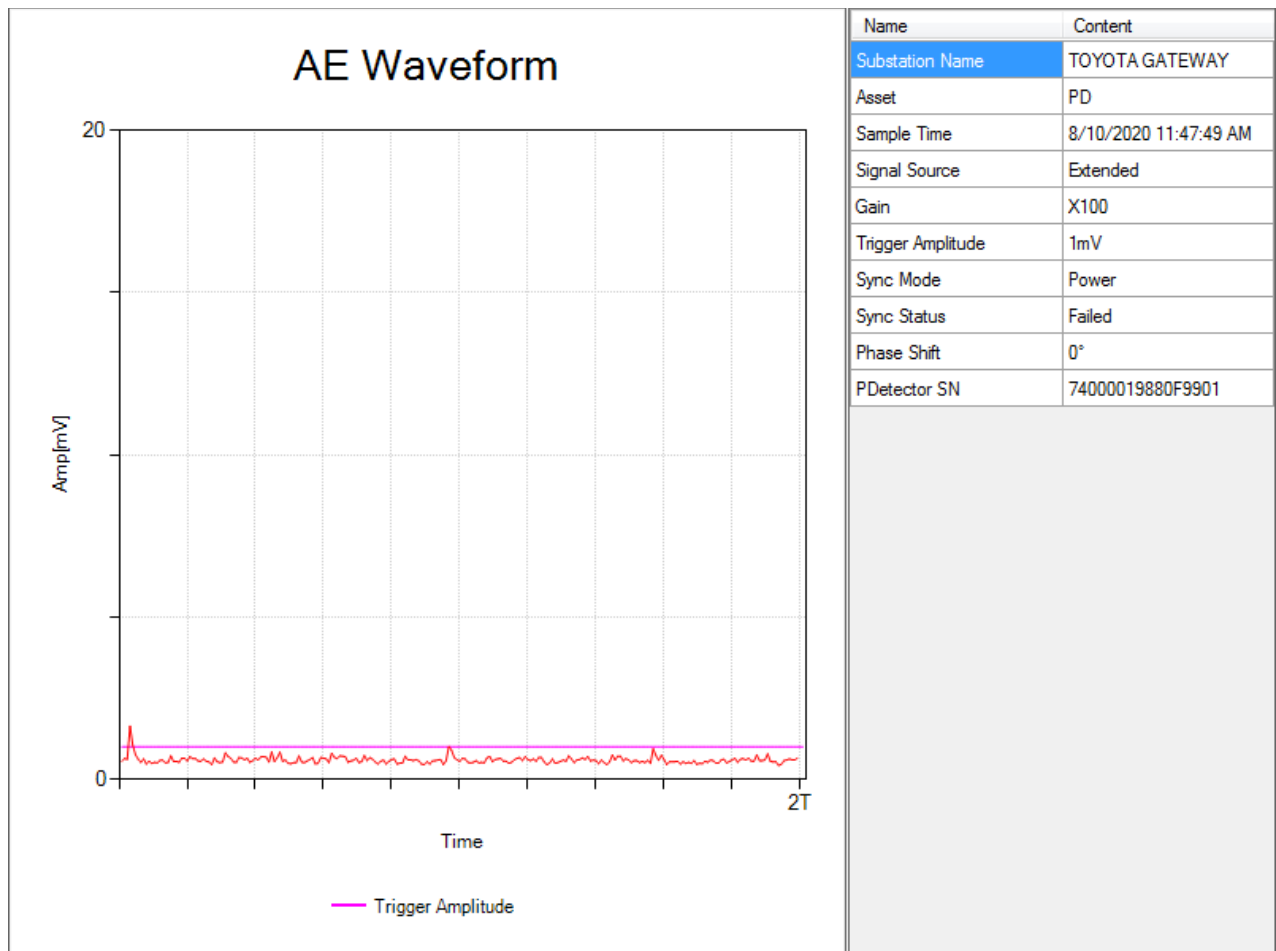
COSTOMER	TOYOTA GATEWAY (THAILAND) CO.,LTD.
SUBSTATION	GIS
POSITION	STATION TR (BACK PANEL)
VOLTAGE LEVEL	22 KV

COMMENT	No Partial discharge (PD) was found.
EVALUATION	Normal
SUGGESTION	No action
TESTED AND REPORTED BY	Mr.Tukdanai Pothanak
APPROVED BY	Mr.Chanvit Crukaew

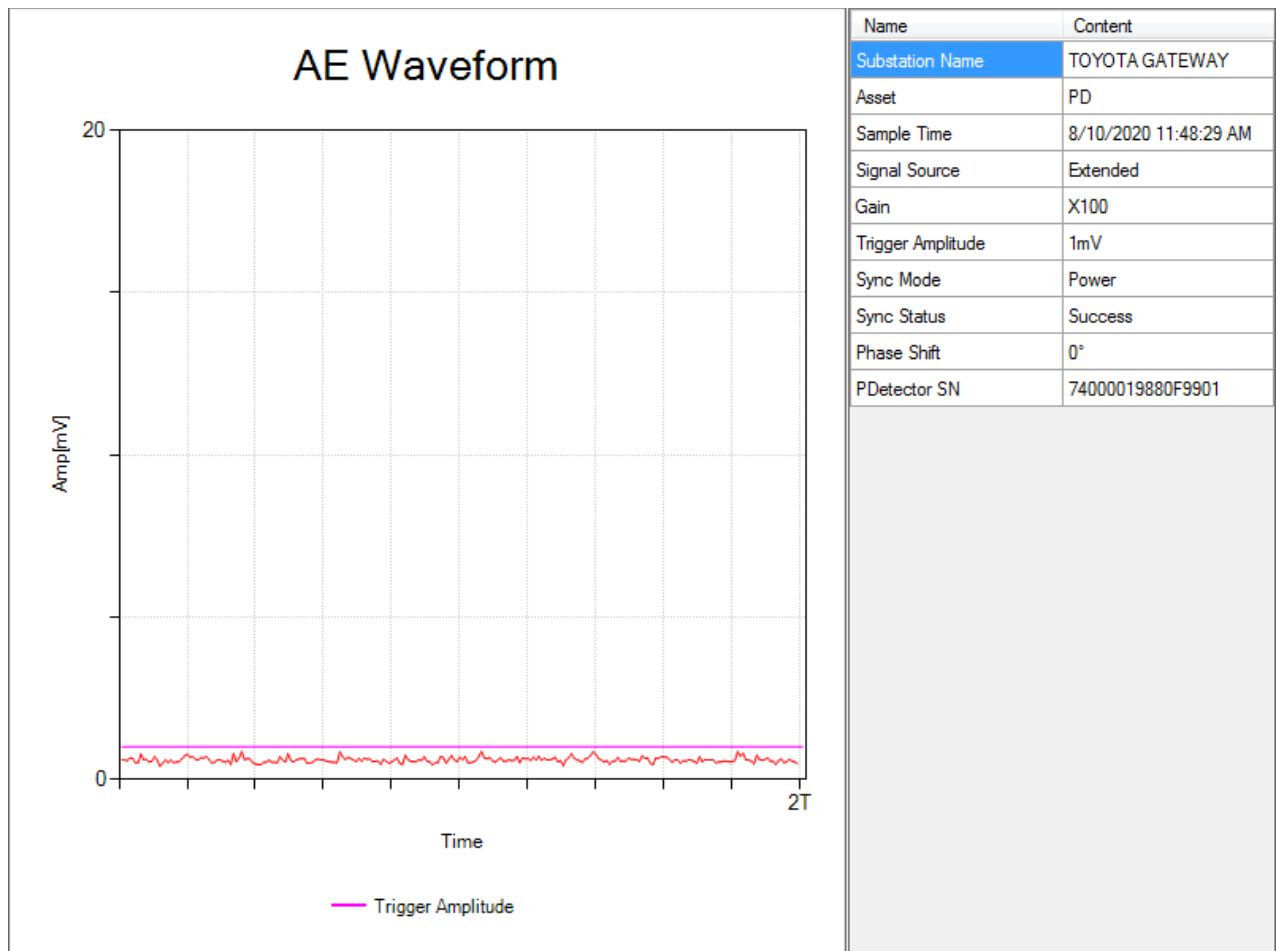
COSTOMER	TOYOTA GATEWAY (THAILAND) CO.,LTD.
SUBSTATION	GIS
POSITION	STATION TR (FRONT PANEL)
VOLTAGE LEVEL	22 KV

COMMENT	No Partial discharge (PD) was found.
EVALUATION	Normal
SUGGESTION	No action
TESTED AND REPORTED BY	Mr.Tukdanai Pothanak
APPROVED BY	Mr.Chanvit Crukaew

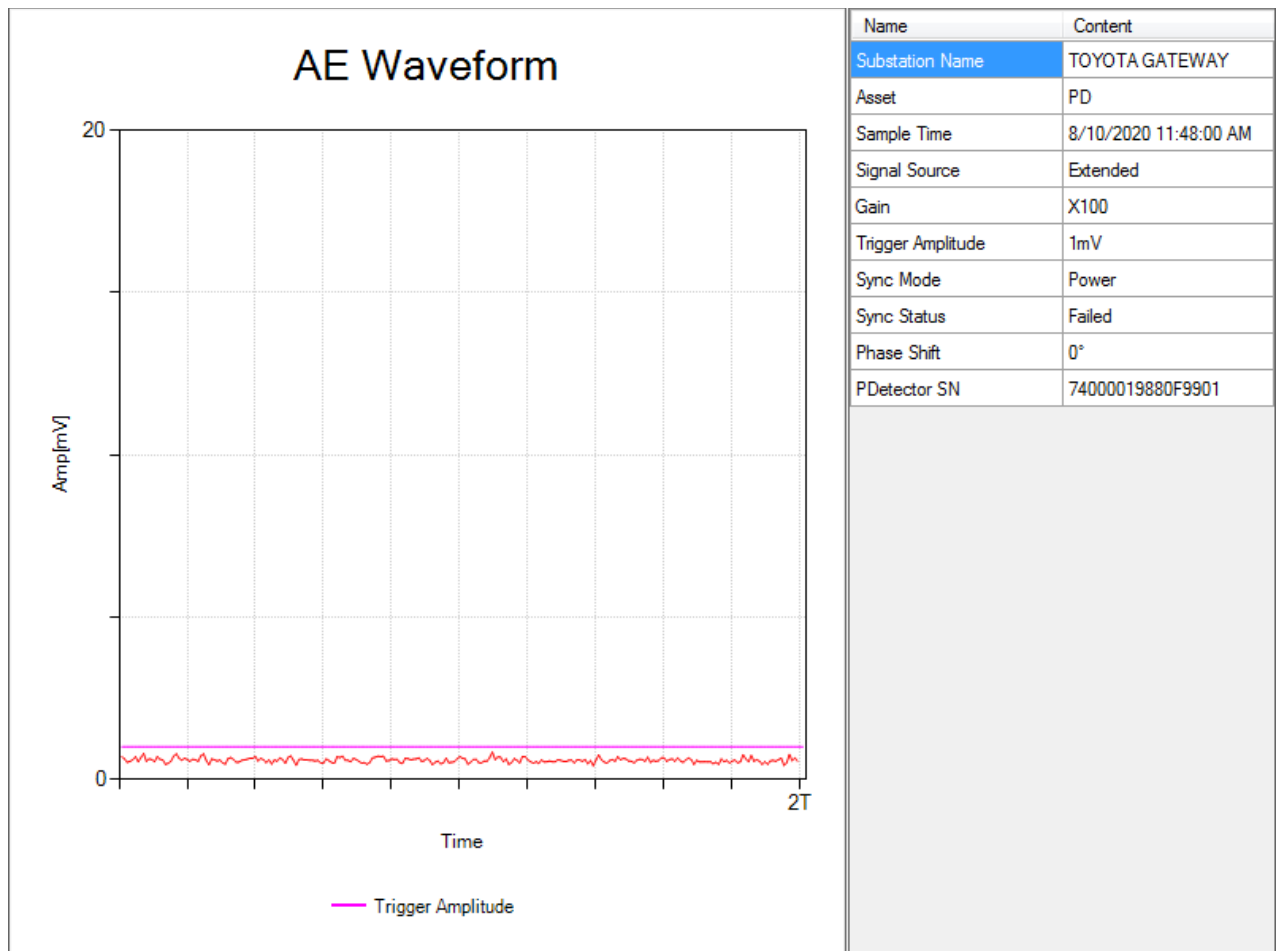
COSTOMER	TOYOTA GATEWAY (THAILAND) CO.,LTD.
SUBSTATION	GIS
POSITION	NO.2BANK BUS-TLE (BACK PANEL)
VOLTAGE LEVEL	22 KV

COMMENT	No Partial discharge (PD) was found.
EVALUATION	Normal
SUGGESTION	No action
TESTED AND REPORTED BY	Mr.Tukdanai Pothanak
APPROVED BY	Mr.Chanvit Crukaew

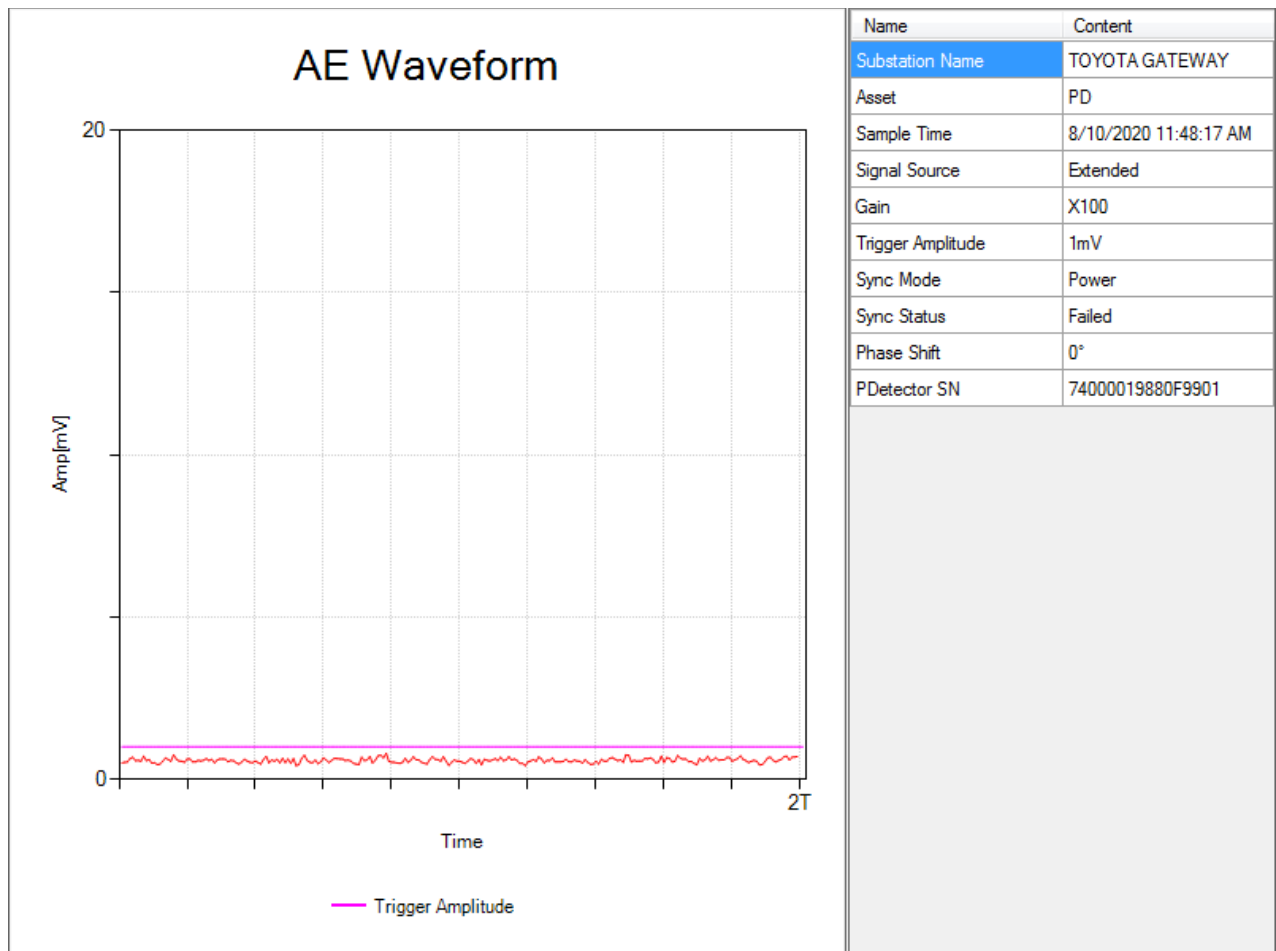
COSTOMER	TOYOTA GATEWAY (THAILAND) CO.,LTD.
SUBSTATION	GIS
POSITION	NO.2BANK BUS-TLE (FRONT PANEL)
VOLTAGE LEVEL	22 KV

COMMENT	No Partial discharge (PD) was found.
EVALUATION	Normal
SUGGESTION	No action
TESTED AND REPORTED BY	Mr.Tukdanai Pothanak
APPROVED BY	Mr.Chanvit Crukaew

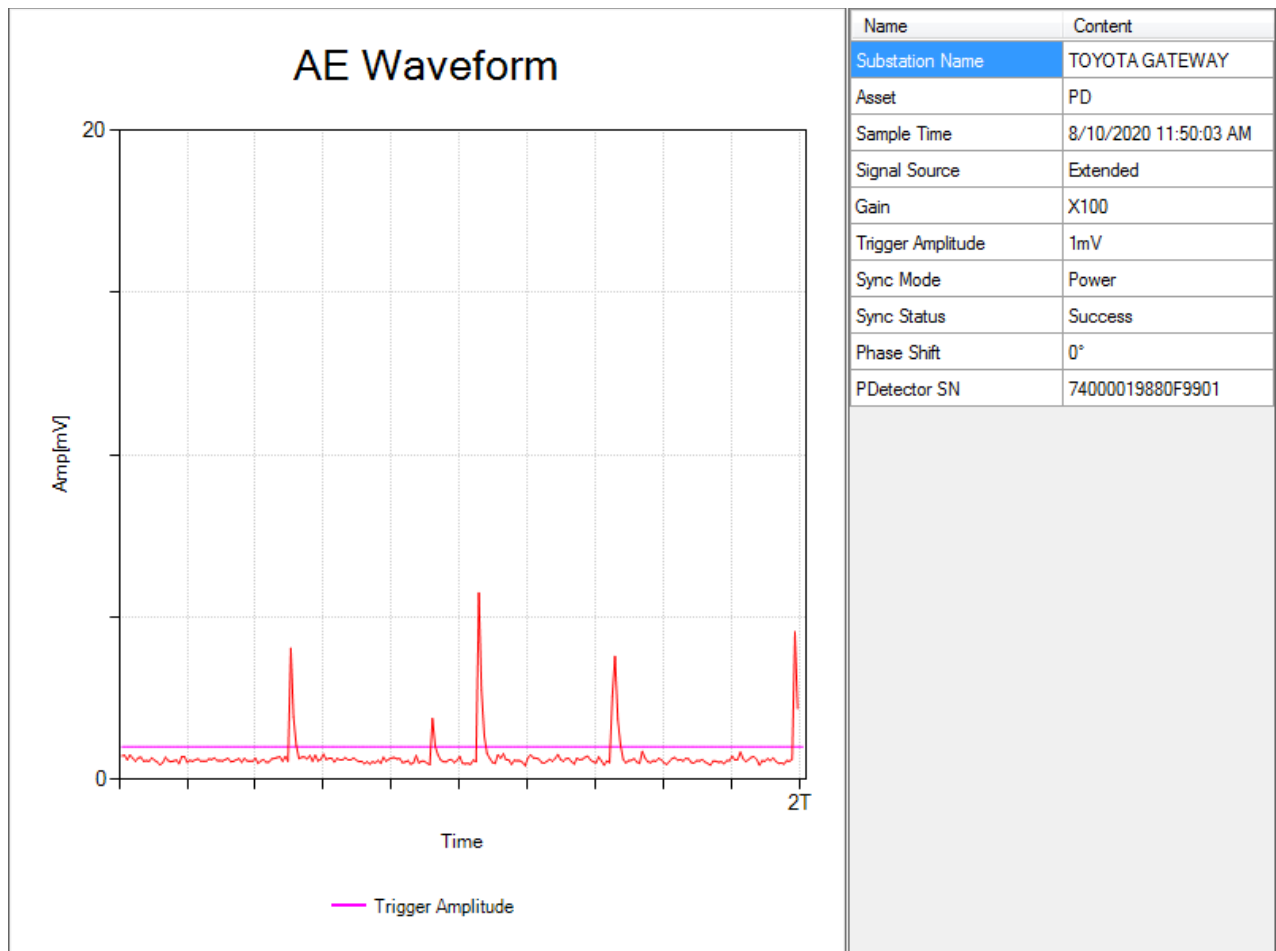
COSTOMER	TOYOTA GATEWAY (THAILAND) CO.,LTD.
SUBSTATION	GIS
POSITION	22 KV GIS NO.2 BANK BUS VT (BACK PANEL)
VOLTAGE LEVEL	22 KV

COMMENT	Partial discharge (PD) was found.
EVALUATION	Warning
SUGGESTION	The partial discharge should be inspected in the next year.
TESTED AND REPORTED BY	Mr.Tukdanai Pothanak
APPROVED BY	Mr.Chanvit Crukaew

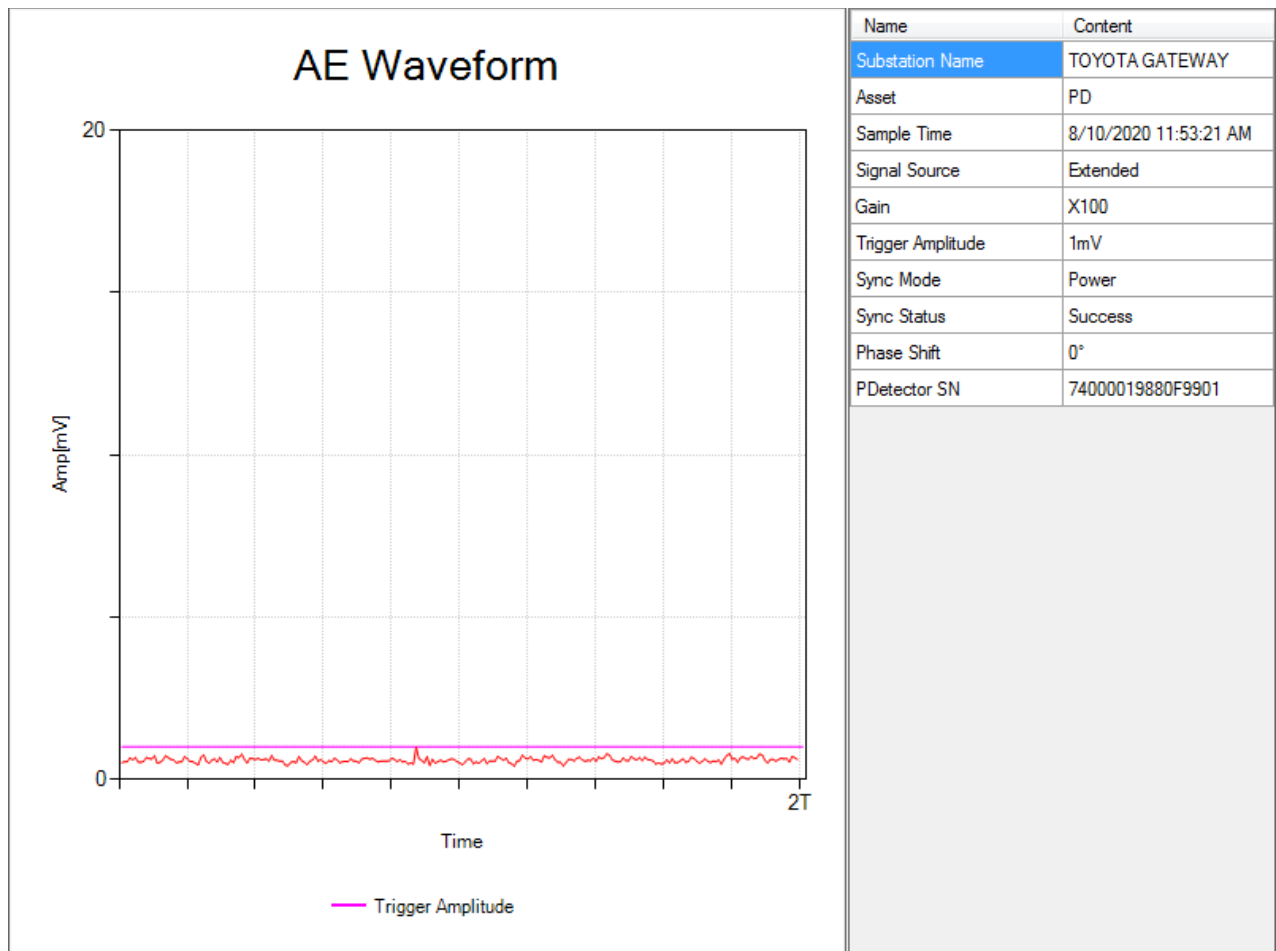
COSTOMER	TOYOTA GATEWAY (THAILAND) CO.,LTD.
SUBSTATION	GIS
POSITION	NO2 BANK BUS VT (FRONT PANEL)
VOLTAGE LEVEL	22 KV

COMMENT	No Partial discharge (PD) was found.
EVALUATION	Normal
SUGGESTION	No action
TESTED AND REPORTED BY	Mr.Tukdanai Pothanak
APPROVED BY	Mr.Chanvit Crukaew

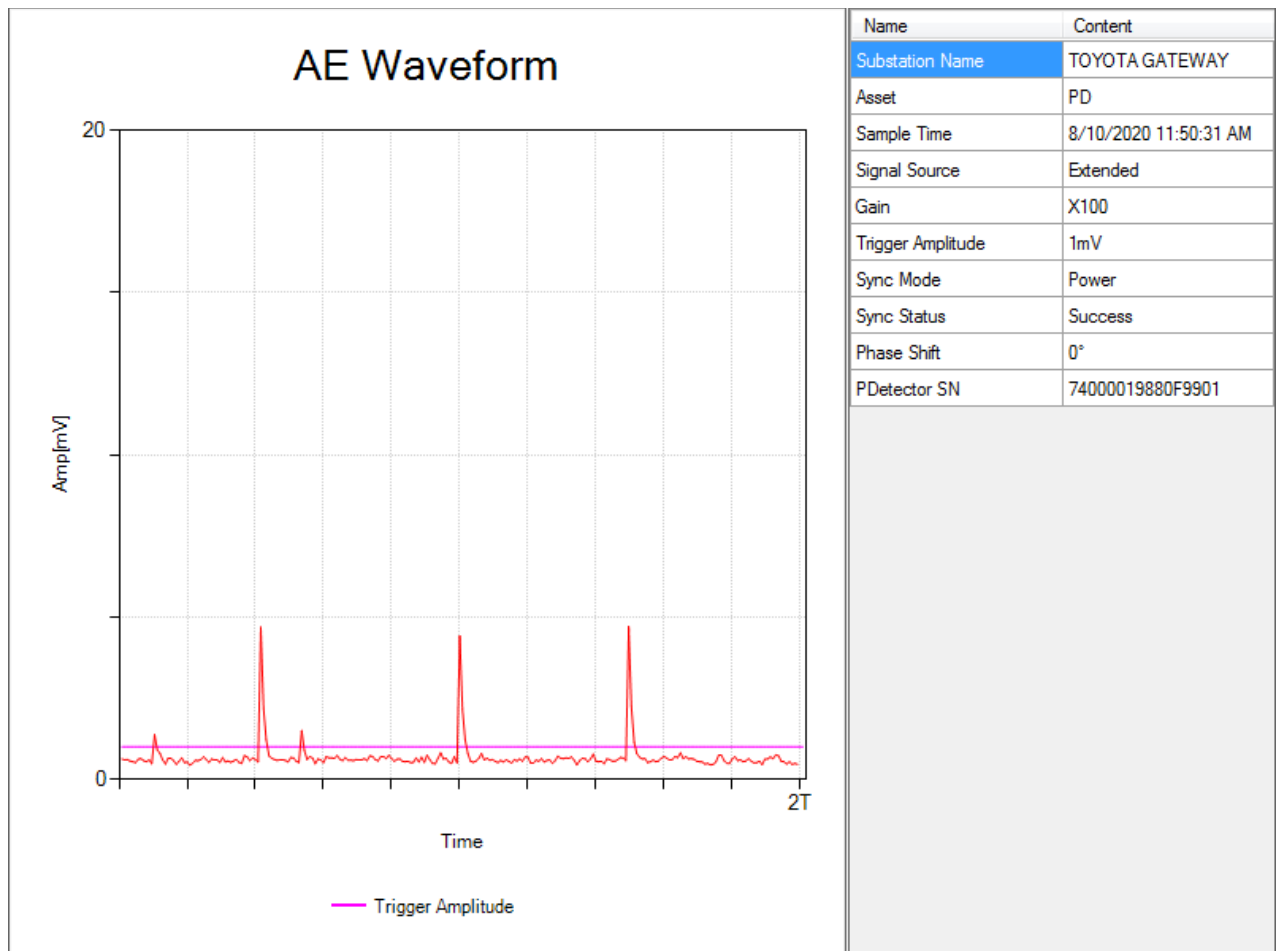
COSTOMER	TOYOTA GATEWAY (THAILAND) CO.,LTD.
SUBSTATION	GIS
POSITION	TR2 TR SEC (BACK PANEL)
VOLTAGE LEVEL	22 KV

COMMENT	Partial discharge (PD) was found.
EVALUATION	Warning
SUGGESTION	The partial discharge should be inspected in the next year.
TESTED AND REPORTED BY	Mr.Tukdanai Pothanak
APPROVED BY	Mr.Chanvit Crukaew

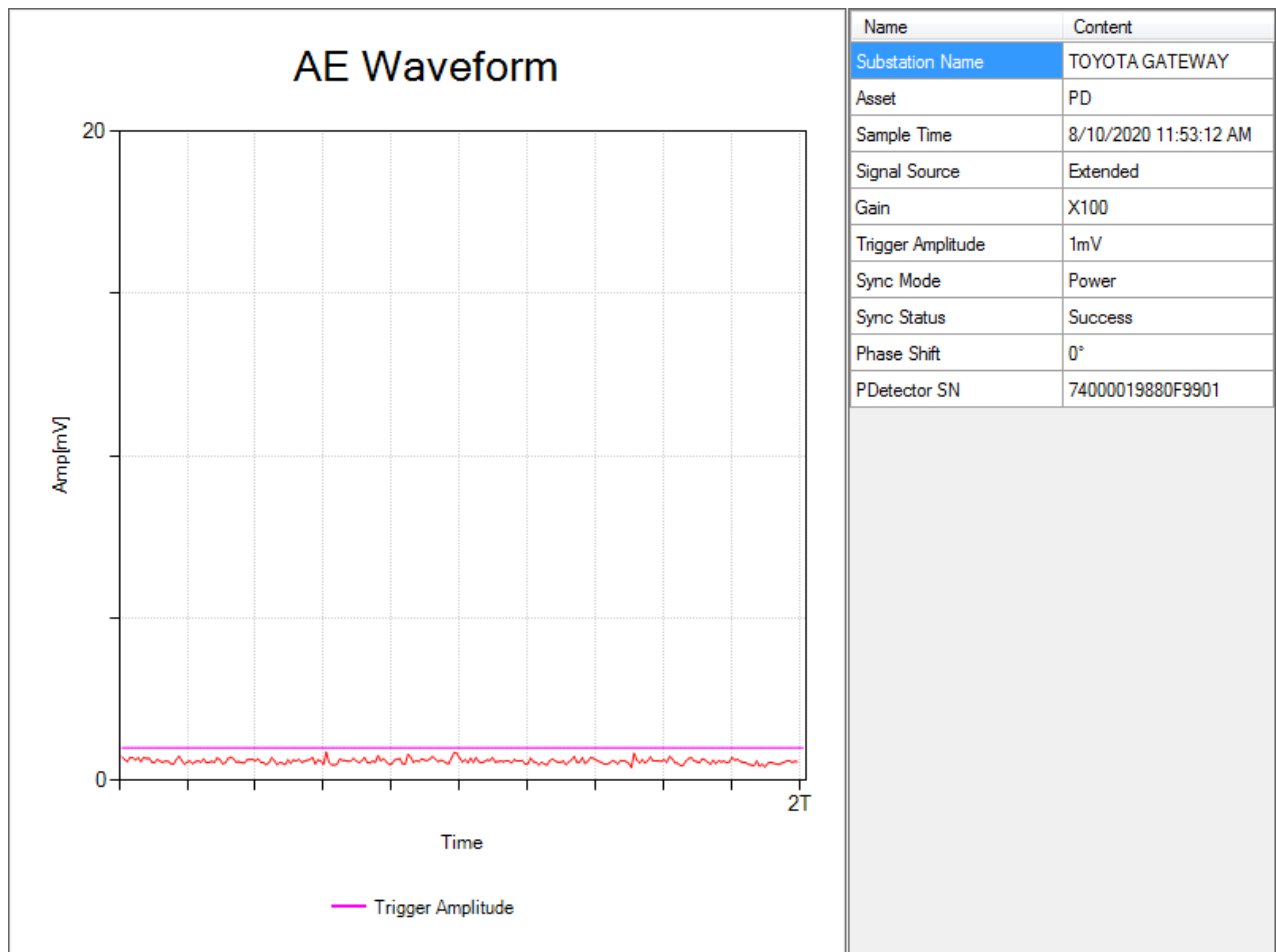
COSTOMER	TOYOTA GATEWAY (THAILAND) CO.,LTD.
SUBSTATION	GIS
POSITION	TR2 TR SEC (FRONT PANEL)
VOLTAGE LEVEL	22 KV

COMMENT	No Partial discharge (PD) was found.
EVALUATION	Normal
SUGGESTION	No action
TESTED AND REPORTED BY	Mr.Tukdanai Pothanak
APPROVED BY	Mr.Chanvit Crukaew

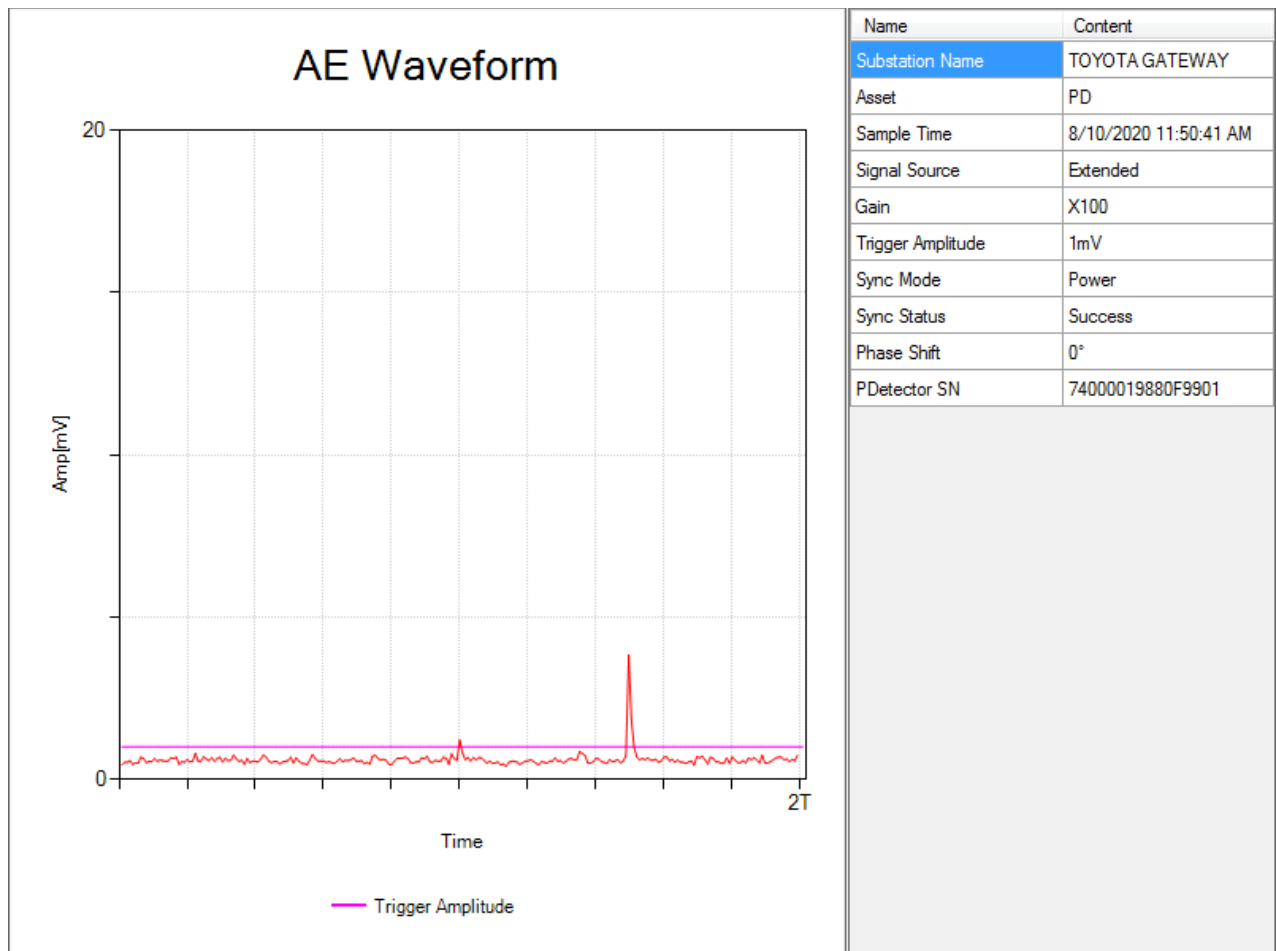
COSTOMER	TOYOTA GATEWAY (THAILAND) CO.,LTD.
SUBSTATION	GIS
POSITION	2-1 FEEDER (BACK PANEL)
VOLTAGE LEVEL	22 KV

COMMENT	Partial discharge (PD) was found.
EVALUATION	Warning
SUGGESTION	No action
TESTED AND REPORTED BY	Mr.Tukdanai Pothanak
APPROVED BY	Mr.Chanvit Crukaew

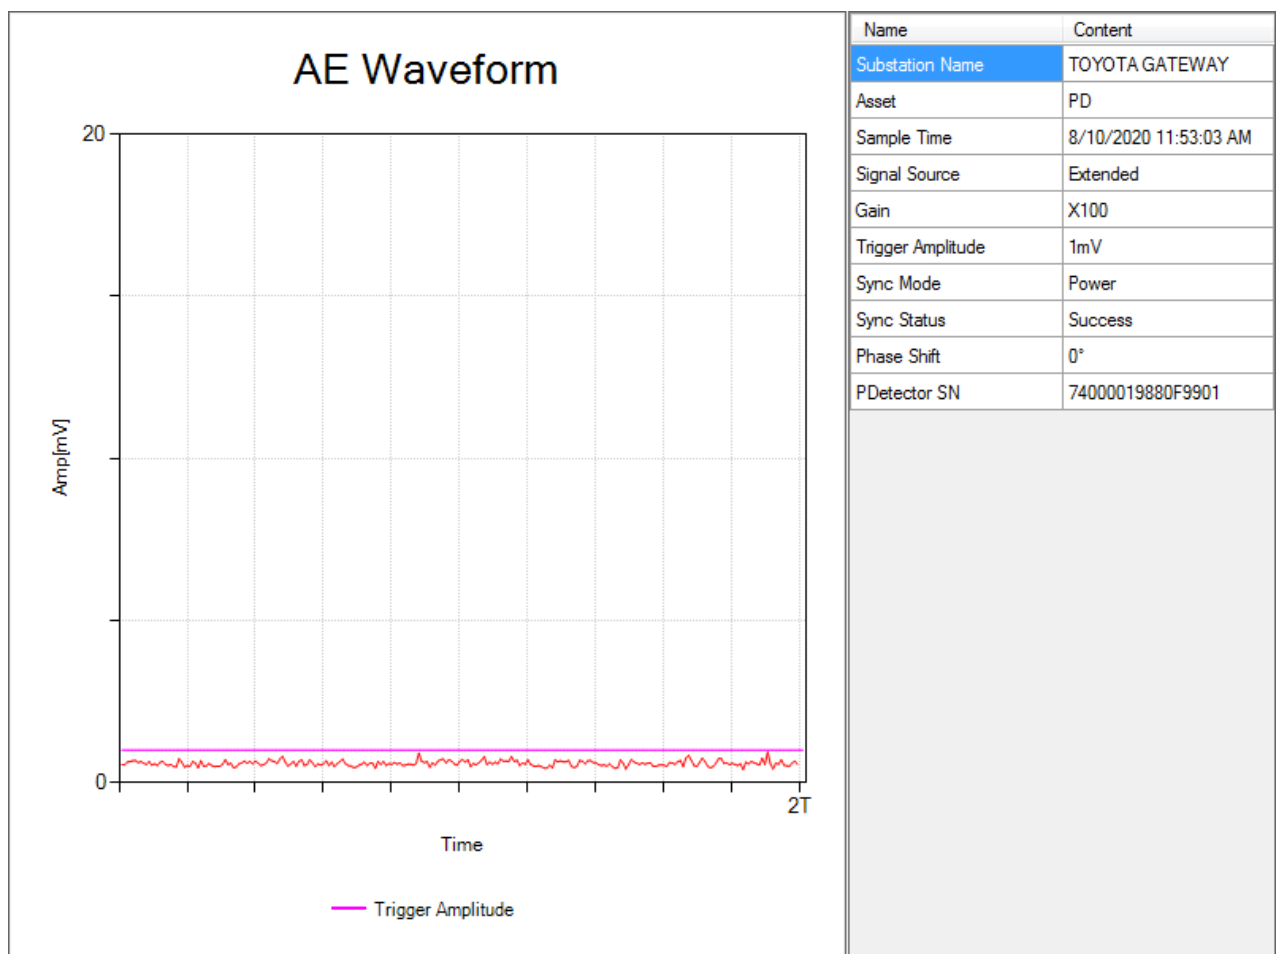
COSTOMER	TOYOTA GATEWAY (THAILAND) CO.,LTD.
SUBSTATION	GIS
POSITION	2-1 FEEDER (FRONT PANEL)
VOLTAGE LEVEL	22 KV

COMMENT	No Partial discharge (PD) was found.
EVALUATION	Normal
SUGGESTION	No action
TESTED AND REPORTED BY	Mr.Tukdanai Pothanak
APPROVED BY	Mr.Chanvit Crukaew

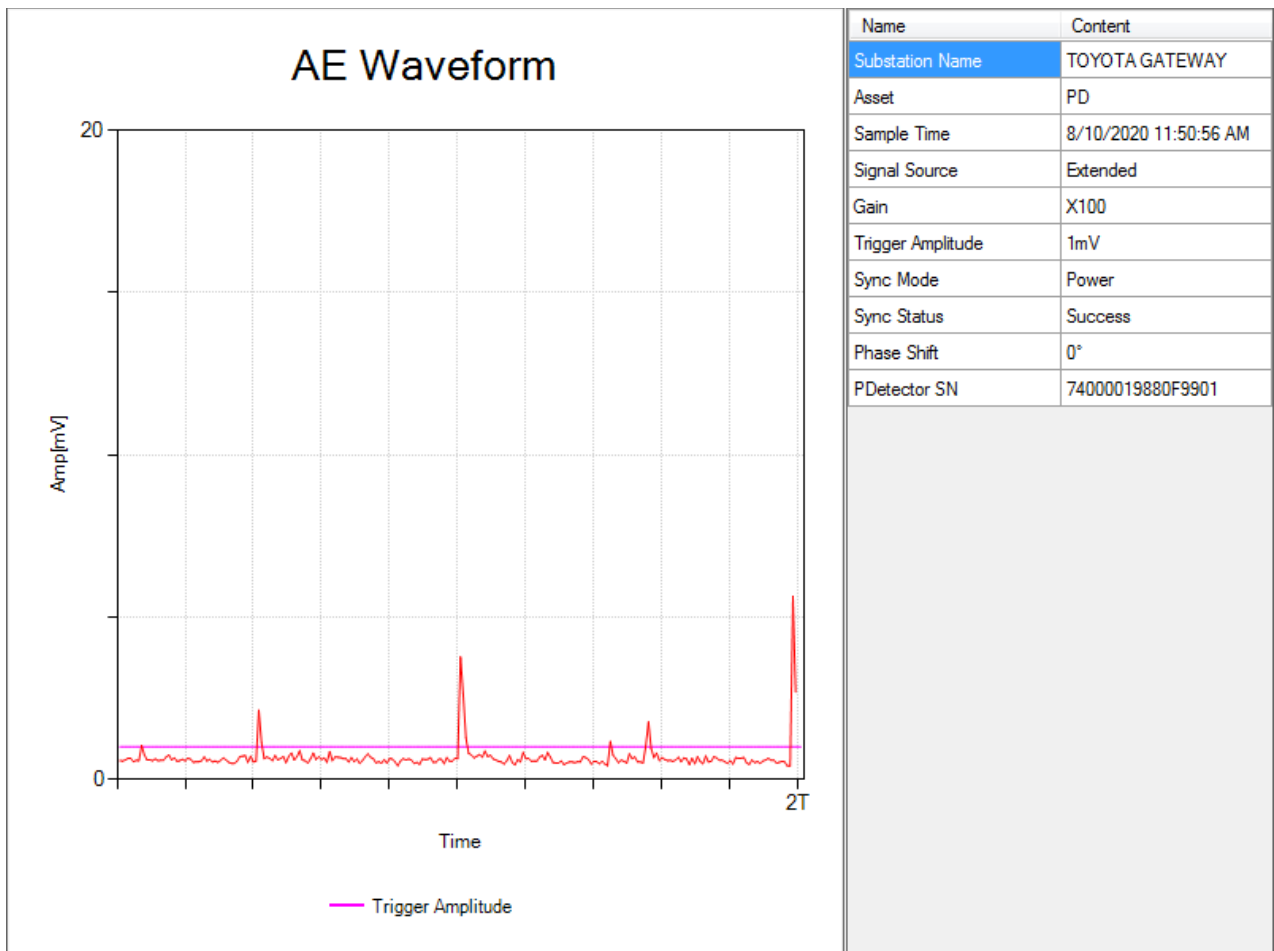
COSTOMER	TOYOTA GATEWAY (THAILAND) CO.,LTD.
SUBSTATION	GIS
POSITION	2-2 FEEDER (BACK PANEL)
VOLTAGE LEVEL	22 KV

COMMENT	Partial discharge (PD) was found.
EVALUATION	Warning
SUGGESTION	The partial discharge should be inspected in the next year.
TESTED AND REPORTED BY	Mr.Tukdanai Pothanak
APPROVED BY	Mr.Chanvit Crukaew

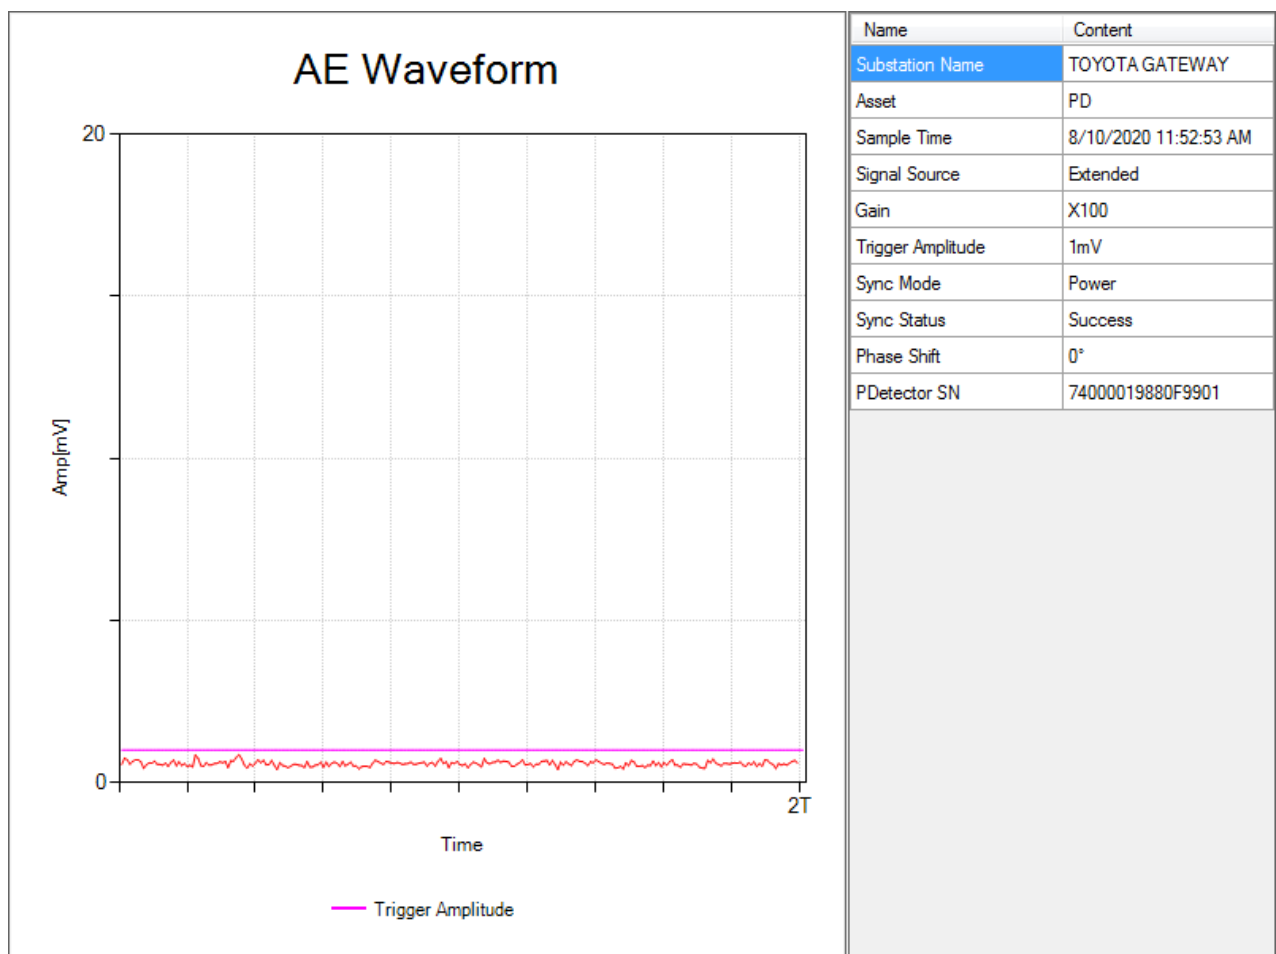
COSTOMER	TOYOTA GATEWAY (THAILAND) CO.,LTD.
SUBSTATION	GIS
POSITION	2-2 FEEDER (FRONT PANEL)
VOLTAGE LEVEL	22 KV

COMMENT	No Partial discharge (PD) was found.
EVALUATION	Normal
SUGGESTION	No action
TESTED AND REPORTED BY	Mr.Tukdanai Pothanak
APPROVED BY	Mr.Chanvit Crukaew
