PARTIAL DISCHARGE REPORT

CUSTOMER :CO.,LTD.

DATE : July 8th, 2020

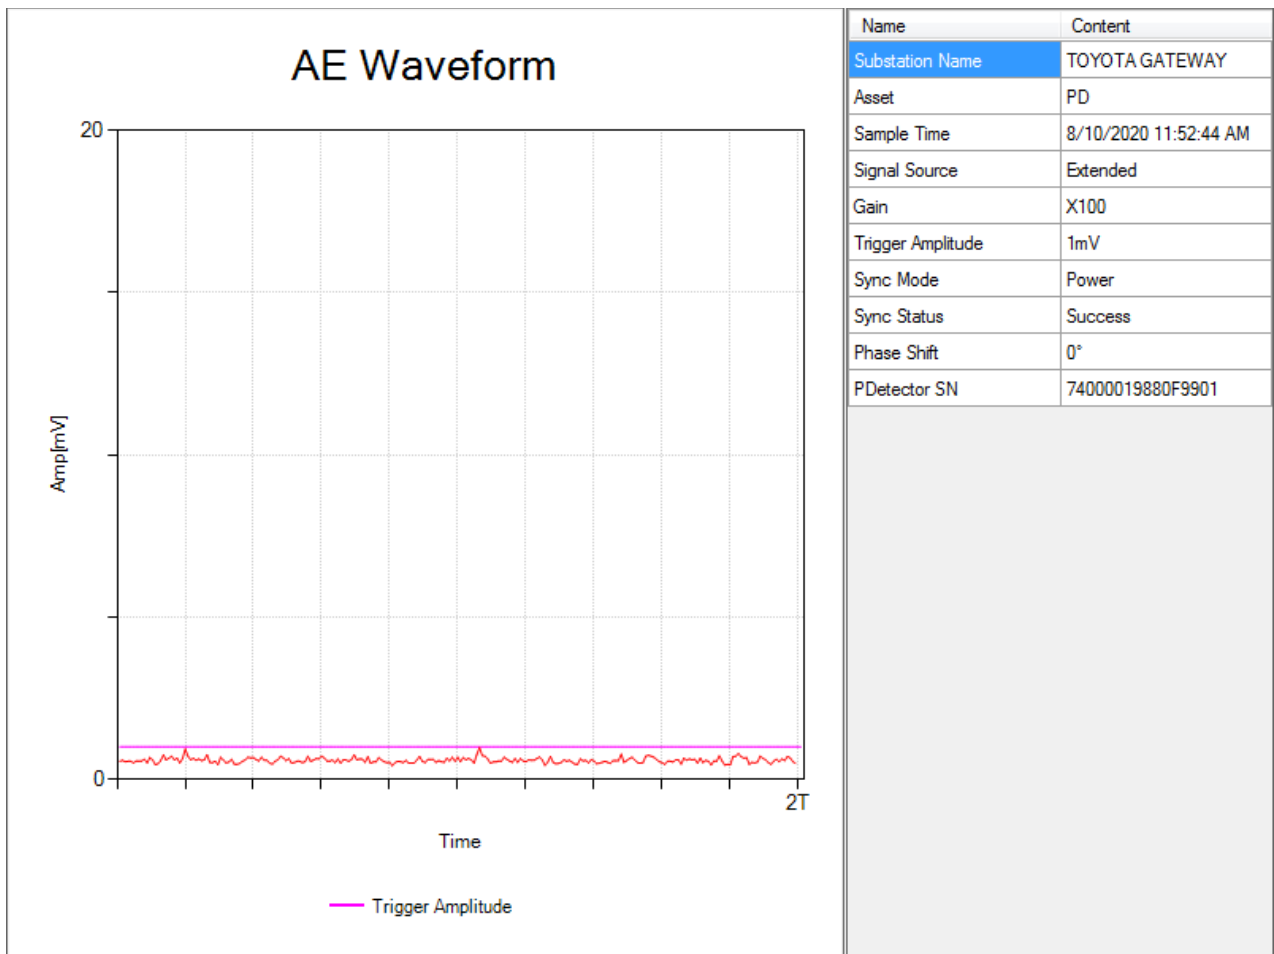
COSTOMER	TOYOTA GATEWAY (THAILAND) CO.,LTD.
SUBSTATION	GIS
POSITION	2-3 FEEDER FRONE PANEL
VOLTAGE LEVEL	22 KV

COMMENT	No Partial discharge (PD) was found.
EVALUATION	Normal
SUGGESTION	No action
TESTED AND REPORTED BY	Mr.Tukdanai Pothanak
APPROVED BY	Mr.Chanvit Crukaew

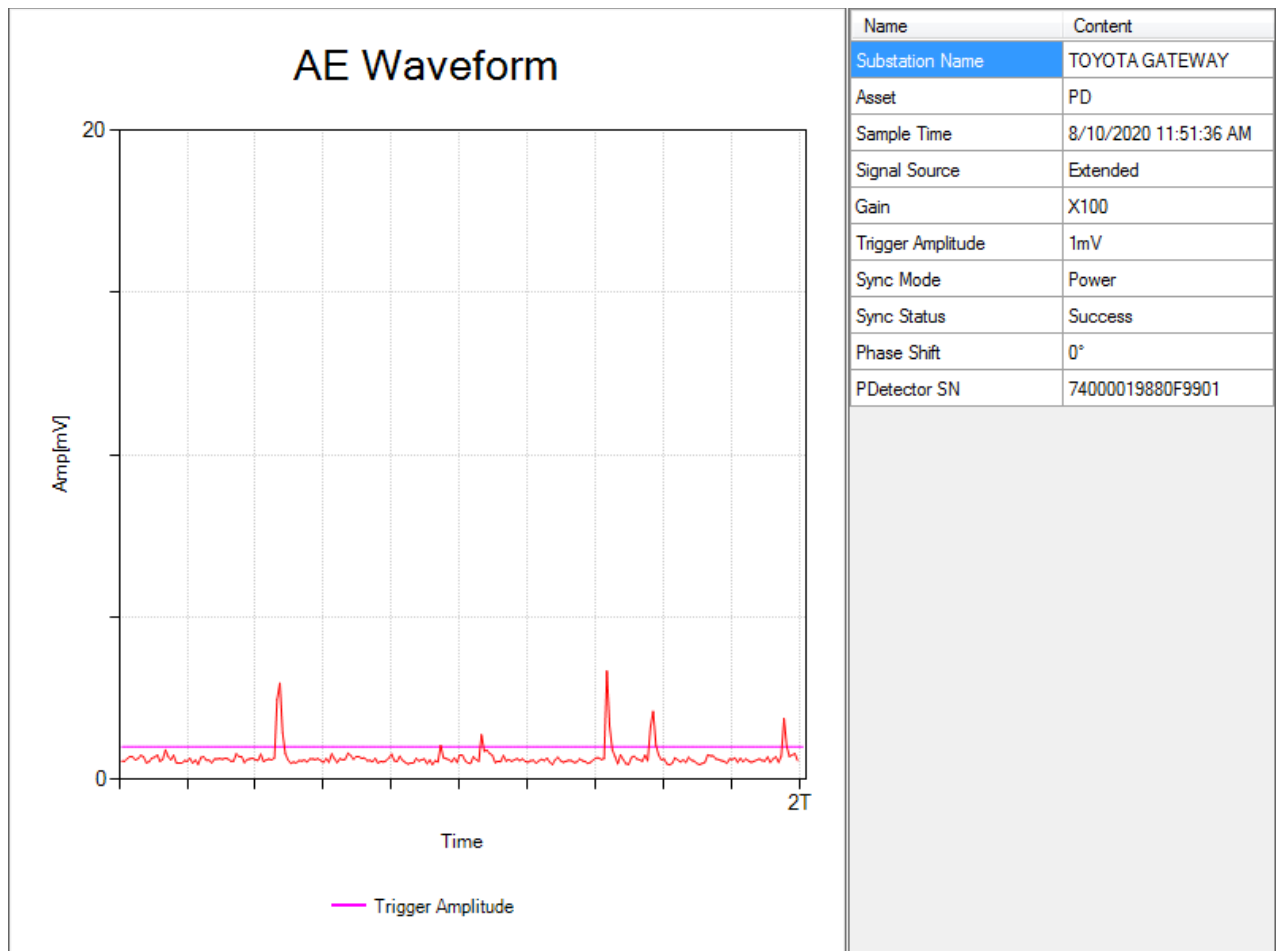
COSTOMER	TOYOTA GATEWAY (THAILAND) CO.,LTD.
SUBSTATION	GIS
POSITION	2-4 FEEDER (BACK PANEL)
VOLTAGE LEVEL	22 KV

COMMENT	Partial discharge (PD) was found.
EVALUATION	Warning
SUGGESTION	The partial discharge should be inspected in the next year.
TESTED AND REPORTED BY	Mr.Tukdanai Pothanak
APPROVED BY	Mr.Chanvit Crukaew

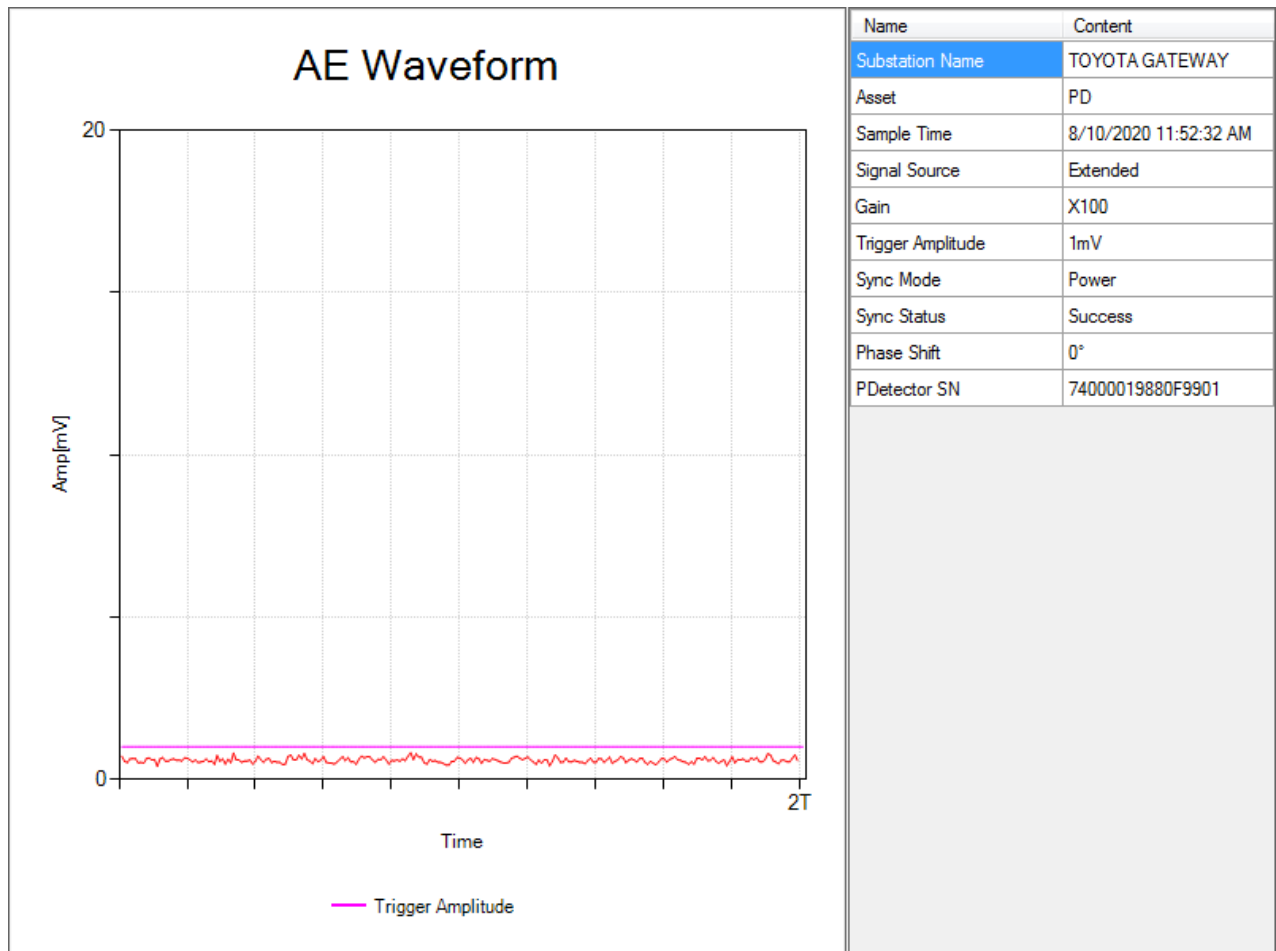
COSTOMER	TOYOTA GATEWAY (THAILAND) CO.,LTD.
SUBSTATION	GIS
POSITION	2-4 FEEDER (FRONT PANEL)
VOLTAGE LEVEL	22 KV

COMMENT	No Partial discharge (PD) was found.
EVALUATION	Normal
SUGGESTION	No action
TESTED AND REPORTED BY	Mr.Tukdanai Pothanak
APPROVED BY	Mr.Chanvit Crukaew

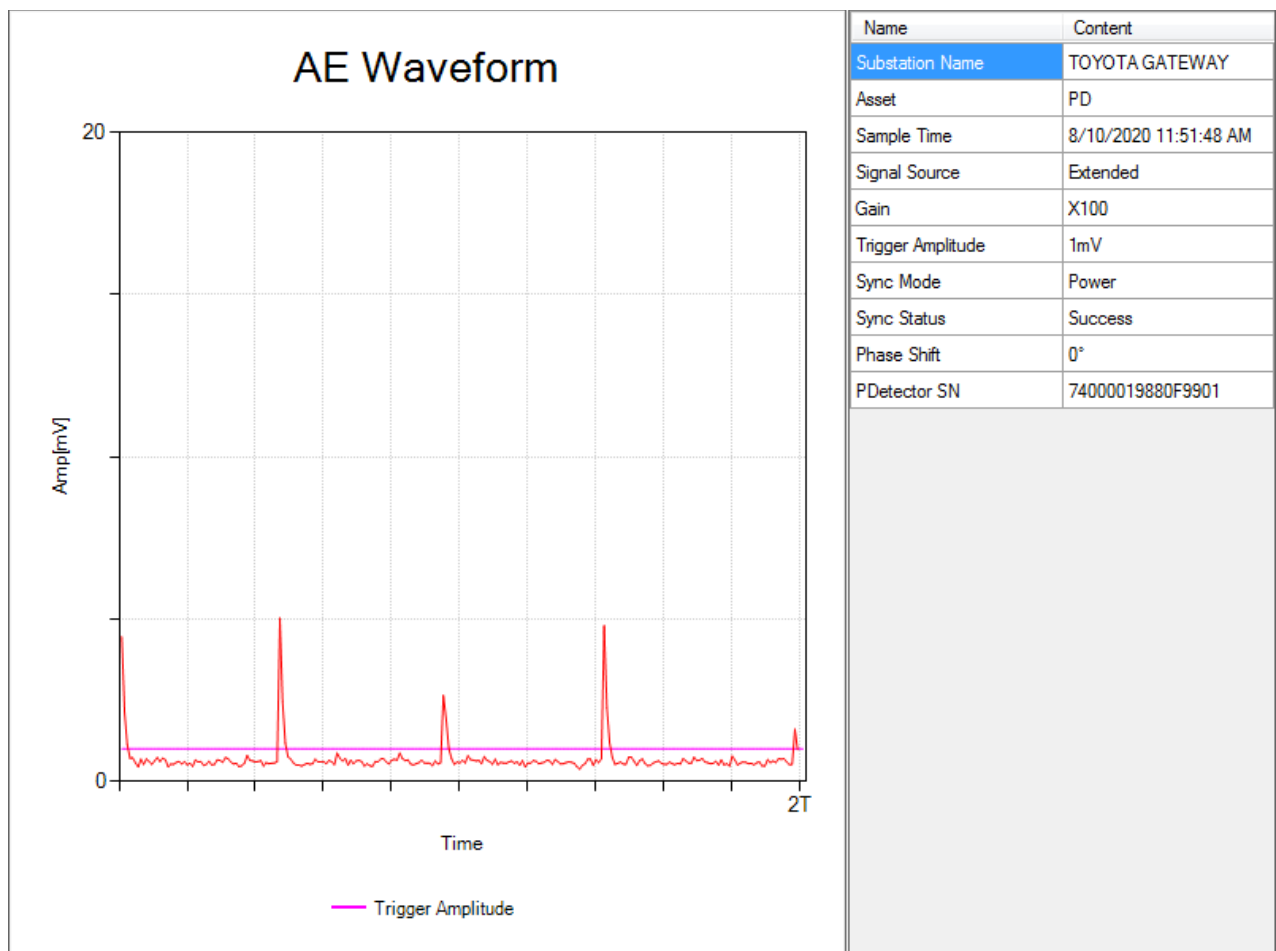
COSTOMER	TOYOTA GATEWAY (THAILAND) CO.,LTD.
SUBSTATION	GIS
POSITION	CAPACIGOR BACK PANEL NO.2
VOLTAGE LEVEL	22 KV

COMMENT	Partial discharge (PD) was found.
EVALUATION	Warning
SUGGESTION	The partial discharge should be inspected in the next year.
TESTED AND REPORTED BY	Mr.Tukdanai Pothanak
APPROVED BY	Mr.Chanvit Crukaew

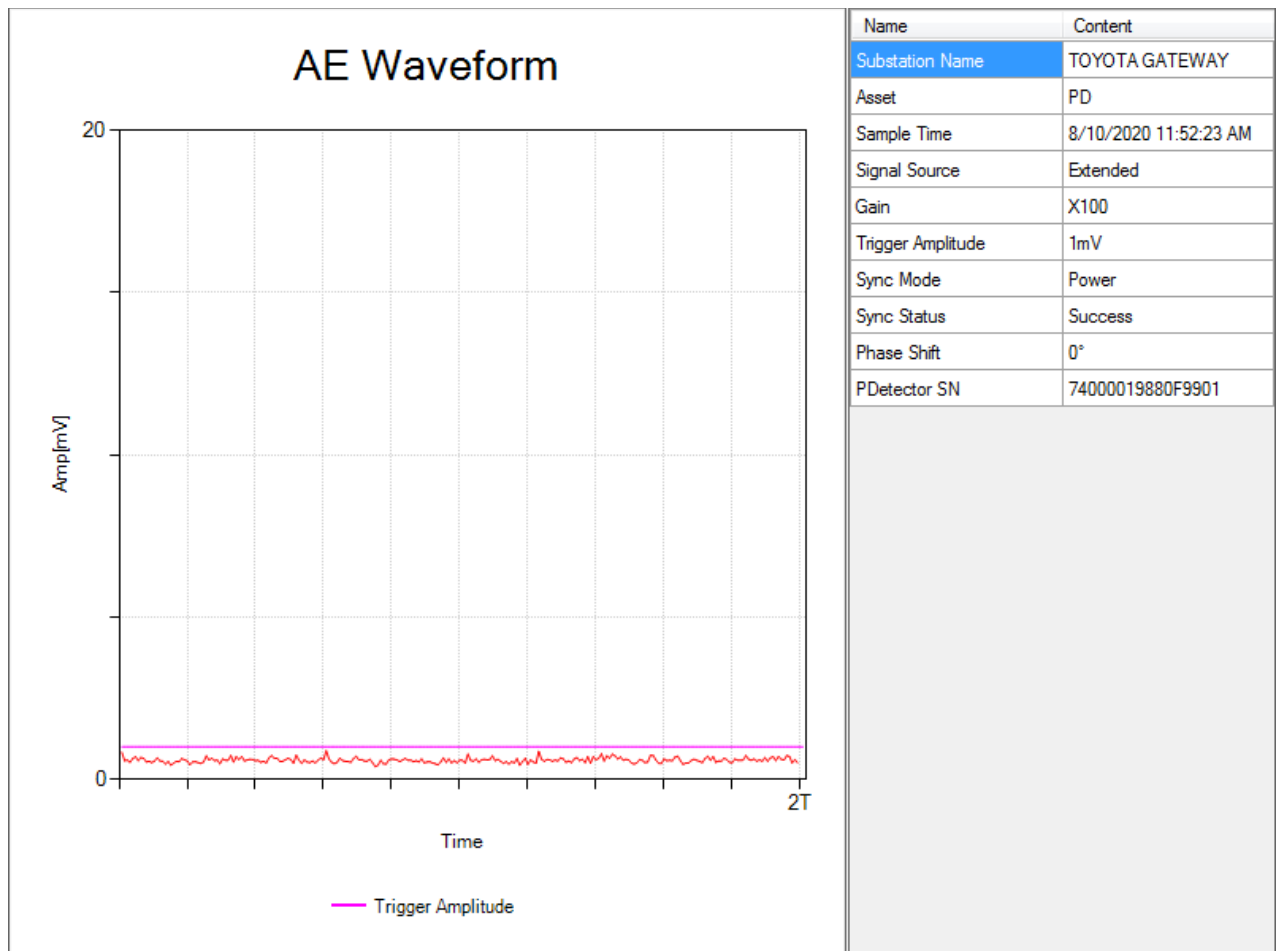
COSTOMER	TOYOTA GATEWAY (THAILAND) CO.,LTD.
SUBSTATION	GIS
POSITION	CAPACIGOR FRONT PANEL NO.2
VOLTAGE LEVEL	22 KV

COMMENT	No Partial discharge (PD) was found.
EVALUATION	Normal
SUGGESTION	No action
TESTED AND REPORTED BY	Mr.Tukdanai Pothanak
APPROVED BY	Mr.Chanvit Crukaew

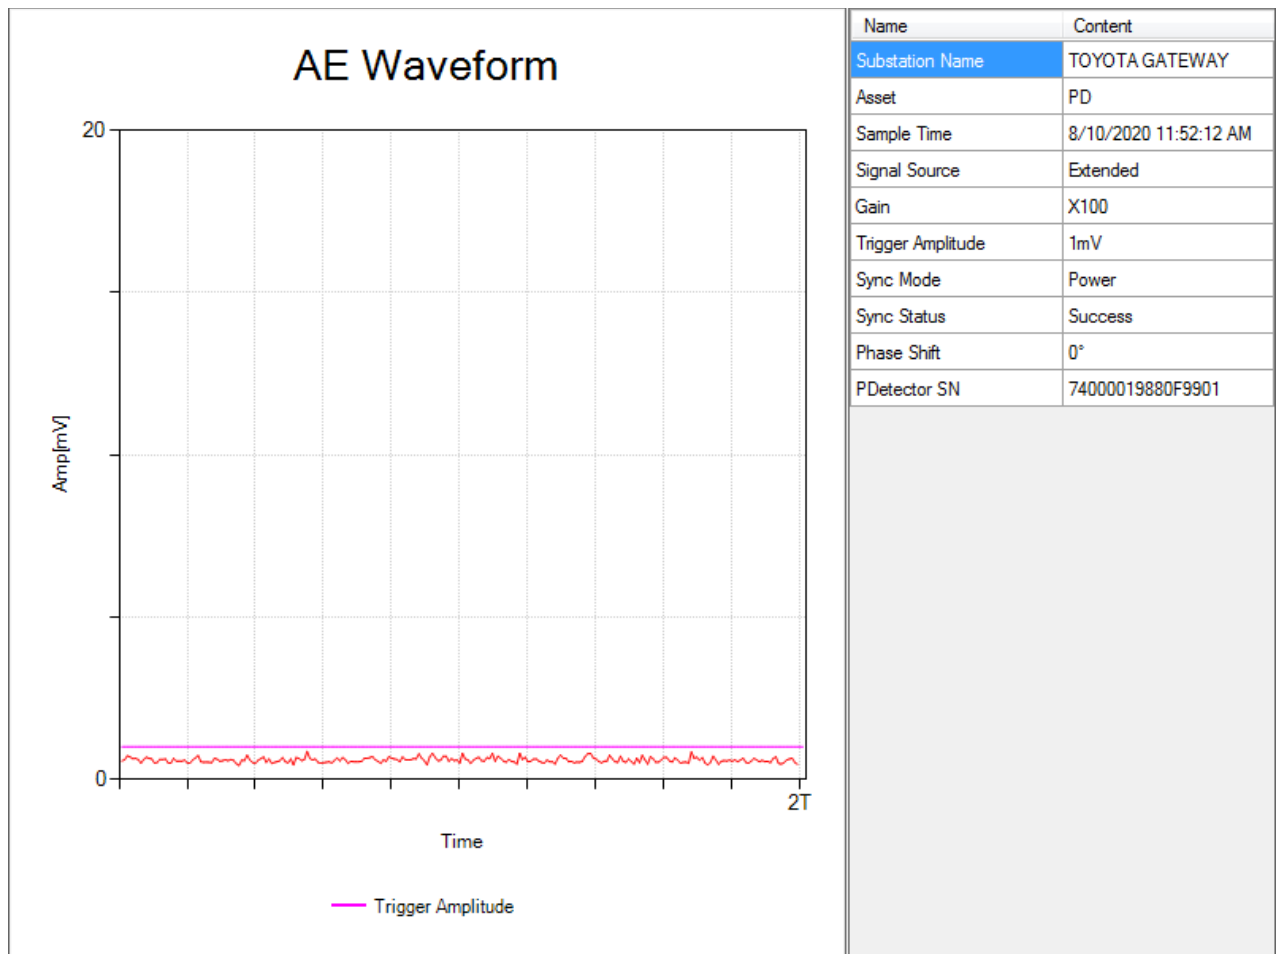
COSTOMER	TOYOTA GATEWAY (THAILAND) CO.,LTD.
SUBSTATION	GIS
POSITION	NO.2BANK BUS-TIE (FRONT PANEL)
VOLTAGE LEVEL	22 KV

COMMENT	No Partial discharge (PD) was found.
EVALUATION	Normal
SUGGESTION	No action
TESTED AND REPORTED BY	Mr.Tukdanai Pothanak
APPROVED BY	Mr.Chanvit Crukaew

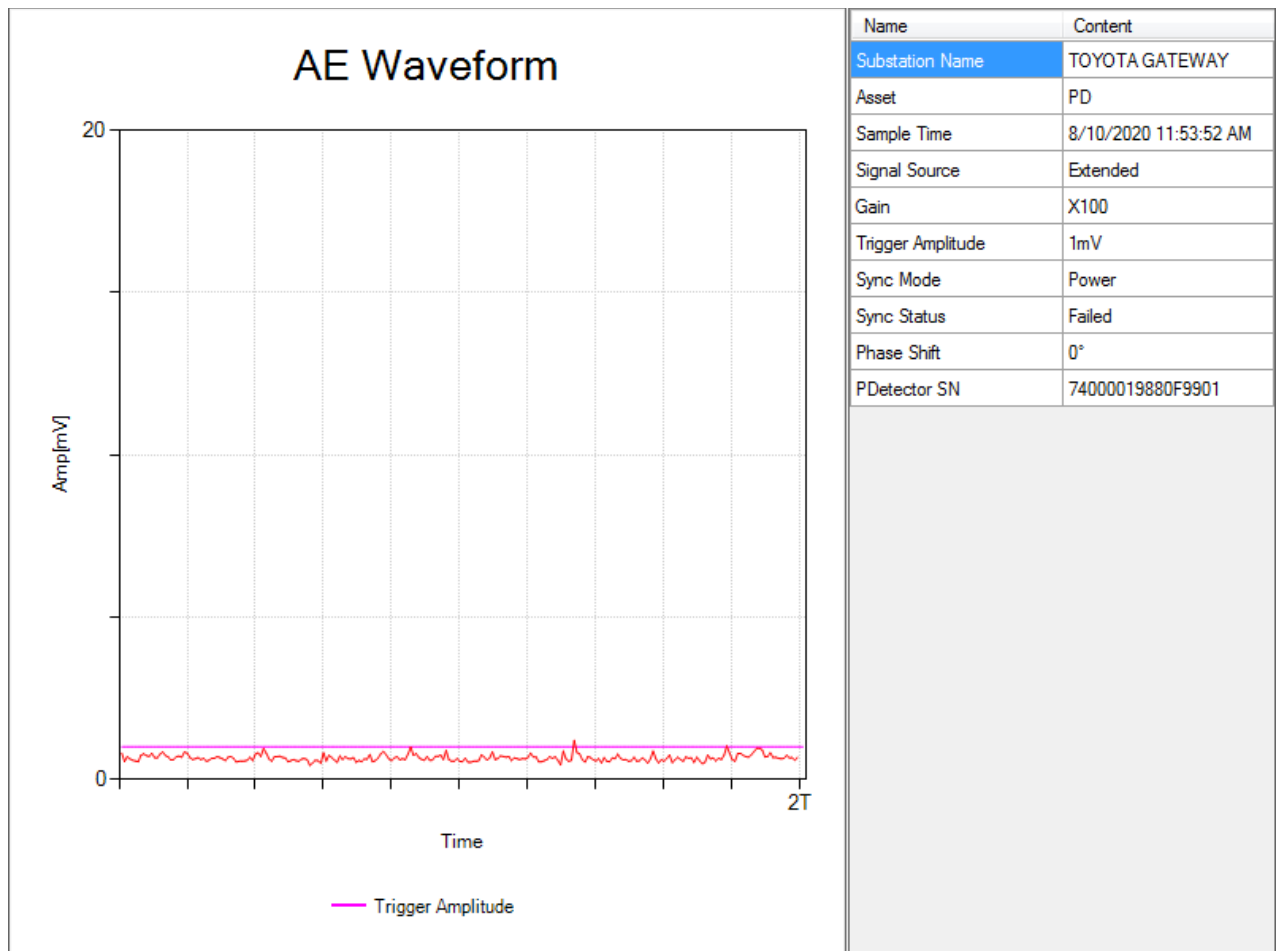
COSTOMER	TOYOTA GATEWAY (THAILAND) CO.,LTD.
SUBSTATION	GIS
POSITION	DC POWER SUP. (FRONT PANEL)
VOLTAGE LEVEL	22 KV

COMMENT	No Partial discharge (PD) was found.
EVALUATION	Normal
SUGGESTION	No action
TESTED AND REPORTED BY	Mr.Tukdanai Pothanak
APPROVED BY	Mr.Chanvit Crukaew

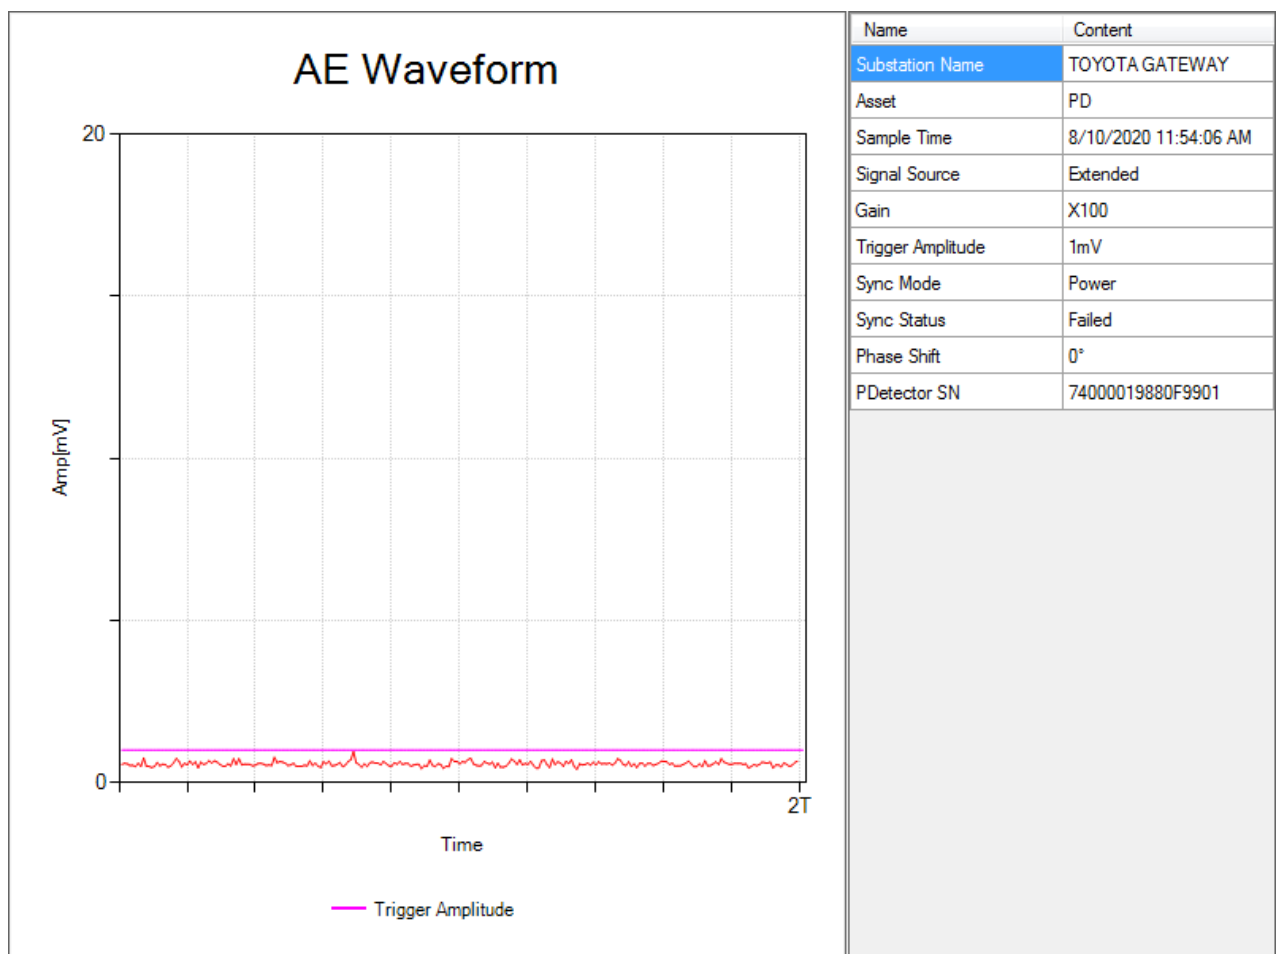
COSTOMER	TOYOTA GATEWAY (THAILAND) CO.,LTD.
SUBSTATION	GIS
POSITION	NO.2BANK BUS-TIE (FRONT PANEL)
VOLTAGE LEVEL	22 KV

COMMENT	No Partial discharge (PD) was found.
EVALUATION	Normal
SUGGESTION	No action
TESTED AND REPORTED BY	Mr.Tukdanai Pothanak
APPROVED BY	Mr.Chanvit Crukaew

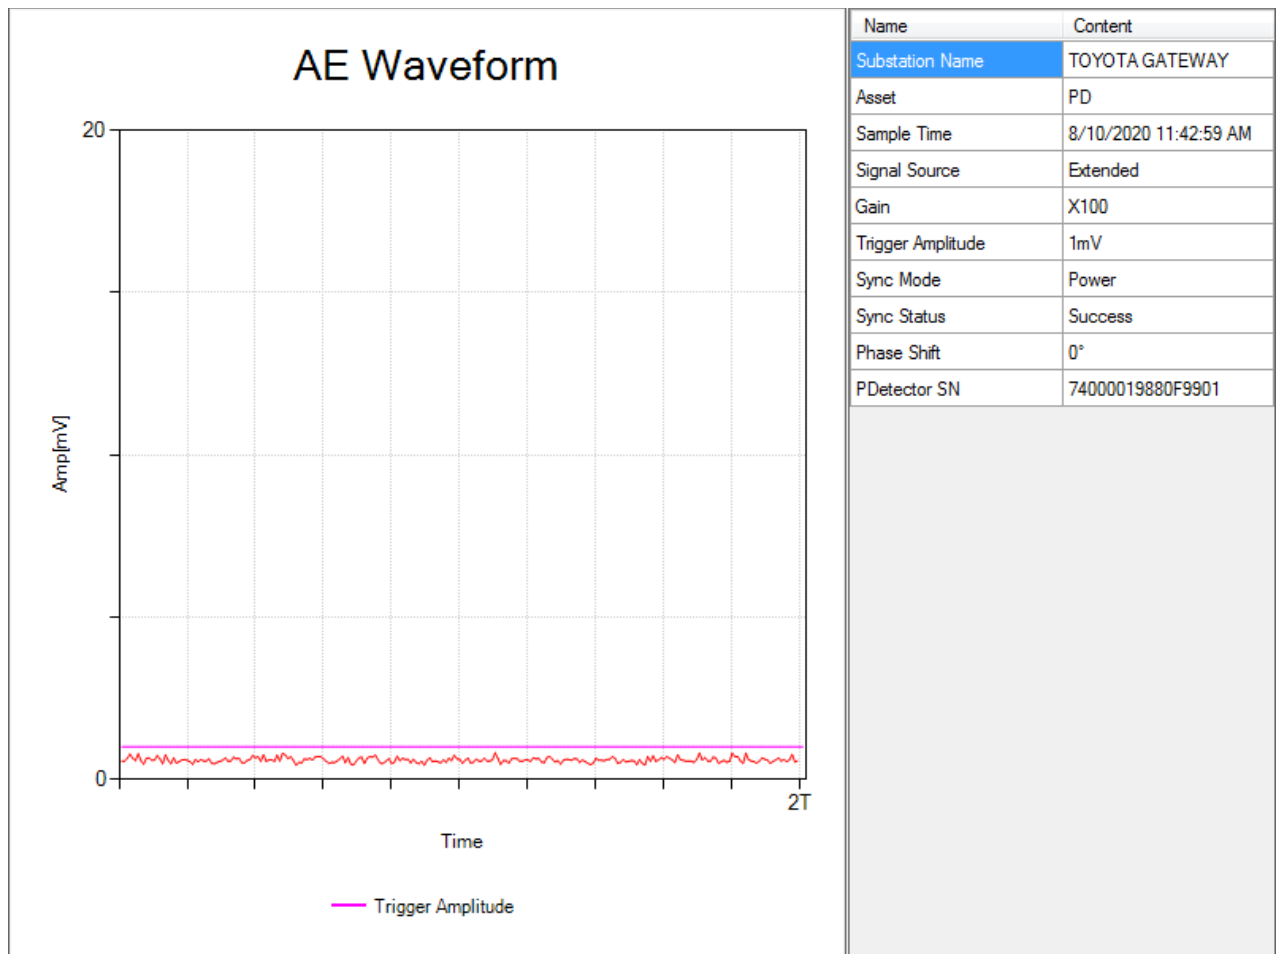
COSTOMER	TOYOTA GATEWAY (THAILAND) CO.,LTD.
SUBSTATION	GIS
POSITION	NO.2 TR SEE (BACK PANEL)
VOLTAGE LEVEL	22 KV

COMMENT	No Partial discharge (PD) was found.
EVALUATION	Normal
SUGGESTION	No action
TESTED AND REPORTED BY	Mr.Tukdanai Pothanak
APPROVED BY	Mr.Chanvit Crukaew

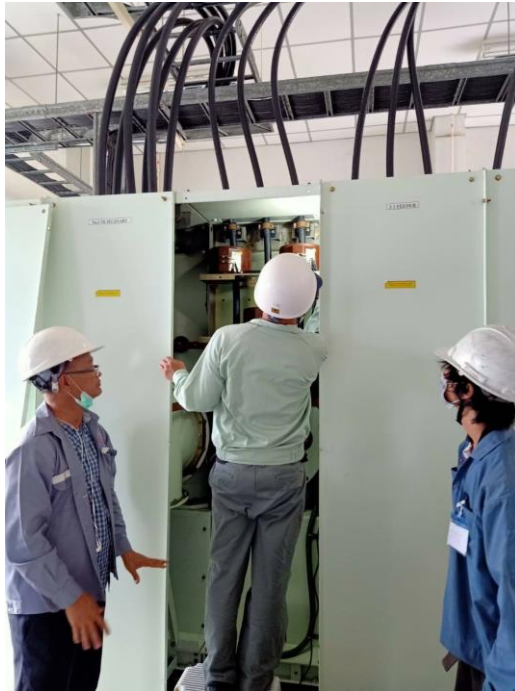
PARTIAL DISCHARGE DETECTED BY VISUALLY INSPECT

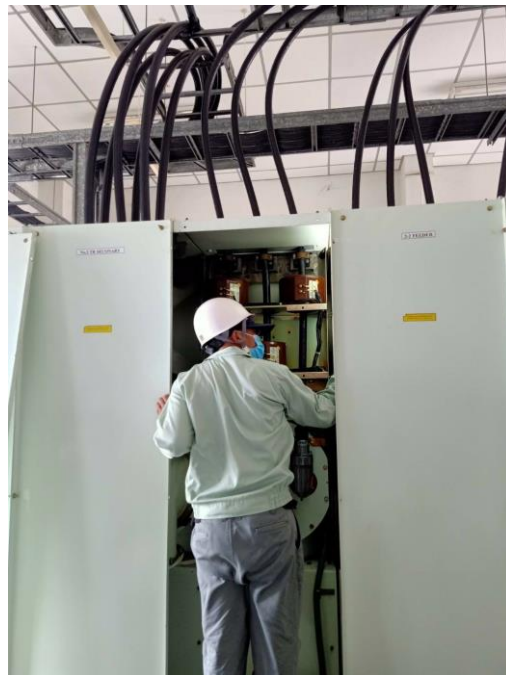
PARTIAL DISCHARGE DETECTED BY VISUALLY INSPECT

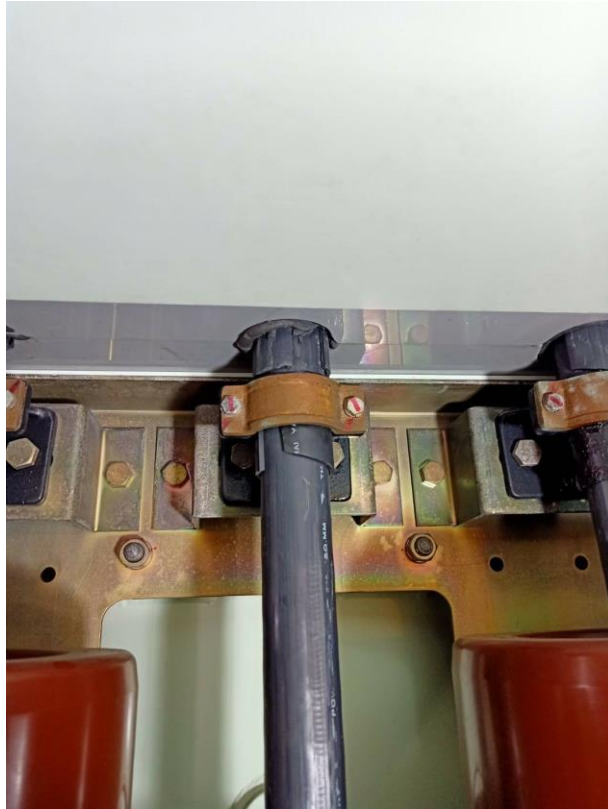
PARTIAL DISCHARGE DETECTED BY VISUALLY INSPECT

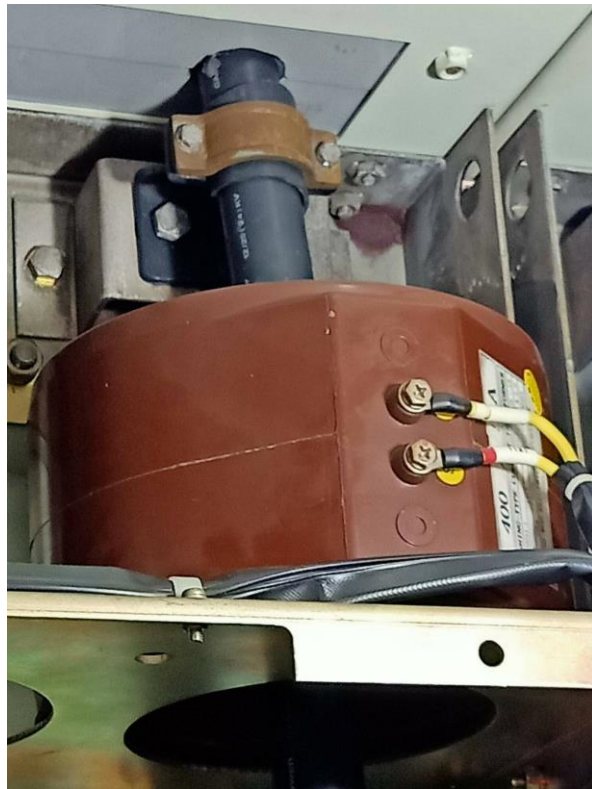
PARTIAL DISCHARGE DETECTED BY VISUALLY INSPECT

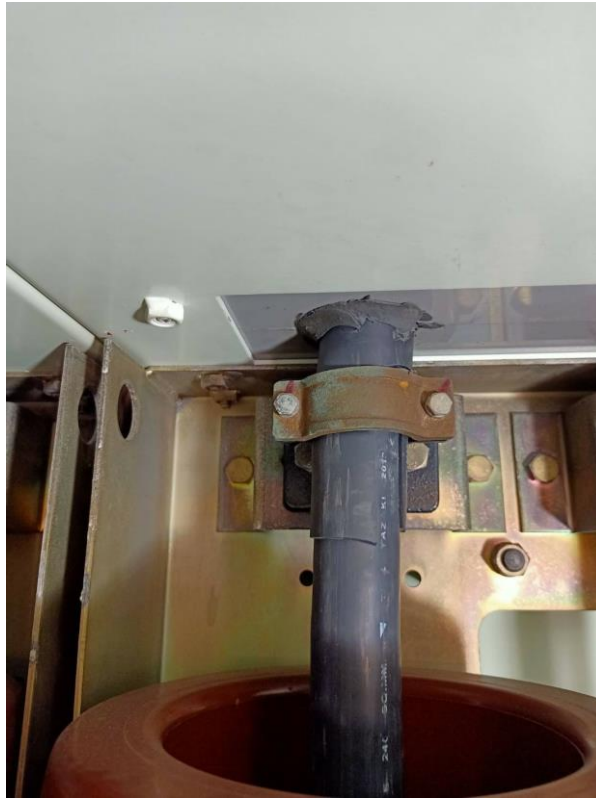
PARTIAL DISCHARGE DETECTED BY VISUALLY INSPECT

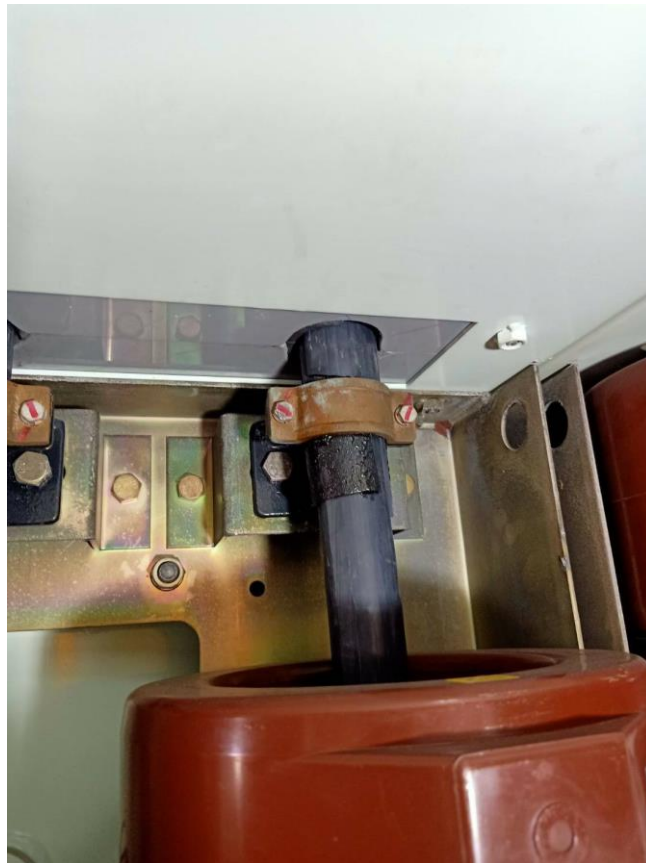
PARTIAL DISCHARGE DETECTED BY VISUALLY INSPECT

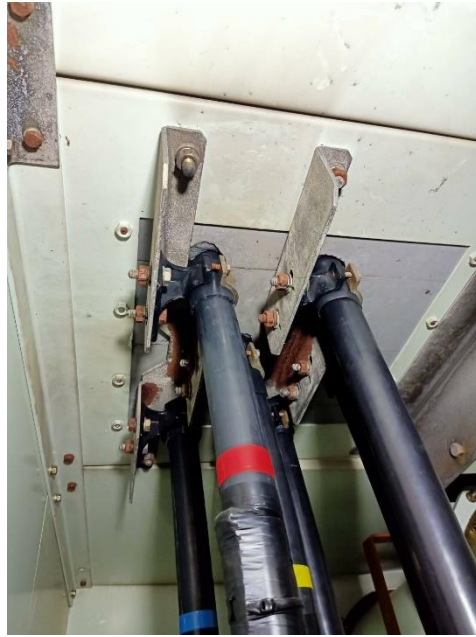
PARTIAL DISCHARGE DETECTED BY VISUALLY INSPECT

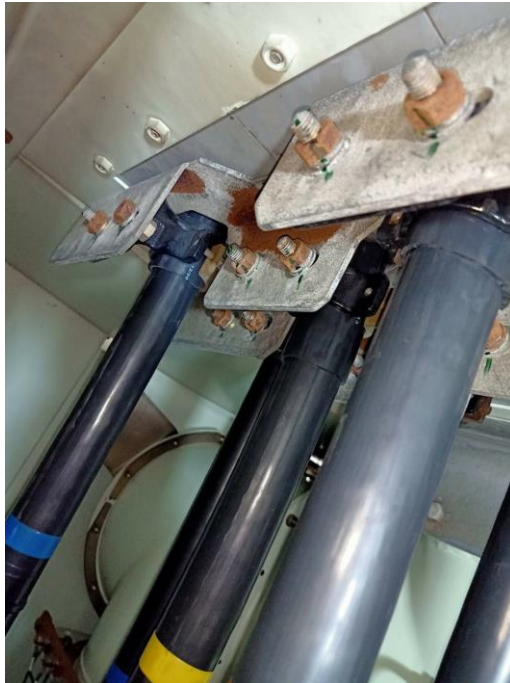
PARTIAL DISCHARGE DETECTED BY VISUALLY INSPECT

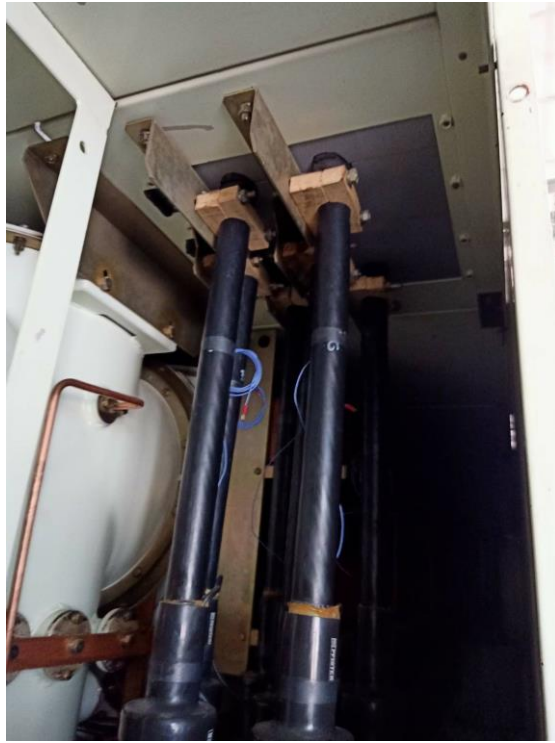
PARTIAL DISCHARGE DETECTED BY VISUALLY INSPECT

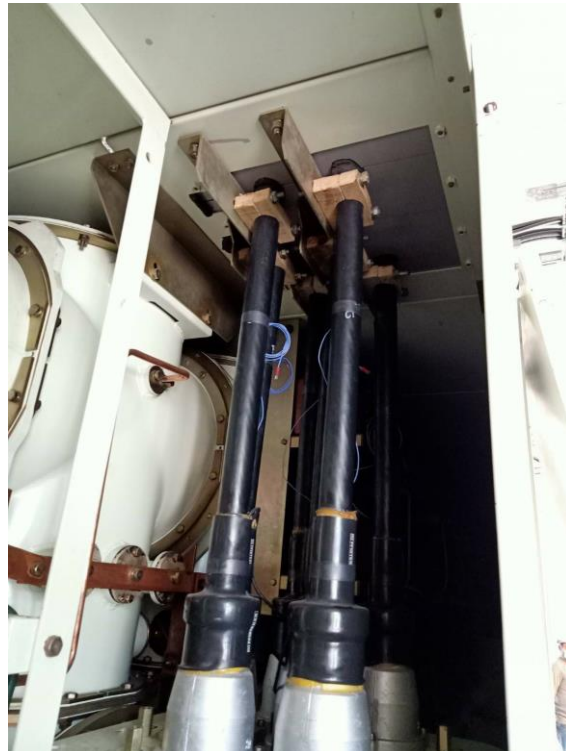
PARTIAL DISCHARGE DETECTED BY VISUALLY INSPECT

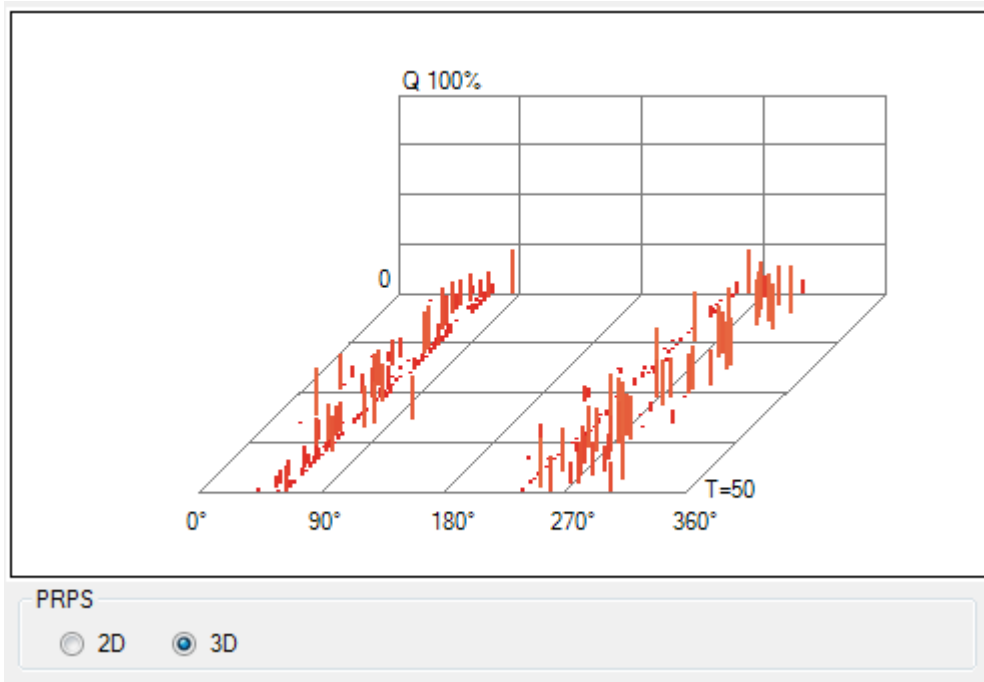
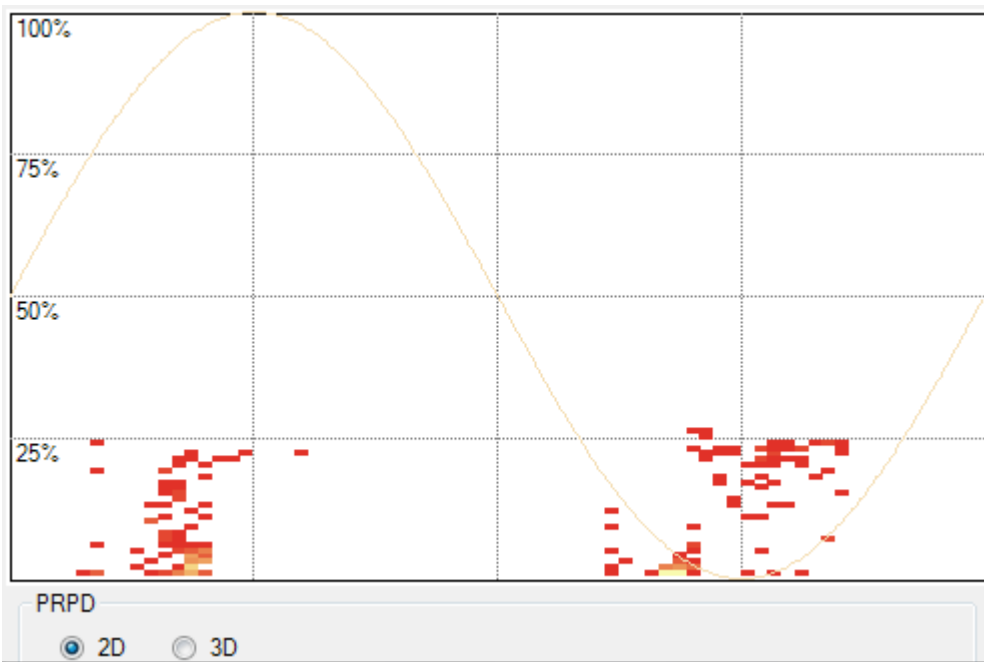
PHOTO.47 VOID OR INTERNAL DISCHARGE PATTERN 7

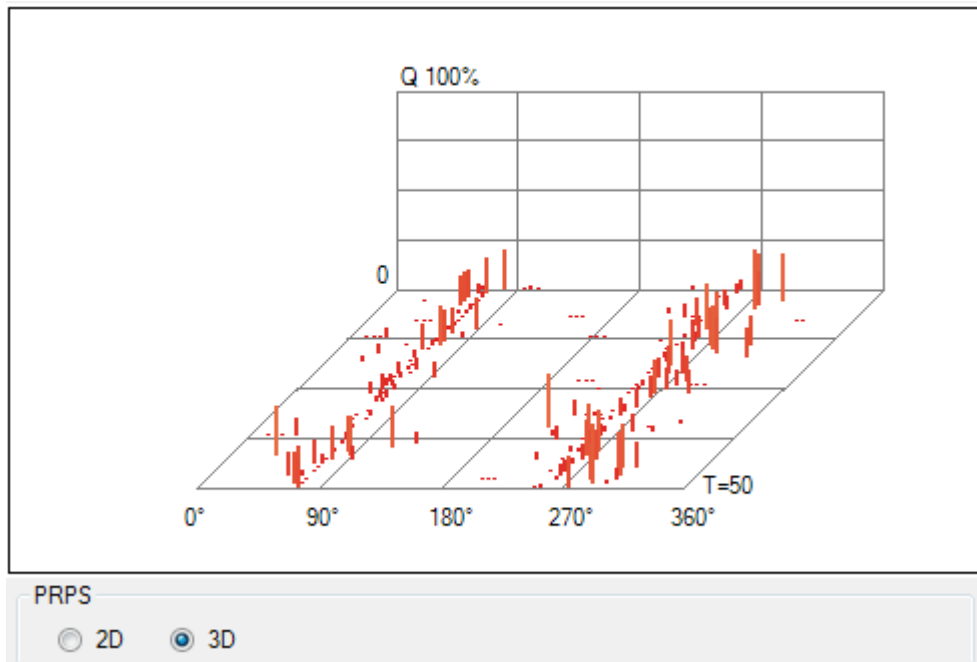
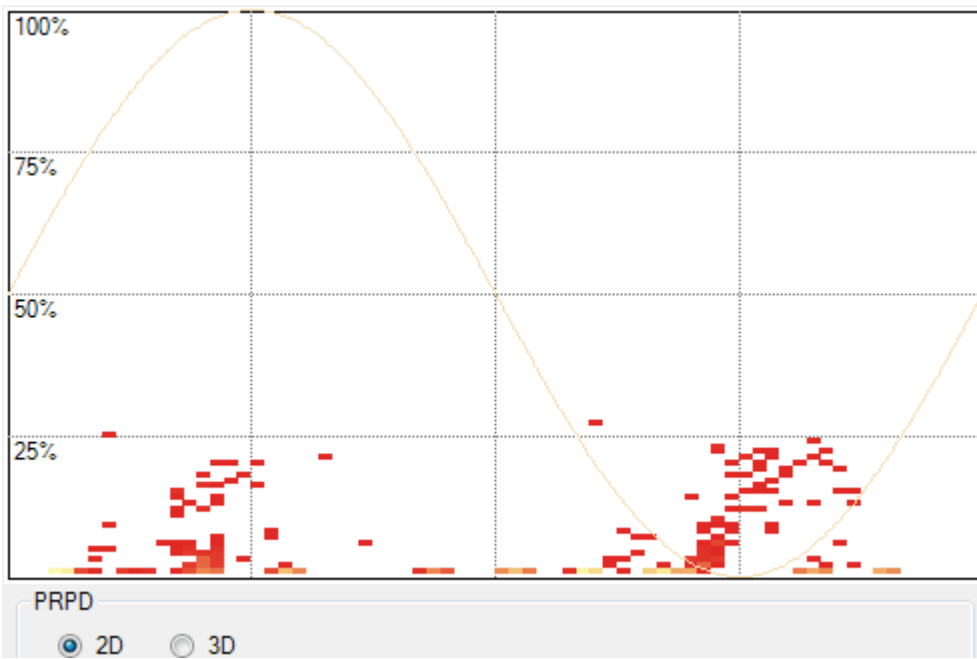
PHOTO.48 VOID OR INTERNAL DISCHARGE PATTERN 8

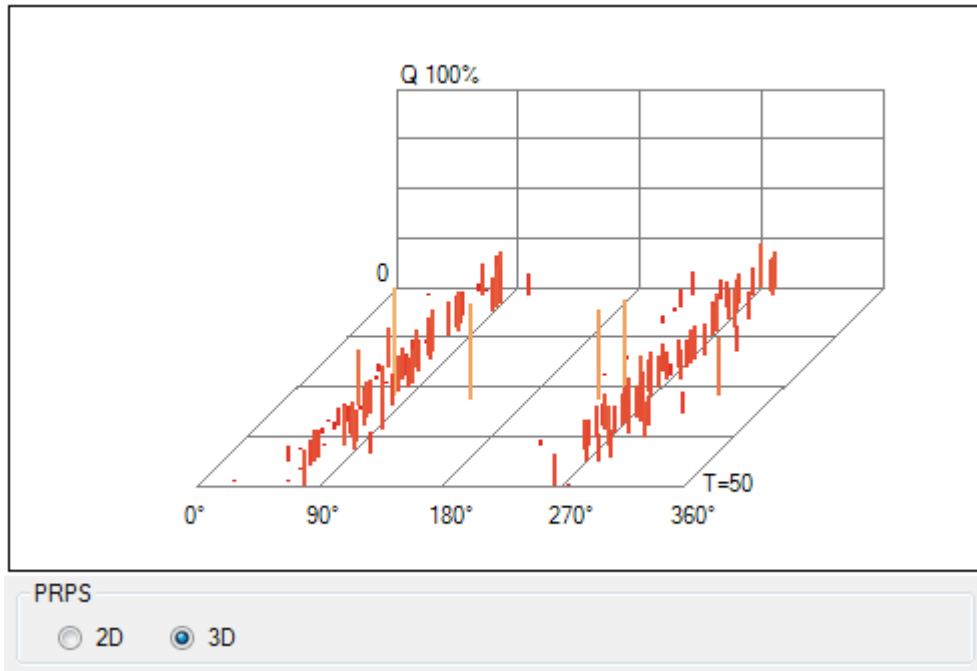
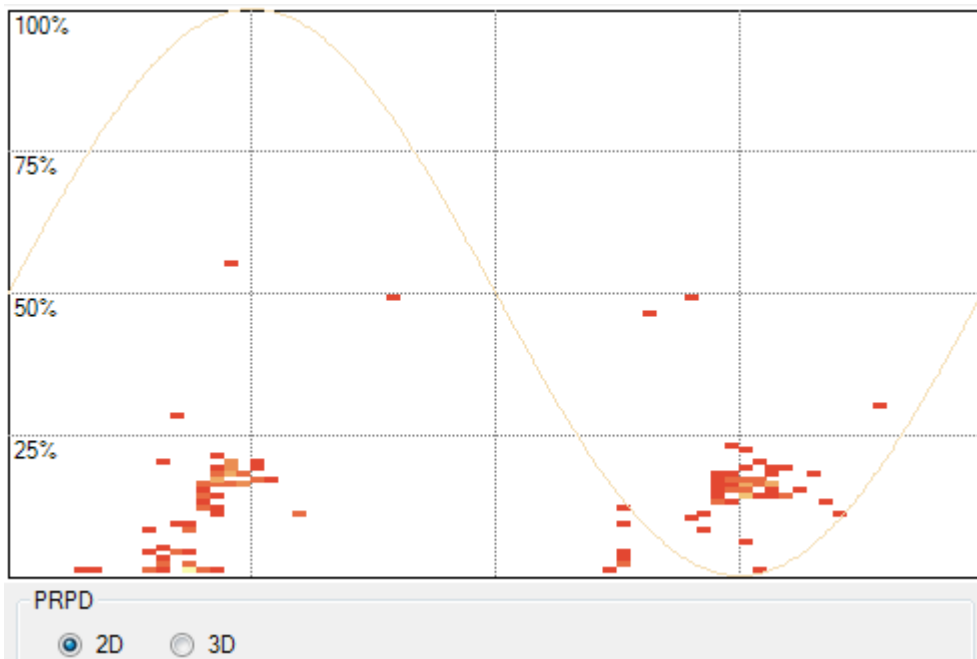
PHOTO.49 VOID OR INTERNAL DISCHARGE PATTERN 9

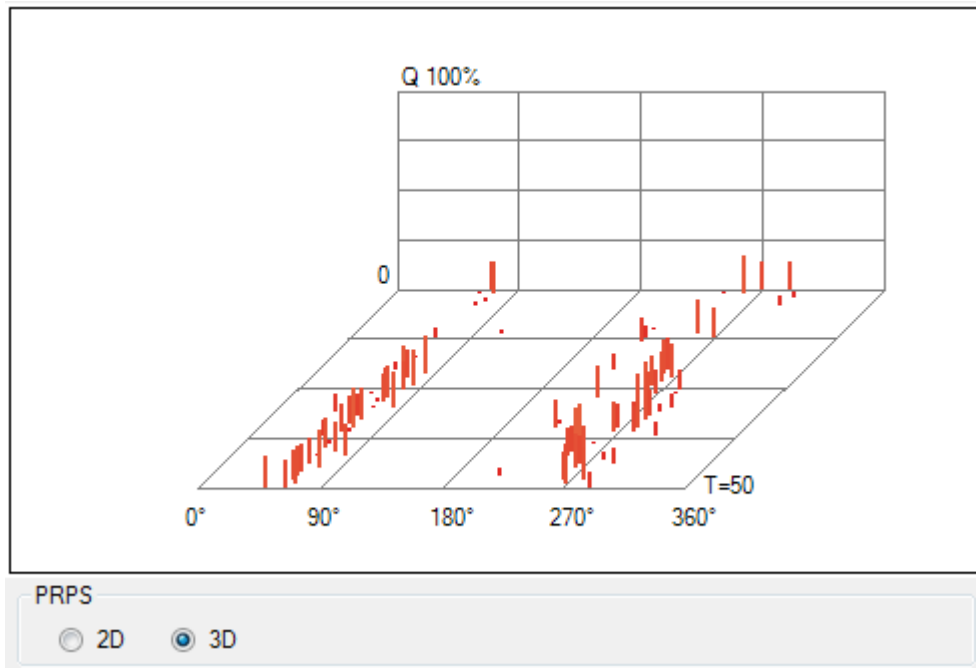
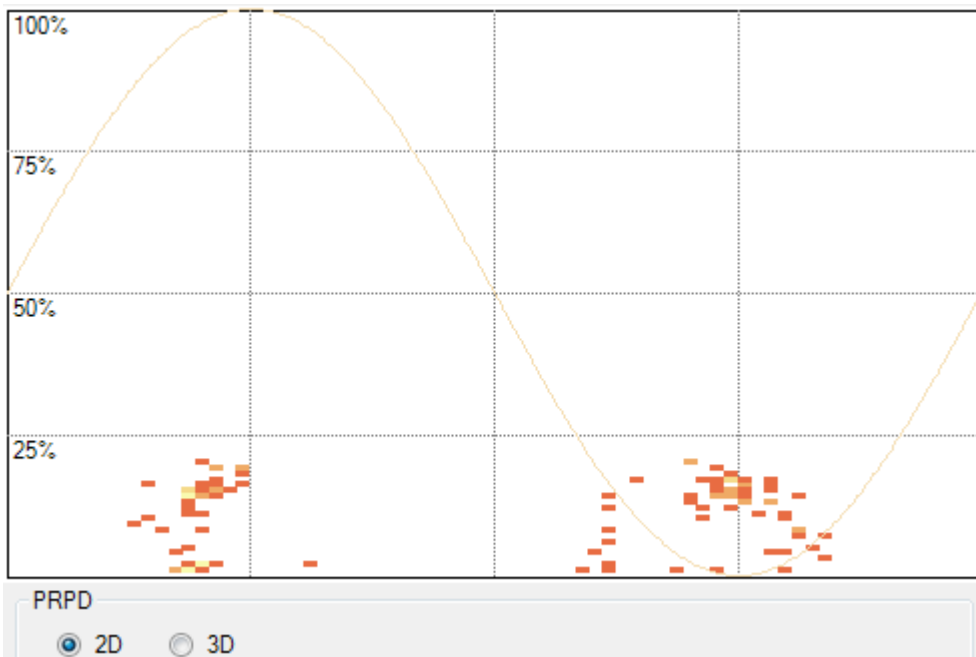
PHOTO.50 VOID OR INTERNAL DISCHARGE PATTERN 10
